Location : Changi Circle Park

Date of inspection : 17-Jun-2020 (Wednesday)

Observation report

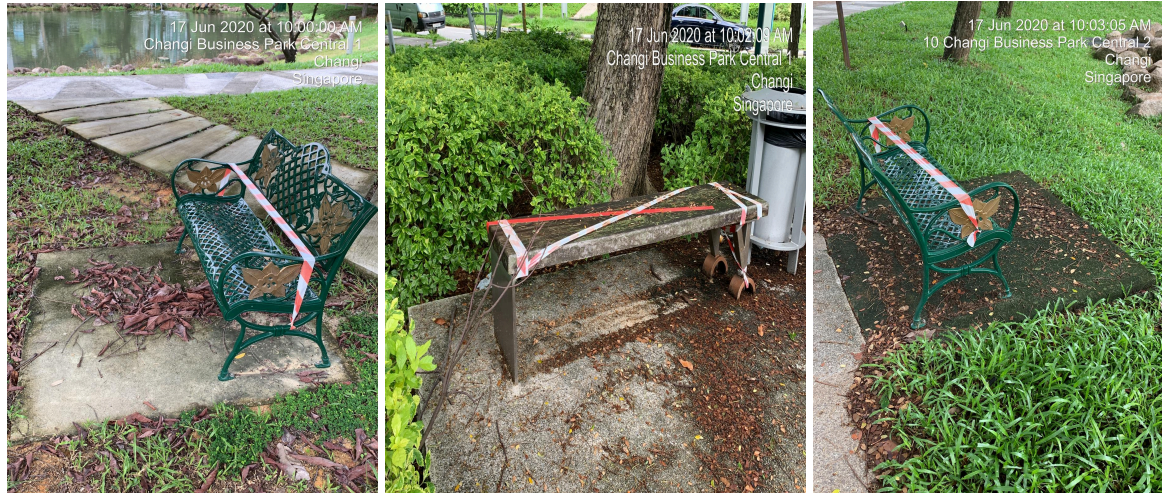
There are several benches and seats that are covered with dried leaves and branches. This might affect the overall satisfaction of the people visiting the park and the view in general.

Solution : To contact the contractor to clean up the dried leaves around the facility.

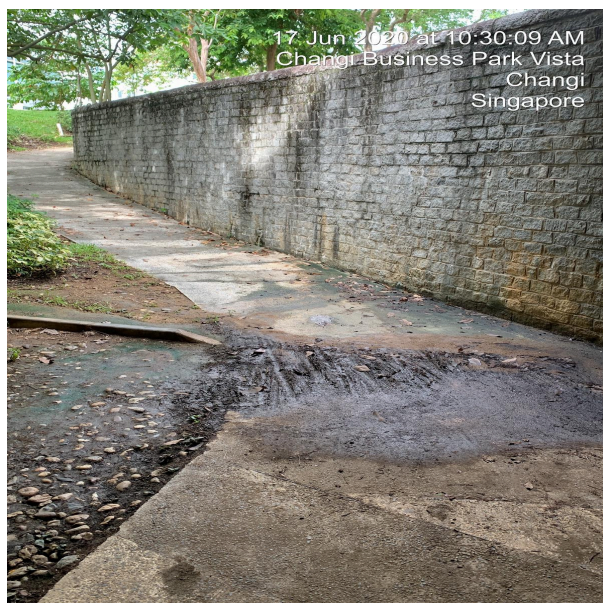
There seems to be a constant soil erosion that happens here due to heavy rain and might cause some inconvenience to pedestrians crossing the underpath.

Solution : To fix a soil erosion barricade between the pathways and the soil.

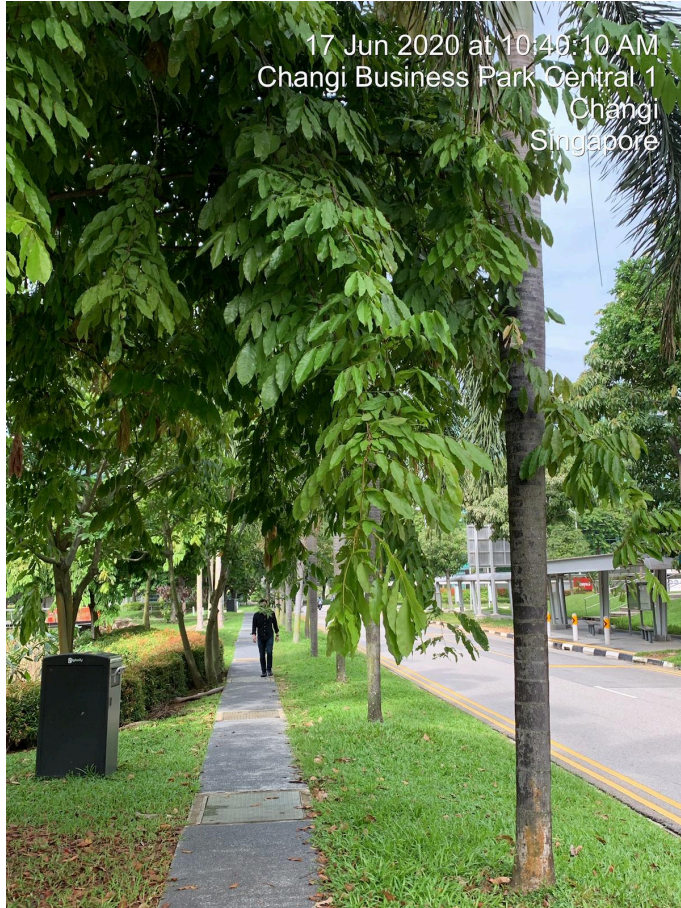
Opposite of lamp post 46

There is an overgrown tree branch extending out into the pedestrian pathway. This will obstruct the pathway of any passerby.

Solution : To call contractor to help trim the overgrown branch.

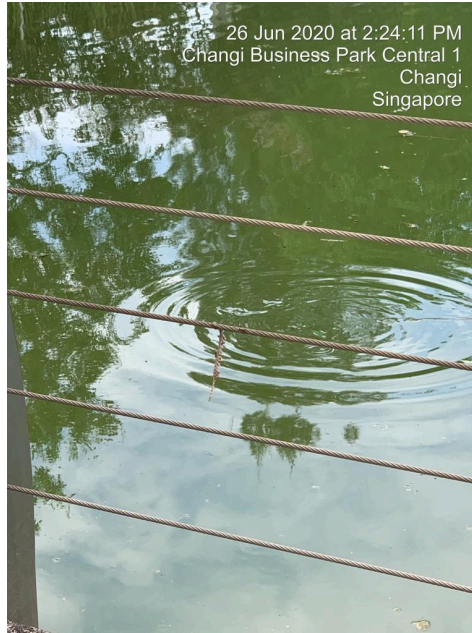
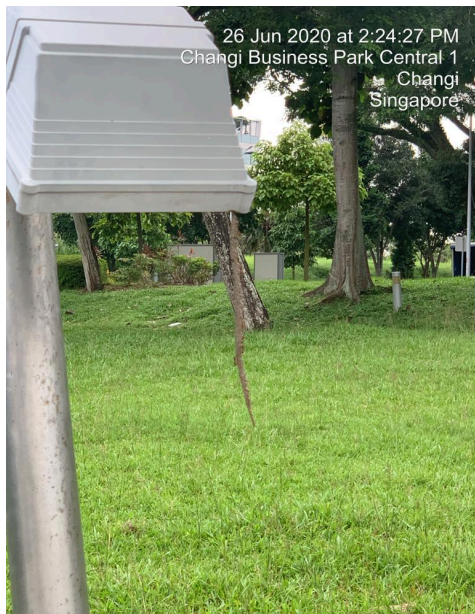
There has been small bees nest emerging in CBP and there is a need to contact Nutrinest to handle and remove the bee hives.

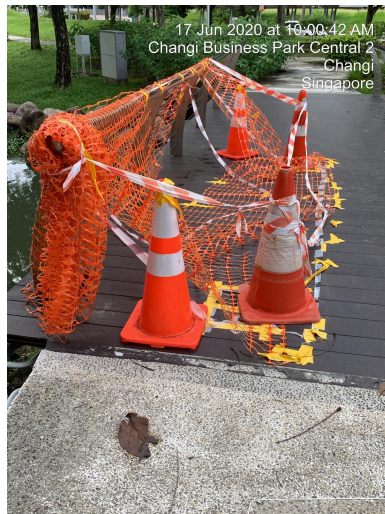
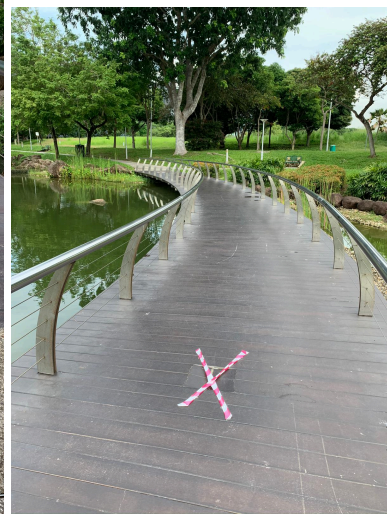
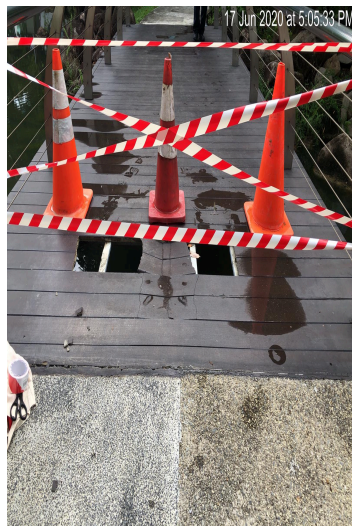
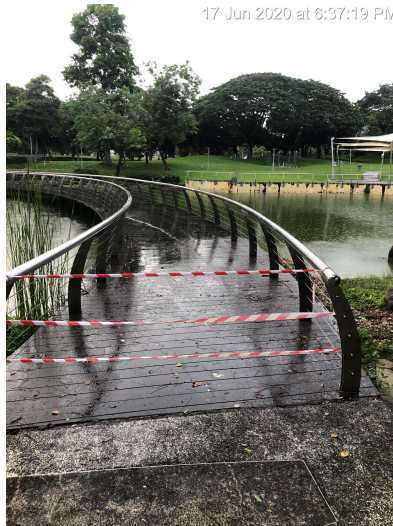
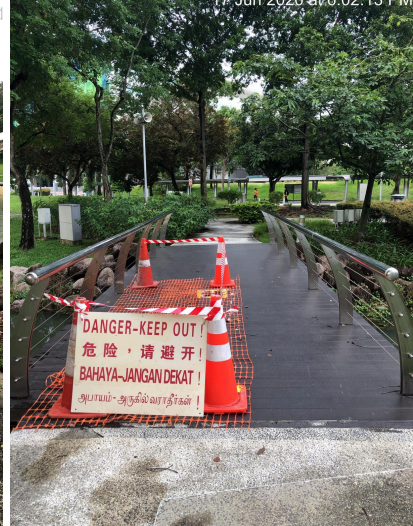
The bridges at the CBP are in unfavorable conditions, shown in the pictures above. The most serious is the one shown on the second photo with 2 very deep holes. However, the bridges was sealed off immediately the next day to prevent pedestrians from walking on it.

Solution : To contact the contractor to patch up the bridge and also propose to JTC about using stronger materials for the bridge to increase its durability.

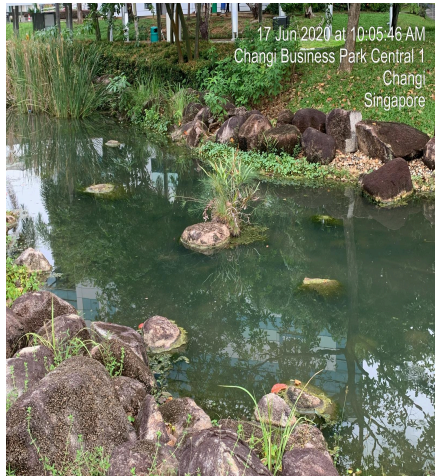
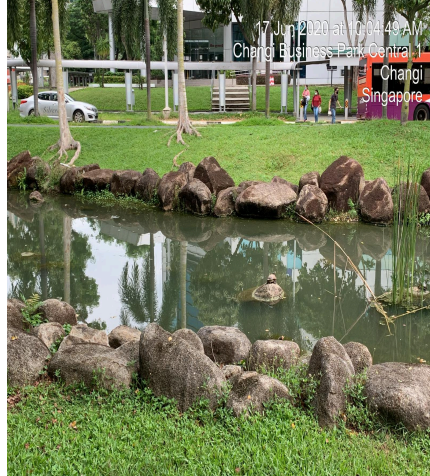
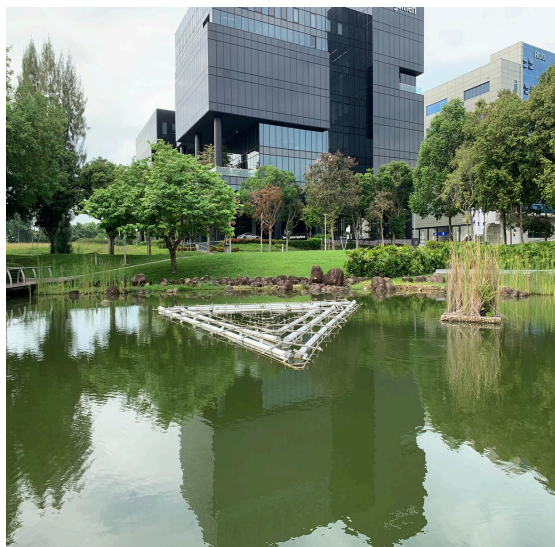
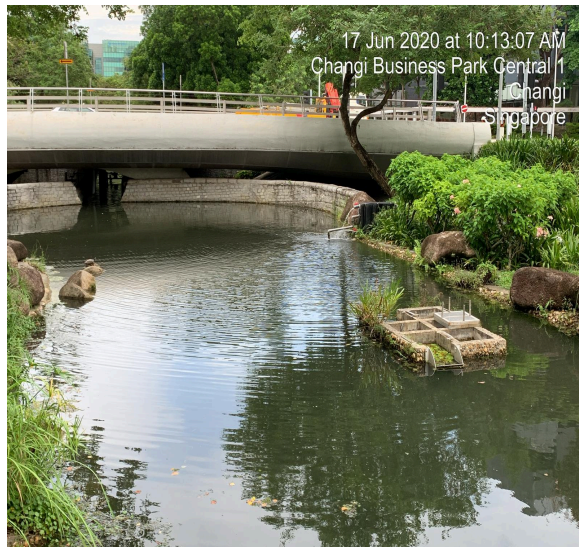
The water filters are still working and pumping out water. However, from my observation the river is on the greener side and can be muddy. The water pump might be reaching or reached its maximum filtration capacity.

Solution : We can contact the contractors to change the filters in the water pumps and also clean up algae growing on the surface of the river.

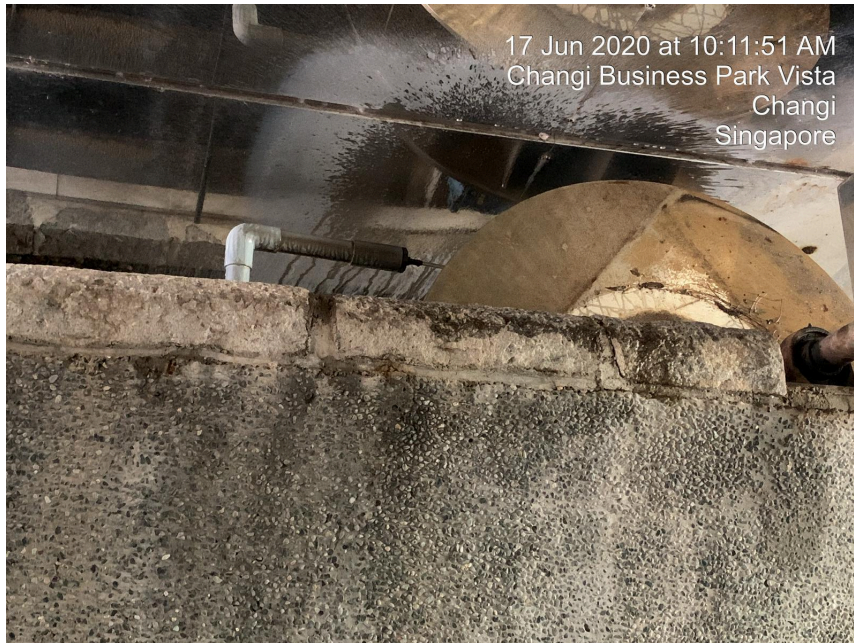
17 Jun 2020 at 10:11:51 AM
Changi Business Park Vista
Changi
Singapore

The old water filtration system underneath the road bridge is still working and is helping carry the load of the filtration.

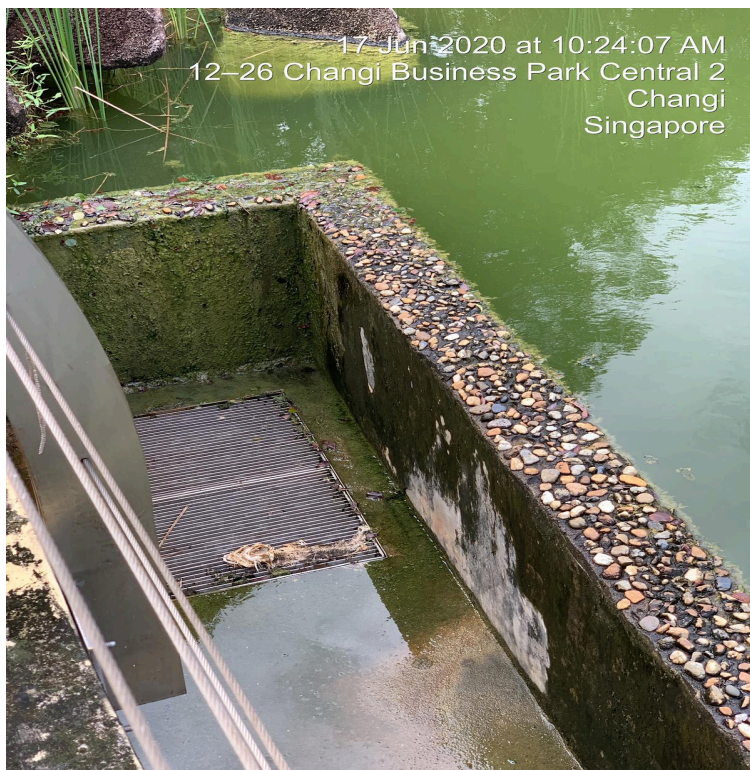
17 Jun 2020 at 10:24:07 AM
12-26 Changi Business Park Central 2
Changi
Singapore

From the photo, there is a remains of a dead fish that fell into the drain. And the cause of it is due to heavy rain which increases the volume of the river and causing the fish to jump over the wall that separates the drain and the river.

Solution : Propose to JTC to build a net on top of the drain to prevent the fishes from going into the drain and also helps to conveniently put the fish back to the river. This in return will also help to reduce the chances of buying more fishes and putting them into the river.
