## History of the Big Dalton Dam

Patrick Gavit, August 2025

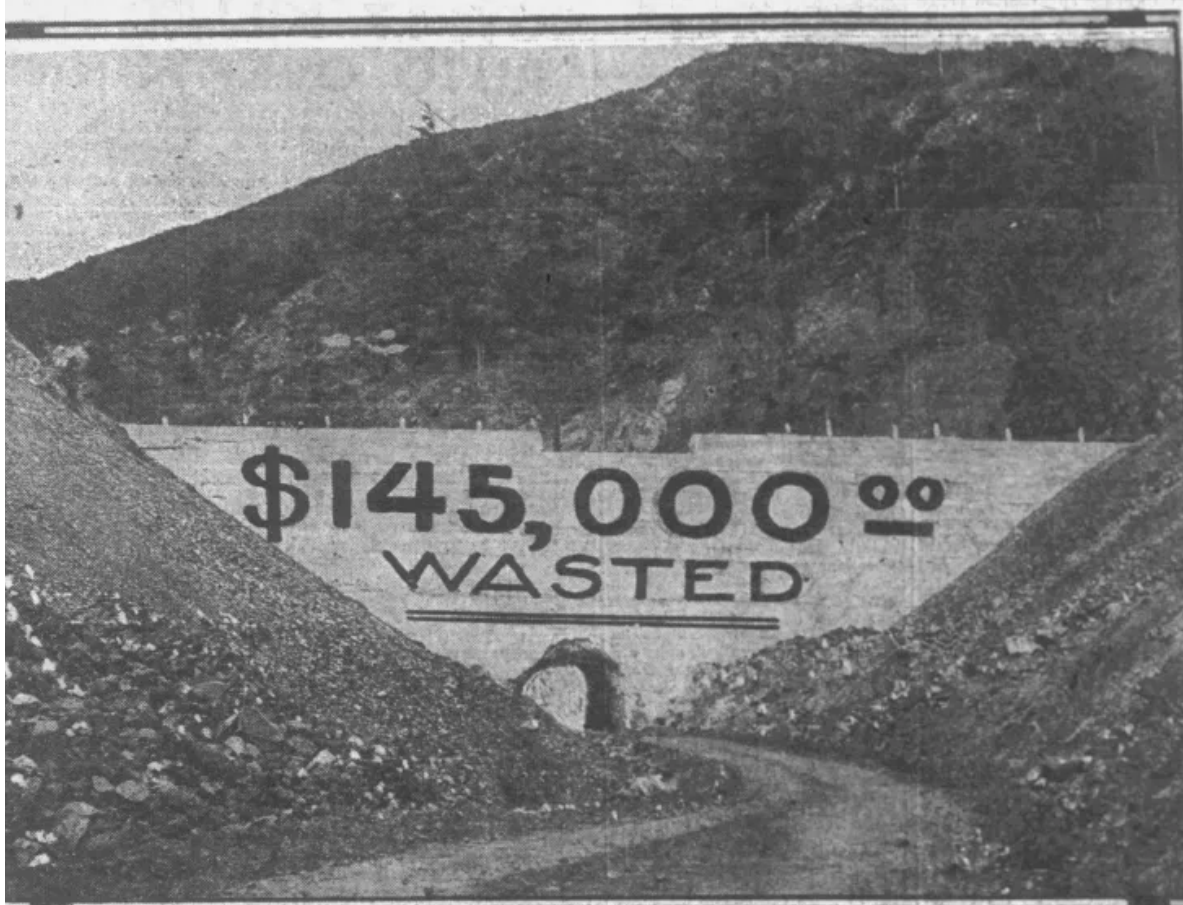
Figure 1: The core wall of the original partially constructed Big Dalton Dam that was abandoned. A road was built through this structure to facilitate construction of a new dam farther up the canyon. In this photo the amount of money that had already been spent was superimposed on the concrete wall.<sup>17</sup>

An engineering study in 1927 questioned not only the design of Big Dalton Dam but other Los Angeles County dams as well. The competence of Reagan as the chief engineer of the Flood Control District was questioned. The engineering study concluded that “for flood control the Big Dalton Dam is of no value” and “without a larger spillway than is now contemplated this dam is considered to be positively unsafe”.<sup>6</sup> Reagan soon resigned and was replaced by Eugene C. Eaton. Over the next several months issues related to the abutment walls emerged during construction of the dam. There was seepage of water and much “broken and disintegrated rock”.<sup>7</sup> Soon after in July 1927 the engineers decided to abandon the current dam and focus on building another. The new dam would be a multi arch type made of stronger and heavier concrete. It was to be located 400 feet upstream of the abandoned dam. The plan was for the abandoned dam to remain and serve as a sort of check dam. Unlike the original dam that was built using “in-house” labor, the new dam construction was put through a competitive bidding process to select a contractor. The contract was awarded to H.W. Rohl Construction Company on October 31, 1927 by the Los Angeles County Board of Supervisors. The winning bid was for \$381,194. This same construction company was also building the Puddingstone Dam. Bids ranged from \$381,000 to \$532,000.<sup>8</sup> Ground was broken on November 17, 1927. Rohl Construction Company also received a contract to build a road up to and around the dam. As part of the plan a tunnel was cut through the old dam to facilitate work on the new dam (Figure 1). When the dam was complete, the hole was plugged and made watertight so that water could be impounded between the two dams. Work on the road began in late December 1927.

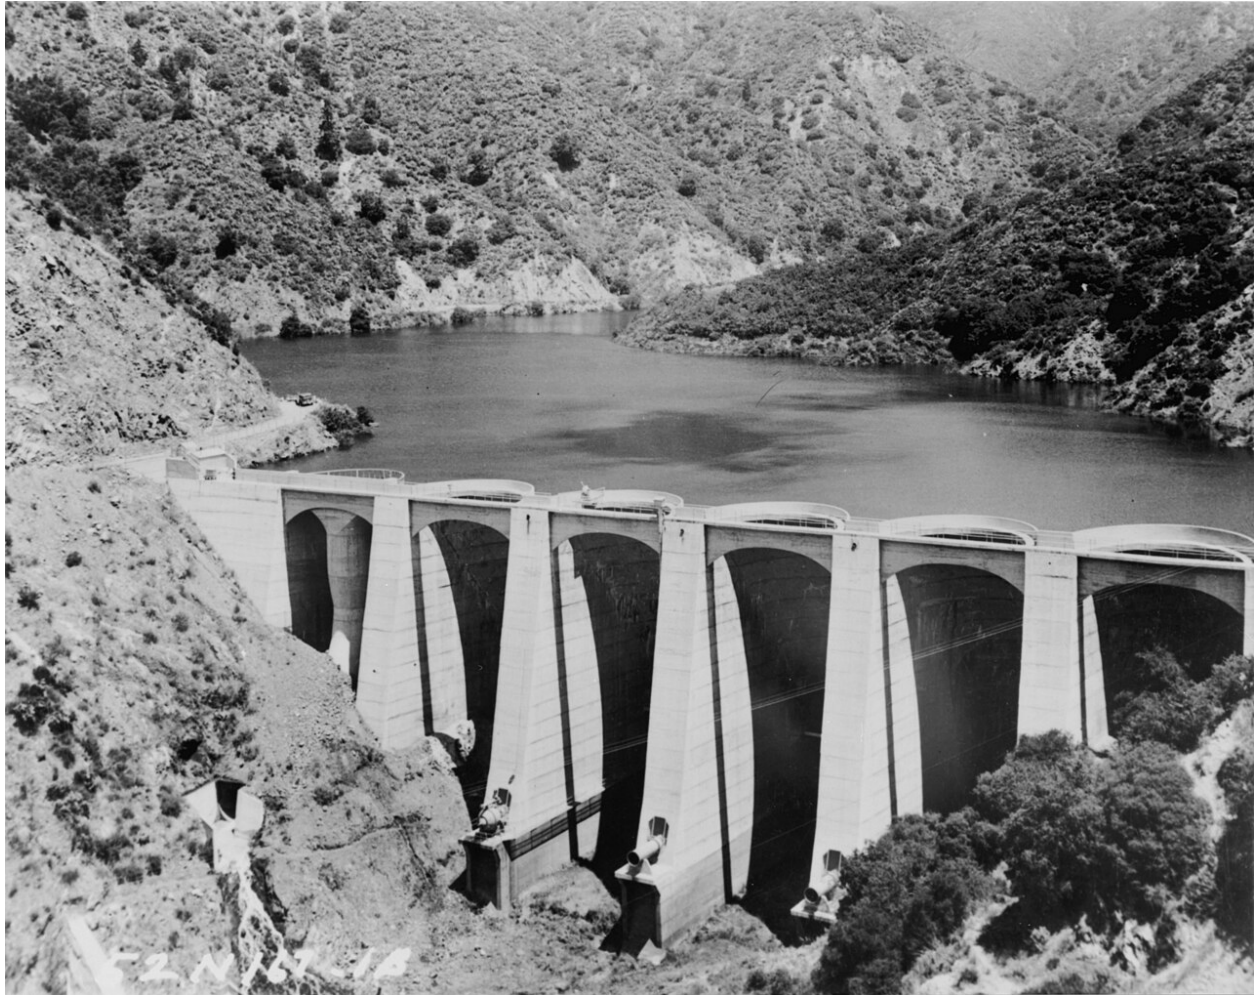
Figure 2: Big Dalton Dam and reservoir near full capacity, February 15, 1973. Photo by Monticello Miller.

The dam was completed in August 1929 and can store over 1000-acre feet of water. The dam is a majestic structure standing 153 feet tall and 480 feet long<sup>15</sup> with a base that is 200 feet thick (Figures 2 and 3). The final cost ranged from \$931,000 to \$1.25M depending on the source. This is considerably higher than the original cost estimate of \$550,000. The original plan called for an eight-arch structure. What ultimately was built was a six-arch structure with gravity abutments on the east and west side. During construction, in October 1928, two men died after they were overtaken by a landslide while they were operating a steam shovel.

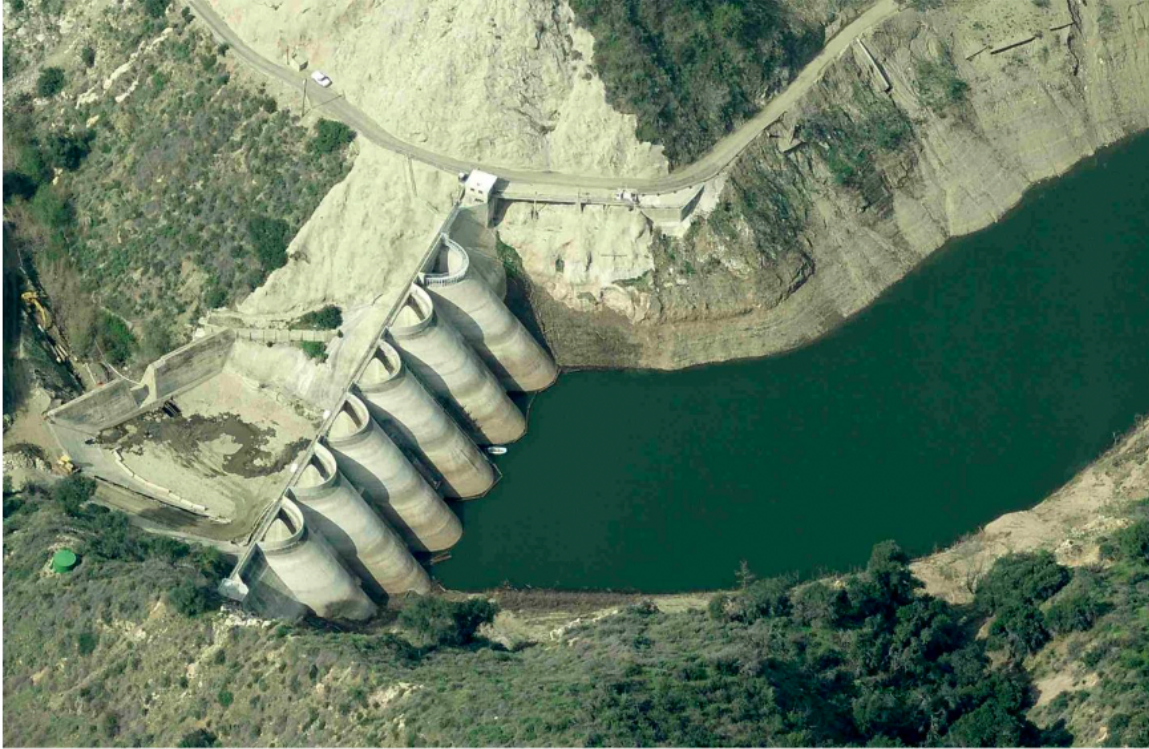
Figure 3: The six multiple arches of Big Dalton Dam. The original dam whose construction was abandoned is seen downstream of the current dam.<sup>16</sup>

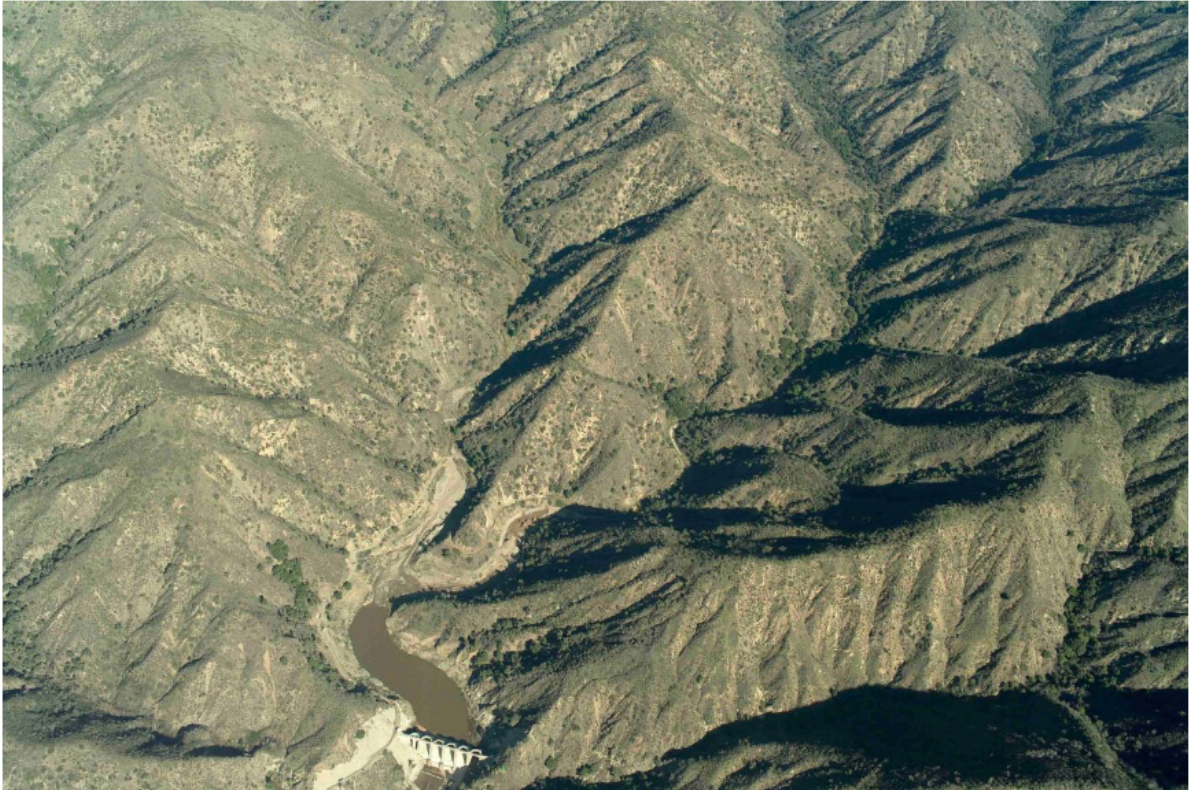
Figure 4: Some of the Big Dalton Canyon drainage area topography with the reservoir and dam at the bottom. The reservoir has a length of approximately 1300 feet and an average width of 400 feet.<sup>16</sup>

The dam drains an area of 4.3 square miles (Figure 4).<sup>15</sup> For any dam, as sediment in the reservoir settles out, the capacity is reduced. To maintain the design capacity the sediment was periodically removed. Up until 2008, sediment had been removed six times, 1969, 1972, 1981, 1993, 2006, and 2008. There have certainly been times since 2008 when sediment was removed, but the author could not find the documentation. The first sediment removal in 1969 was done using a technique known as sluicing. In this method, the water level in the reservoir is first lowered. Then when there is heavy rainfall the sluice gates near the bottom of the dam are opened to allow sediment to be flushed downstream. All other sediment removal was done using excavation. Initially the excavated material was placed at the Big Dalton Sediment Placement Site (Figure 5). However, that sediment placement site is at capacity and unable to store more sediment. The Big Dalton Sediment Placement Site currently holds 3 MCY (million cubic yards) of sediment. The material cannot be transported out because of an agreement between the United States Forest Service and the Los Angeles County Flood Control District that stipulates the sediment placement site must be revegetated. The Dalton Sediment Placement Site further west can however be used as a temporary site for storing sediment and then gradually transported out (Figure 5).<sup>16</sup>
