On June 3, 2015, a rock slide closed the Stillwater River Road 0.15 miles west of Midnight Canyon Road, which is about 12 miles west of Absarokee. Since that time the rock slide has not been cleared off the road. There are road block signs to the east and west of the rock slide. This slide has the road blocked off completely, therefore many of the people that live on the southwest side of the slide now have to add a minimum of 50 miles to their commute because this slide is in a remote and rural area, being there is no way around it without crossing private land. Therefore, travelers have to nearly double their travel distance to get around the slide.

"Possible Slide Solutions," dated December 31, 2015. Written by Richard Hanners. This article states that an 18 page draft report by the engineering company hired arrived on at the Commissioner's office on Dec. 23. The failure zone measures about 5-10 feet wide, 5 feet deep, and 50 feet long.

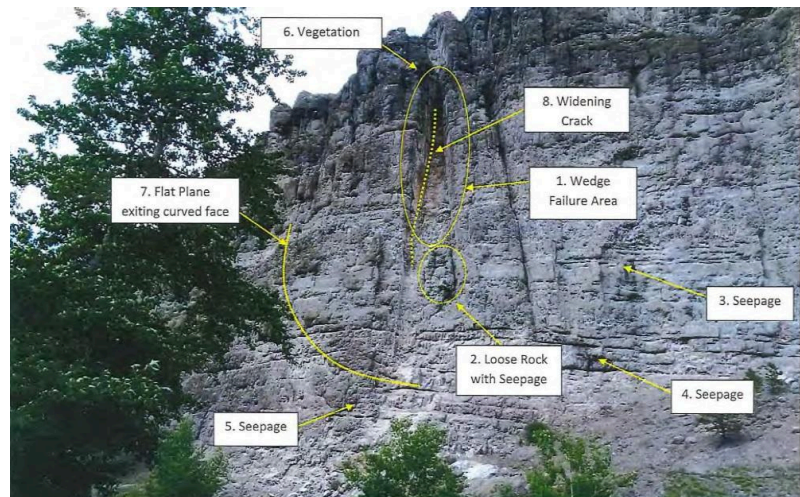
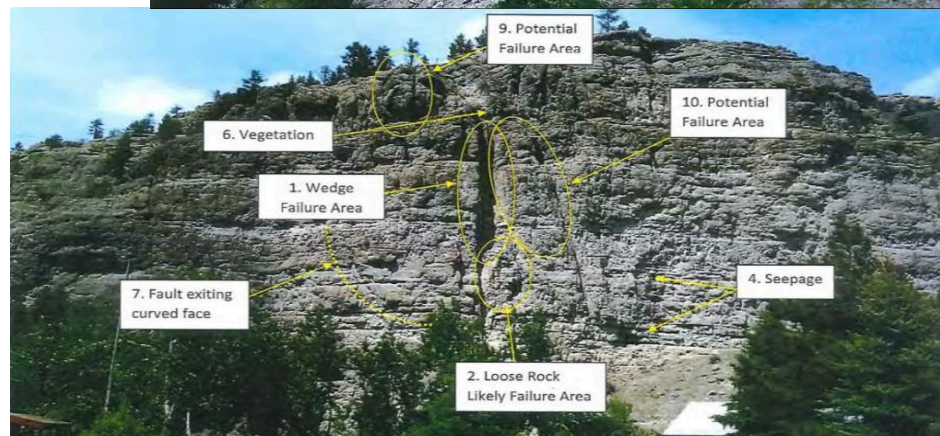
SK Geotechnical states, " the rock slide was a wedge-shaped failure approximately 50 feet long, 5 to 10 feet wide and about 5 feet deep, this failure was about 30-40 feet above the roadway. The Stillwater River is about 15 feet below the surface of the road." Several areas around the slide was reported to be seeping water from the face. These seeps were located about 10-15 feet away from the failure point. This group also say, "the proximity of this rock face to Stillwater County Road and residences represents a significant hazard to people and property... The only way to eliminate these risks is to close or relocate the roadway. Closing the roadway would force residents west of the failure area to take an alternate route, while relocating the road would require building two bridges and a new section of county road." They recommend "rockfall" signage be placed along the road to warn the public of the risk. A percentage of gasoline tax collected by cities and towns to be used for construction maintenance and repair on rural roads as per Montana State law.

The pictures posted in part 3 analyzes the rock face and helps to predict the possibility of future slides, and where they might occur. Label #2 is a portion of rock hanging just below the wedge failure. It was observed to be damp and possibly seeping, but not dripping. In the vicinity of label #2, several suit-case sized rocks were observed which appeared to be relatively loose. Areas #9 and #10 have discontinuities that intersect to create a wedge. A large rock mass is defined by the discontinuity shown with lines labeled #7 and #8. In and around the existing wedge failure, portions of the rock face have similar joint conditions and are at risk of failing. The rock face has always had a risk of failure and subsequent hazardous conditions. The risk of failure increases seasonally with the highest risk coming in the spring with heavy snow melt and spring rains. SK Geotechnical says, "Assuming some risk is acceptable, then it is our opinion the road can be cleared and opened when the visible seeps are no longer apparent.

- Option 1 calls for slope scaling, with workers removing rocks from the face that had been loosened by the freeze-thaw cycles.
- Option 2 calls for erection of a 250-300 foot long rockfall fence between the road and the river capable of stopping rocks up to 5 feet in diameter from entering the river.
- Option 3 calls for erecting a 200-250 foot long rockfall fence about 30 feet above the road on the cliff face.

- Option 4 calls for erecting a 200-250 foot loin rockfall detection fence that could automatically close a gate on the road or signal the county road department. How soon additional evaluation work can be conducted could depend on winter conditions and access.

Our options also include the erections of numerous rockfall fences capable of stopping rocks up to 5 feet in diameter. These fences of variable geometry are fabricated from a complex system of steel cables, connections of steel cables to structural elements, energy absorbing devices and anchorages, capable of high deformation capacities which are designed to be easily transported and assembled in extreme conditions.
