Buell 1125r - Rotor and Stator Replacement

A collection of documentations, by TMB

2009 Buell 1125R Stator Rewind and Rotor Modification

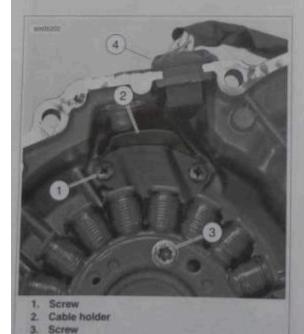
Figure 7-35. Stator

- See Figure 7-34. Remove the stator wire harness from the clip on the top of the ignition cover.
- See Figure 7-35. Remove the two screws (1) securing the cable holder (2).

- Loosely thread in the cover fasteners.
- Route the stator wire harness through the clip with the CKP sensor wire harness and snap in place.
- Wrap the stator leads around the mechanics wire left as a leader through the engine support. Lubricate with silicon spray and pull the leads through the support.
- See Figure 3-148. In sequence, tighten the cover fasteners to 11 Nm (97 in-lbs).
- 9. Install the oil cooler lines. See 5.9 OIL COOLER.

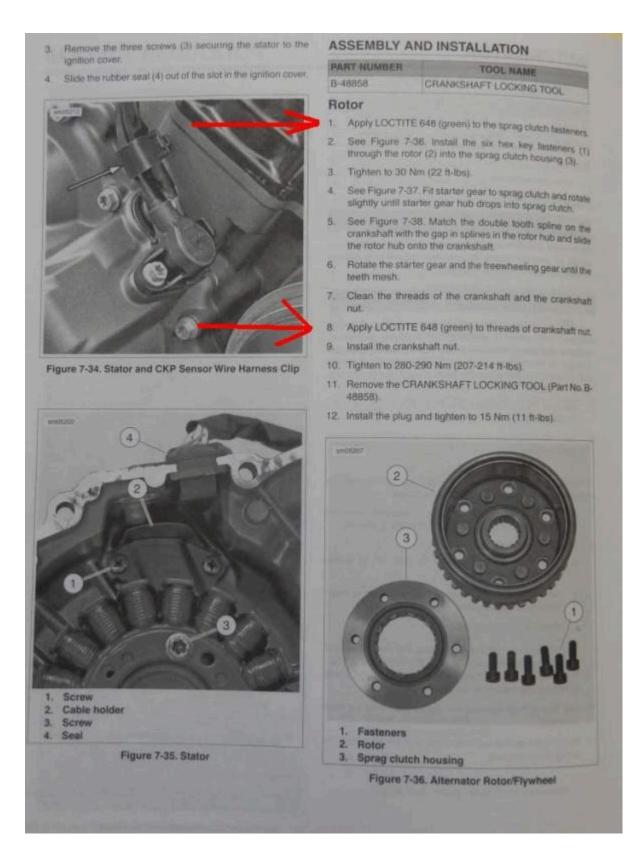
Figure 7-36. Alternator Rotor/Flywheel

The point for the worries about the nut coming loose, which actually is a problem caused by the splines having too much play, cause the rotor can move under extreme acceleration and deceleration.

EBR has experienced under racing conditions that it came loose and advises customers to tighten the nut to a whopping 400 NM of Torque.

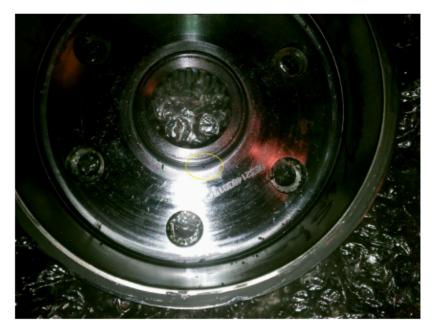
If you look carefully at the photo of the rotor above, you can see the tiny oil spraying hole in the area circled in yellow. It looks tiny, but it doesn't take a very big hole to spray enough oil to cool things down.

Erik Buell Racing, in their very gracious support of the 1125 platform, developed and released such a rotor! The cost of this rotor is \$425, \$250 of which is a core charge that gets refunded upon return of your original rotor.

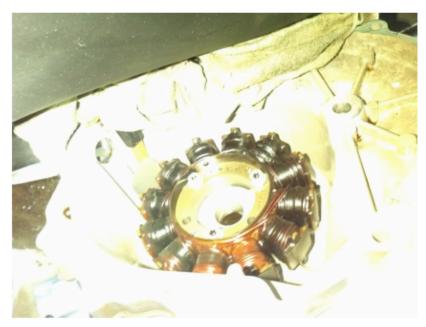
Unfortunately, when installing the new rotor, I could tell that my stator was almost toast. It had the tell-tale burnt epoxy and looked in bad shape. So, I began investigating options for a new stator.

There are several options now for having your stator rewound with high quality materials. When I made the decision to rewind mine myself, there were less options, and they cost more. Thanks to Gregory Hildstrom's writeup, I was able to source my wire from the same place he did (and for a similar cost), and purchase one of the epoxies he discussed.

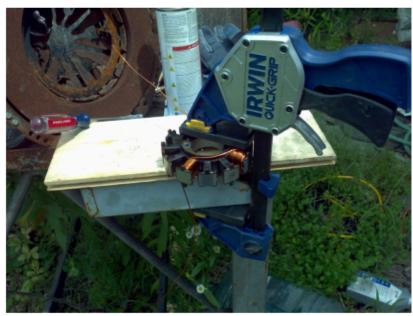
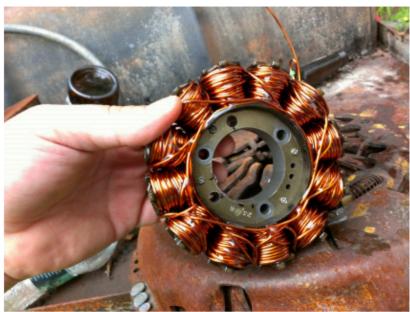
My first rewound stator failed. This was due to my windings being messy. I'm almost embarassed to show pictures...

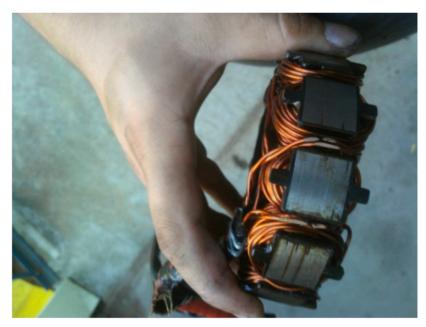
I took the stator out, and immediately saw why it failed:

The windings were too messy, and some made contact with the rotor, and eventually rubbed through. Unfortunately, this took a toll on my new rotor as well. Rotor is still working fine, it just looks ugly. Next time I have the motor apart for a valve check/adjustment, I'm going to fill in the damaged section with epoxy.

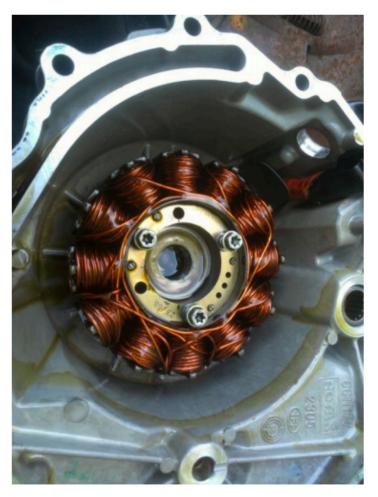
The stator lasted several thousand miles before failing, and almost all of that time was spent on the stock, shunt regulator (fill discuss this in the regulator section, but shunt regulators short the stator out to bring it down to the regulated voltage, so stator is always running at maximum output). The stator, aside from the damage, still looked brand new, so I'm confident in the wire and epoxy choice:

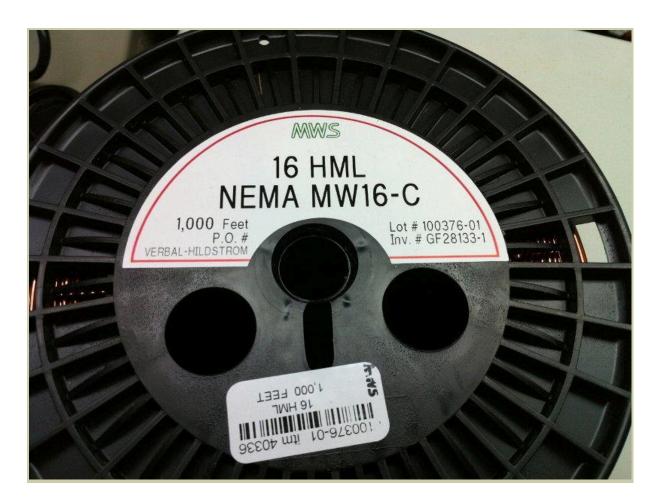
I have been unable to determine the insulation class or varnish/epoxy type used on the factory stator. My plan is to use 240C polyimide (ML) coated magnet wire in AWG 16 size with heavy build. Thankfully, MWS Wire provided me with a decent quote for more wire than I needed in 16 HML. You cannot get much higher temperature wire without moving to ceramic coated wire, but that requires much larger bend radius. If the original stator was wound with polyimide-insulated wire, parts of the windings must have spent significant time at or above 270C/518F for it to fail at 4000 miles/hours. It is also possible that the original stator was wound with different insulation or a bad batch of polyimide that would fail at lower temperatures.

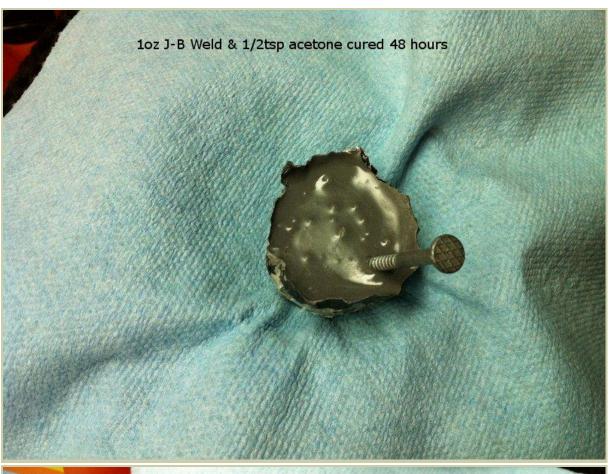
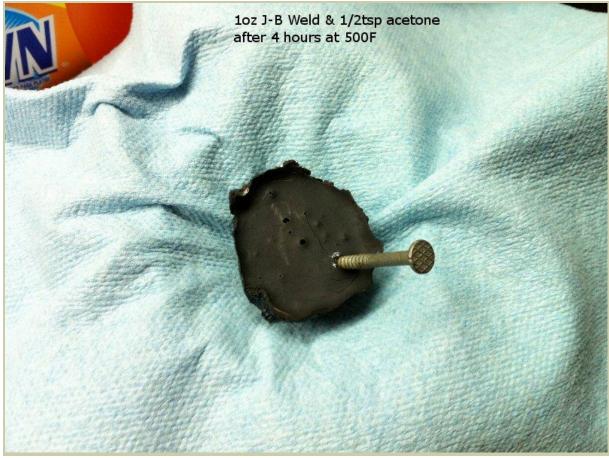
Special thermally conductive epoxy, like <u>Duralco 132</u>, has viscosity comparable to or greater than J-B Weld and it is expensive at \$86/pint. Electrically resistant epoxy, like <u>Duralco 4461</u>, is good at penetrating windings, but expensive at \$90/pint and not thermally conductive. I plan to use <u>J-B Weld</u> epoxy, which can withstand 500F/260C continuous, to hold the windings in place and protect against vibration, but I plan to use as little as possible. The thermal conductivity of J-B Weld is 0.59 W/(m*C) or 2.36 BTU-in/(hr*ft^2*F), which is similar to water and a bit less than Cotronics Duralco 4460/4461 at 4 BTU-in/(hr*ft^2*f). I bought the J-B INDUSTRO WELD package that works out to \$15/10oz or \$24/pint. I tested some J-B Weld thinned with acetone, which would penetrate windings better, heated to 500F for 4 hours and it held up really well. It was still strong and hard as a rock afterward, but I did not like the surface microcracks. The internal color was a lot more uniform than the photo, which over-emphasizes the fracture surface shadows, but I should have probably done a more thorough mixing job.

I tested some J-B Weld heated to 500F for 4 hours and it held up great. The embedded popsicle stick turned to charcoal. The very dark gray surface is due to either surface overheating from the radiant heating elements, surface oxidation at elevated temperature, or bread crumb smoke absorption.

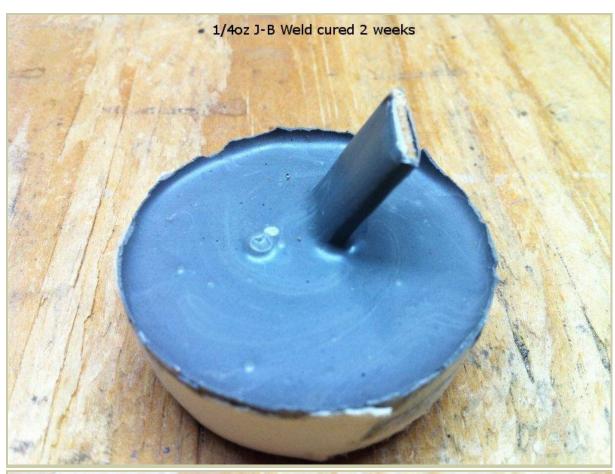
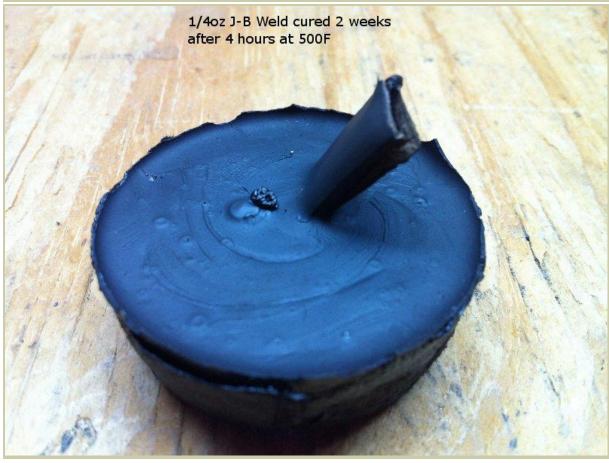
Next I tested how J-B Weld flows when heated instead of thinned with a solvent. After I smeared the room-temperature J-B Weld on the 200F 4-layer 16 AWG test coil, it thinned, flowed over the coil, and dripped off the bottom. It flowed better with heat than with the recommended amount of acetone. After curing for 24 hours, I cut it open at an angle to see how well it penetrated. It penetrated the first and second layers on the top side with gravity's help. It barely penetrated the first layer on the bottom side with gravity working against it. I think the J-B Weld pulled a significant amount of heat out of my tiny test coil, which also limited the penetration. The stator has significantly more thermal mass. If I heat it to 200F and keep my heat gun on it, I should get much better penetration. I also plan to wipe any excess off for a very thin layer on the outside.

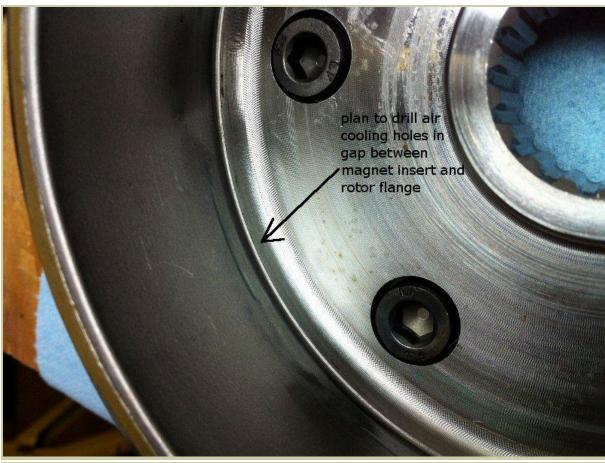
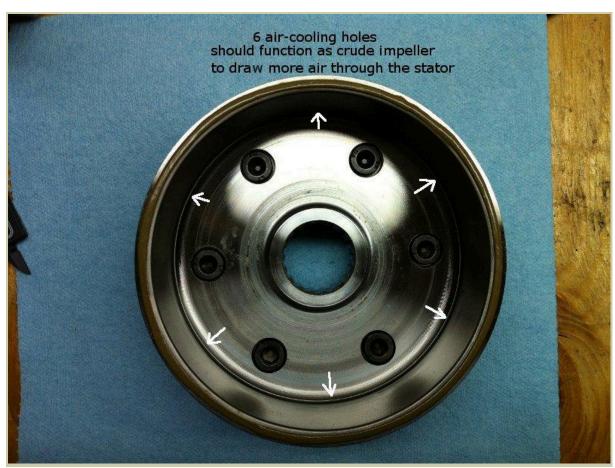
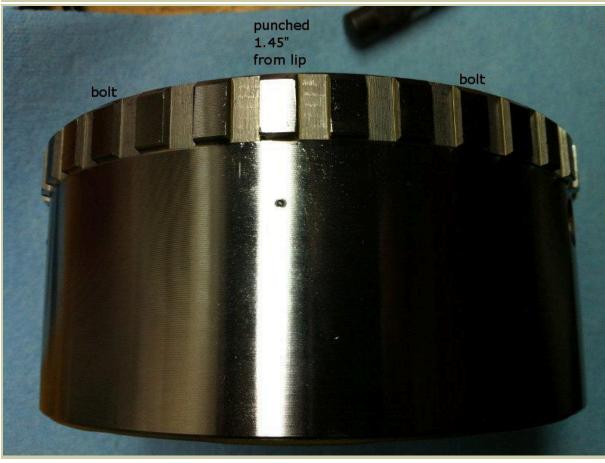
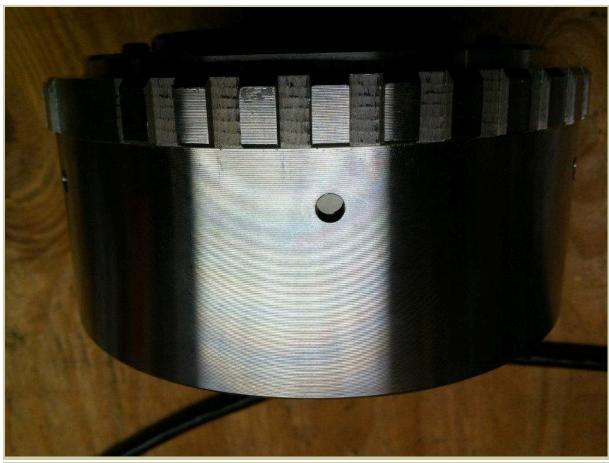
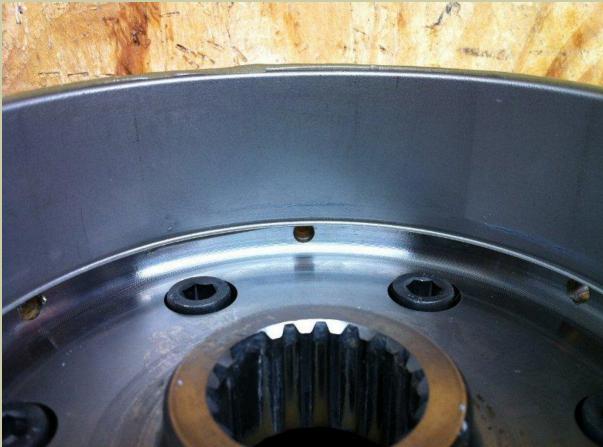
EBR's original fix for the overheating stator problem was a kit that contains a rotor with a precision machined oil jet in addition to a lower power rotor and stator. This oil jet sprays oil on all of the stator poles as the rotor rotates. That's pretty cool, but I'm not willing to try that with my hand tools or spend that much money right now. One thing I noticed is the total lack of forced air cooling for the stator. The stator fits tightly in the rotor and there is nothing forcing air in or out of the rotor. My idea, which is sure to be controversial, is to drill six small air cooling holes in the rotor between the magnet insert and the rotor flange. I did not find any oil in this area of the rotor when I removed the case, so this modification will not affect oil distribution. These holes will be small and will not interfere with the magnets, so I feel risk is minimal. Also, the holes are symmetrical, so balance should not be affected much. As the rotor spins, these six holes will function as a crude impeller / centrifugal air pump and force air from inside the rotor to outside the rotor on the engine side, which must be replaced by air flowing past the stator and into the rotor on the open side. I started by punching the hole location to accurately locate the drill, used an 1/8" drill, and then finished up with a 3/16" drill. The steel rotor is about 1/4" thick where I drilled the holes.

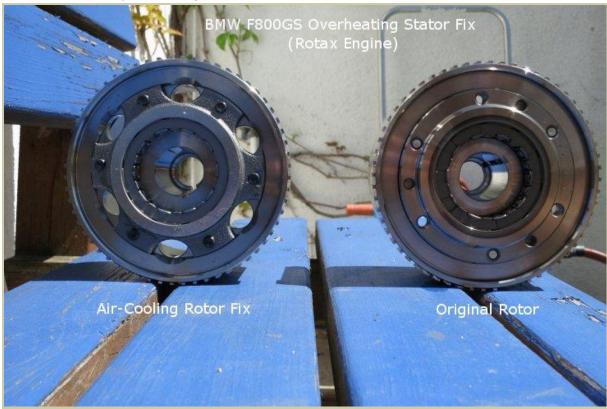
Almost a year after doing this rotor modification and debating its effectiveness on BadWeB, an interested reader informed me of some overheating stator problems on the BMW F800GS, which has a parallel-twin Rotax motor. The official fix from BMW/Rotax is, get this, an air-cooling rotor design. Hopefully this lends a little credibility to my hair-brained hand-drilled idea. Notice the same 6 air holes spaced exactly half way between the 6 bolts. The main difference is that I placed my air-cooling holes at the rotor perimeter and BMW/Rotax chose the rotor flange. These flange holes are bigger, but I obviously thought perimeter holes would make better use of centrifugal force. Anyway, the original rotor construction looks remarkably similar to the 1125, which is no surprise. Both this air-cooling design and my hand-drilled one are easier to manufacture than the precision machined oil jet in EBR's rotor. Very interesting.

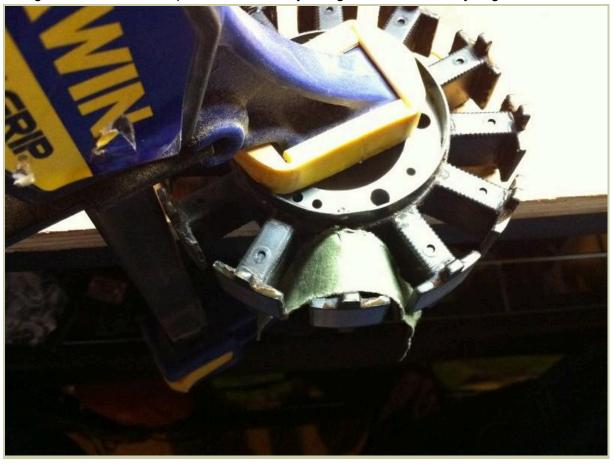
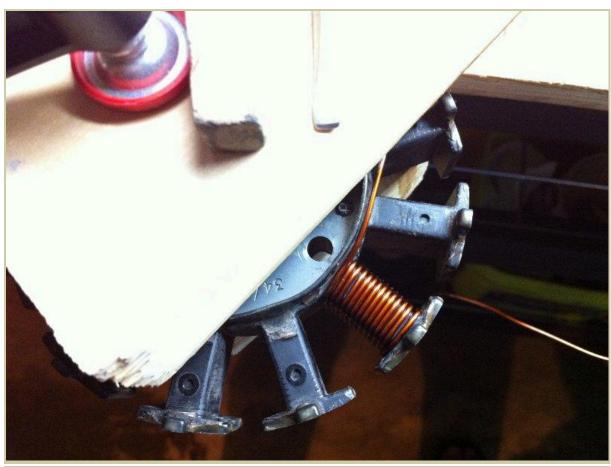
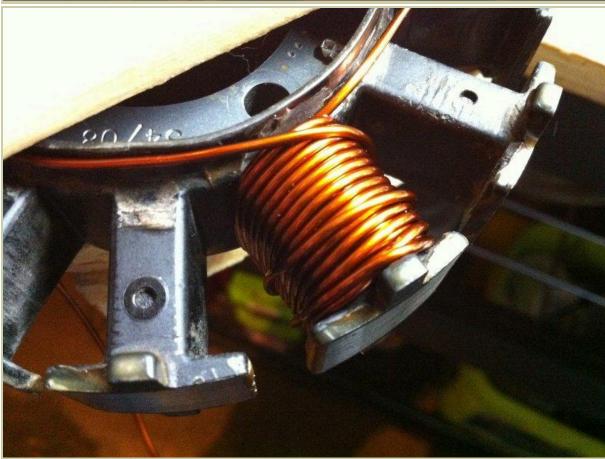
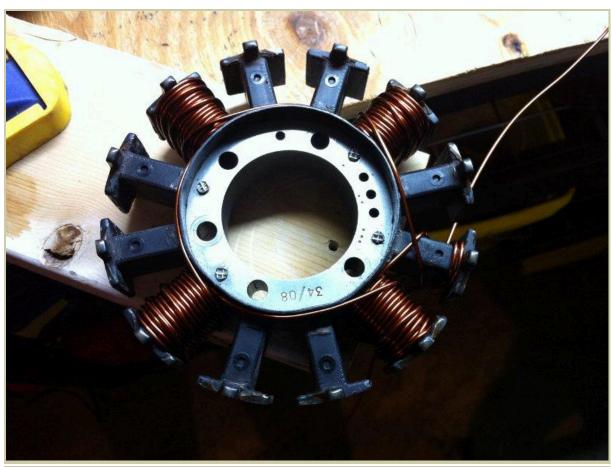
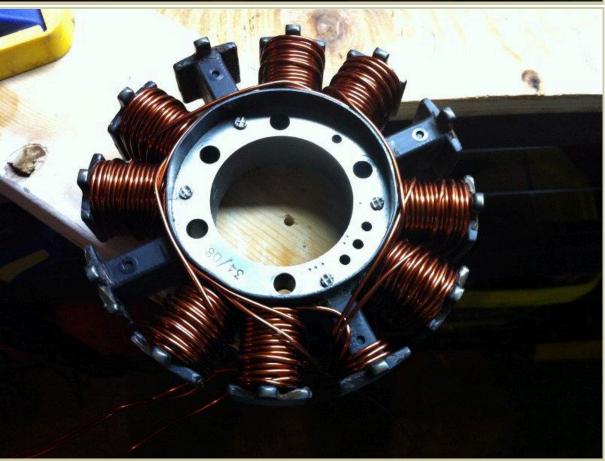
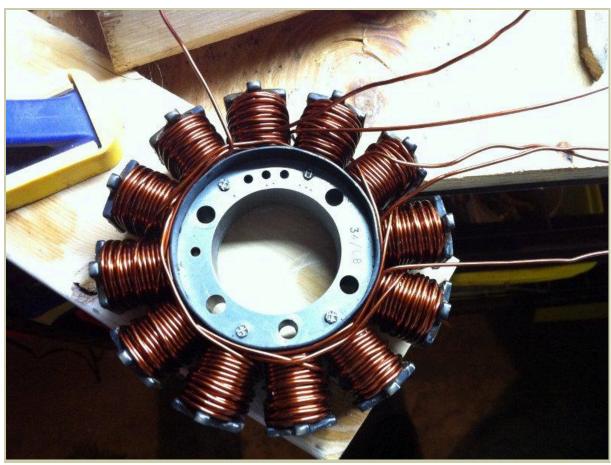
I first tried to hold the laminations in my left hand and wind with my right hand, with no gloves. Big mistake. I could not get the wire tight, my hands hurt, and the ridges in the lamination plastic coating made it very difficult to adjust the first layer of windings. So, I sanded the plastic coating around each of the corners. Then I rigged up some clamps and 2x4s to hold the laminations, which allowed me to wind using two gloved hands to pull the wire tight. I used an old wire brush handle to manipulate the windings and to press the first finished layer flat. The first three layers were all about 13 turns with the fourth layer 5 turns or less; 13*3+5=44. I was happy to complete the four poles of the first phase. I did one

phase per day for three days and finally twisted the proper wires together for the delta configuration. Check each phase for continuity and ground isolation as you go.

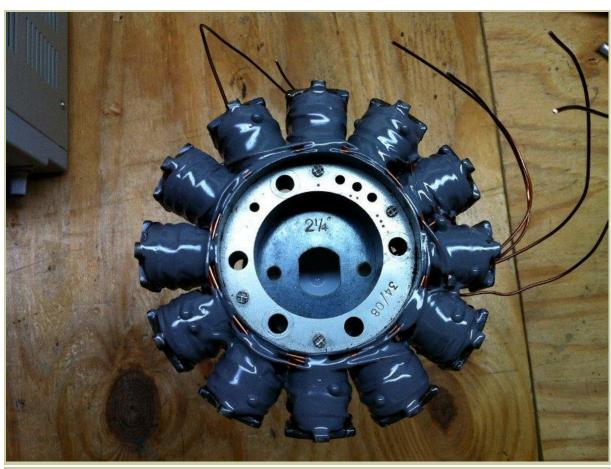
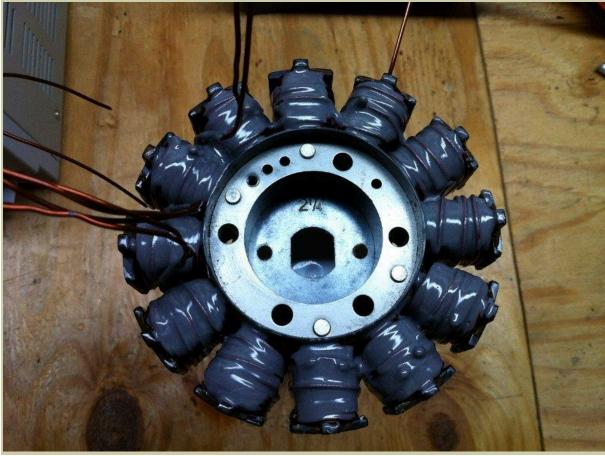
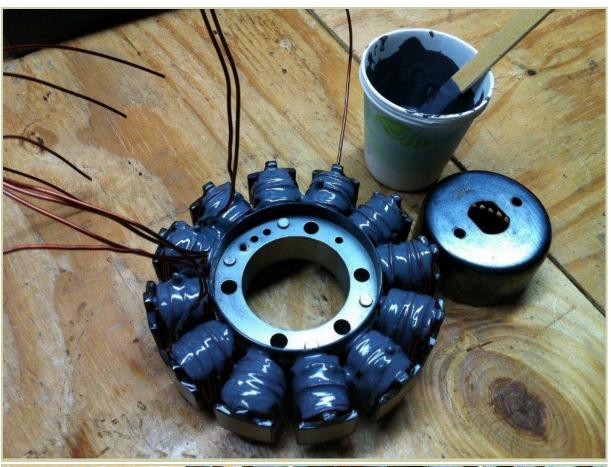
Next, I heated the stator in our toaster oven on convection bake, which uses an internal air circulation fan, at 200F for one hour to make sure it was heated completely through. I marked the inside of a bathroom cup with a pencil using tablespoons of water as a guideline. I mixed up two tablespoons (1 oz) of J-B Weld using one tablespoon of resin, one tablespoon of hardener, and a Popsicle stick. As soon as I felt it was mixed thoroughly, I removed the stator from the oven and set it on a 2.25" hole saw on top of some newspaper. I applied J-B Weld to the engine side first. It had a thick and almost pasty consistency at room temperature (70F), but it thinned, ran, and dripped after a few seconds on the hot stator coils. The drips did not form J-B Weld stalactites on the bottom of the stator, so I know that was a result of small thermal mass in my penetration test earlier. The larger thermal mass of the stator allowed its temperature to stay elevated for much longer, which allowed the J-B Weld to remain thinner for longer. I did not need my heat gun. I applied two coats on the engine side, but that was probably not necessary. A side effect of the heat was extremely fast cure time. A few minutes after I finished coating the engine side, it was no longer tacky and I flipped the stator over to coat the cover side. After pulling the delta wires through to the cover side, I applied one coat on the cover side and you can see it is thinner. In most places the engine side and cover side flowed enough to run and meet in between poles, but some windings were exposed in several places. I was not looking for perfect coverage, just enough to keep things from vibrating and to help conduct heat between layers. With my rotor modification, any exposed copper between poles will function as cooling fins. The side of a pole shown below with exposed windings was the one with the least side coverage; all the rest had better coverage. Based on my lower-temperature penetration test and the fact that the fourth stator layer was only 5 turns with huge gaps, winding layers 2-4 should be well bonded together at the top and bottom of the poles. The elevated temperature and longer duration may have even penetrated into the first layer, but I'd rather not disassemble it just to find out. After doing both sides of the stator and waiting for it to set up (20 minutes), the J-B Weld in the mixing cup was still usable.

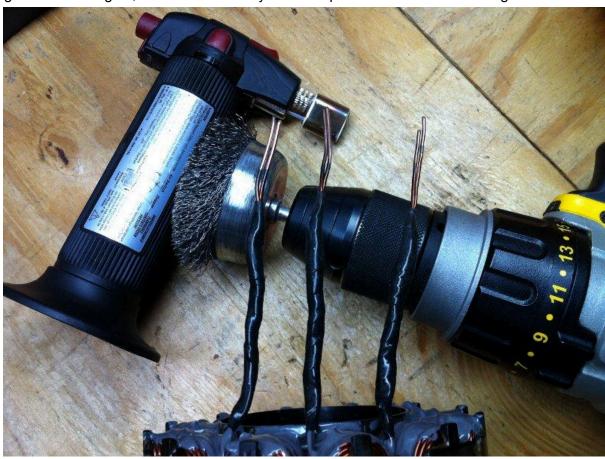
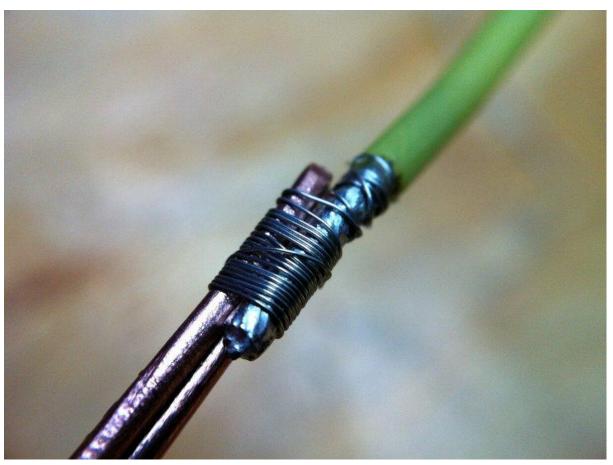
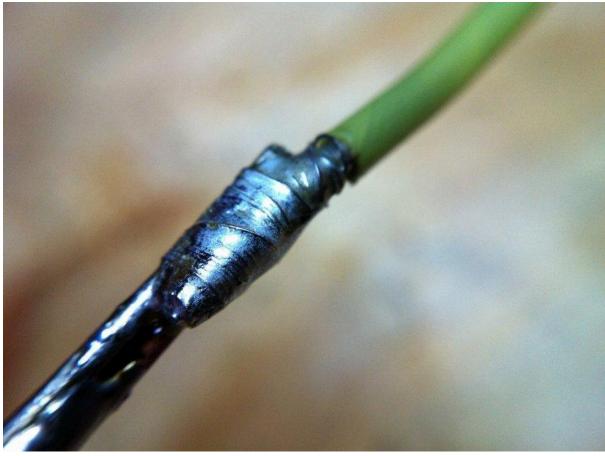
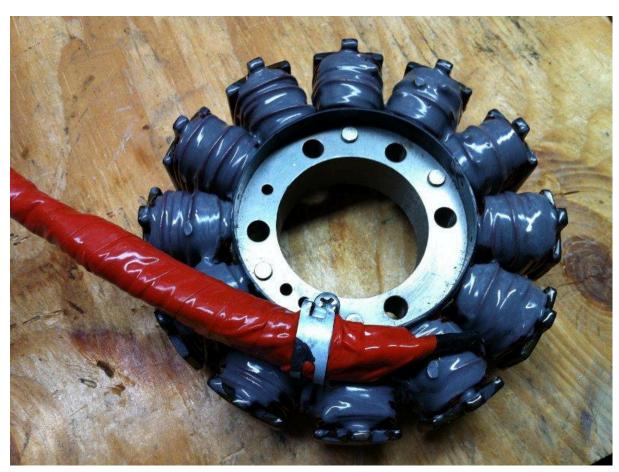
The polyimide coating is incredibly tough. I tried hand sanding the ends of the wire, but that got me nowhere fast. I used my mini torch to heat the ends of the wire until they glowed orange, which charred and destroyed the polyimide. Then I removed the charred remains of the coating with a wire wheel and my drill. I used self-fusing silicone tape, aka Rescue Tape, aka F4 Tape, for electrical tape. It is good to 500F, a great electrical insulator, chemical resistant, and very tough. In order to try to replicate the original attachment method, I used a strand of wire to wrap each lead to each pair of delta windings. Then I soldered it, taped it all up, put down a bead of Permatex Ultra Black RTV Silicone, and mounted it back in the ignition cover. Again, check for continuity between phases and isolation from ground.

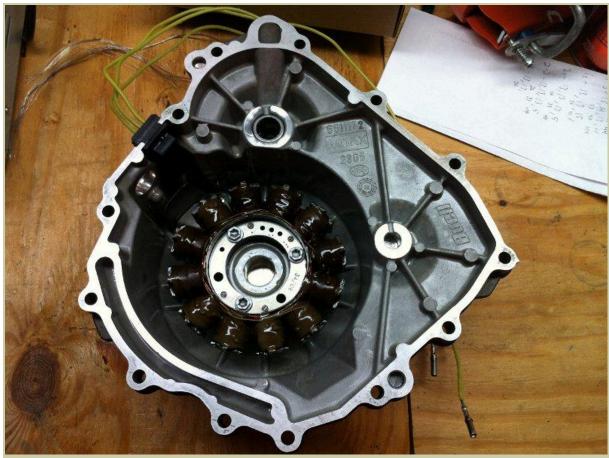
About 200 miles later, on my 12 mile ride home from work, voltage dropped from 13-14 to 11-12 regardless of RPM. It got as low as 11.1 when I had to wait for 3-4 traffic light cycles. It was about 90F in the shade and my coolant temperature got up to 220F thanks to the extremely low fan voltage. I knew something was very wrong. As soon as I got home, I removed the seat, unplugged the stator, and tested it for a short to ground. It was shorted to ground. I disassembled it this past weekend and found the short. One of the solder joints had been pinched between the cable clamp and the case. The silicone tape could only withstand so much pressure and heat before it tore open. This was probably a result of different wire lengths, different insulating tape thickness, and improper centering of the wires under the cable clamp.

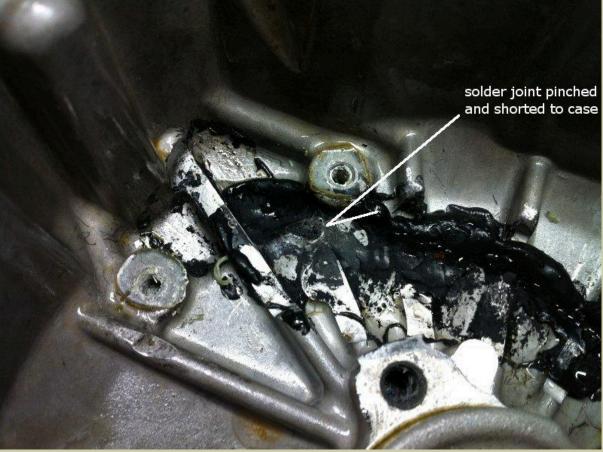
I was very curious about the discoloration of the J-B Weld after only about 190 miles of normal operation and 10 miles shorted to ground. I really hoped that the discoloration was not throughout the J-B Weld, which would indicate severe overheating and a need to rewind again. I lightly sanded the surface of the J-B Weld on two poles. The discoloration was only on the surface. The internal color was at least as light as my 500F test sample if not lighter. The discoloration must be a result of the oily mist getting deposited on or sticking to the hot stator.

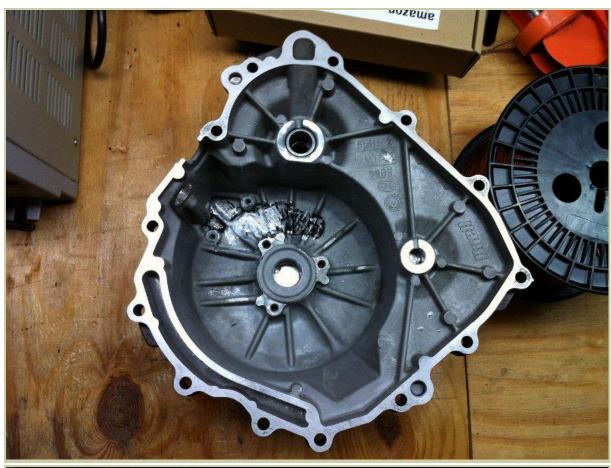
If you look at the photos, you can see why I did not center the wires properly. There is a sharp raised stiffening rib cast right in the middle of the clamp area where the clearance should be at a maximum. I went crazy with my air die grinder and took care of that.

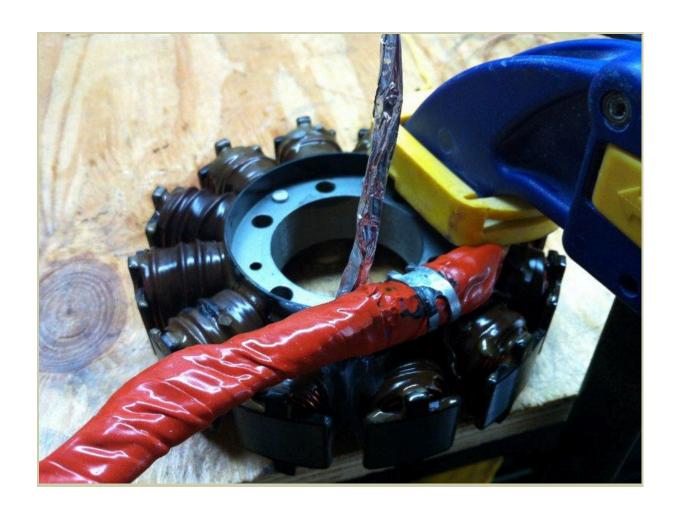
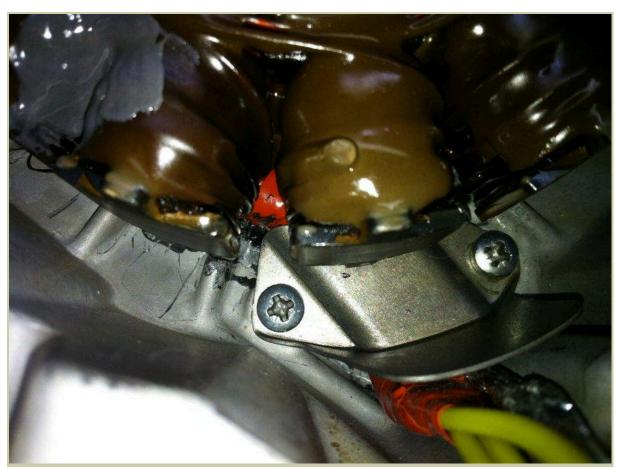
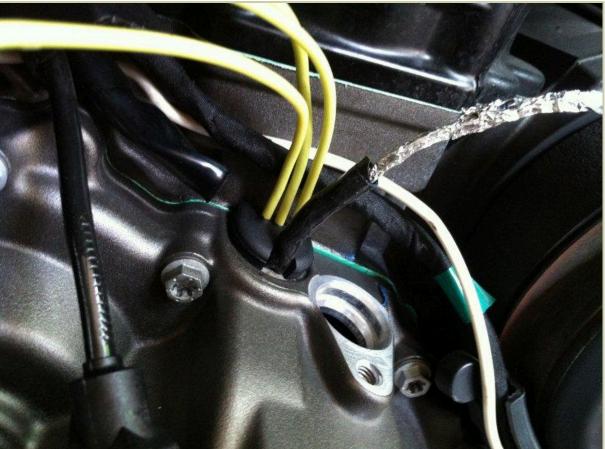
I bought and tested a thermocouple. I hooked it up to an Arduino Uno using a ProtoShield and MAX6675 pre-mounted to a breakout board or a SOIC to DIP breakout board because soldering tiny wires to tiny SOIC pins is difficult. I tested the sensor at room temperature and in boiling water; it was within about 5 degrees Fahrenheit for both. Then I tested it in my toaster oven at 300, 400, and 500F. My toaster oven has about +15F -25F range as its thermostat cycles. I used J-B Weld to attach the thermocouple as deep between two poles as I could. I applied several coats, so the thermocouple is embedded under 1/8" to 1/4" of epoxy. After twisting the wire a bit, I shielded it with 1"x1' strips of aluminum foil before taping it along side the stator wires. I paid much more attention to routing the stator wires to avoid pinching them this time and they were taped wide and flat instead of circular.

I wrote up a simple Arduino sketch based on this example and logged 1Hz data to the serial monitor. The J-B Weld had only partially cured, but I had to know if it was going to work properly. I started the bike with the stator disconnected. I got 21VAC at idle just like before. The thermocouple temperature rose steadily and the interference was not bad. Next, I started the bike with the stator connected to the CE-605 SB voltage regulator, temperature rose more quickly, and interference was still not bad at all. Then I stopped the bike and let it cool some. I have three more sensors to add to the data logger before I start riding and logging, but at least I know the stator thermocouple is working well. I'll post photos, schematics, and code once the logger is complete.

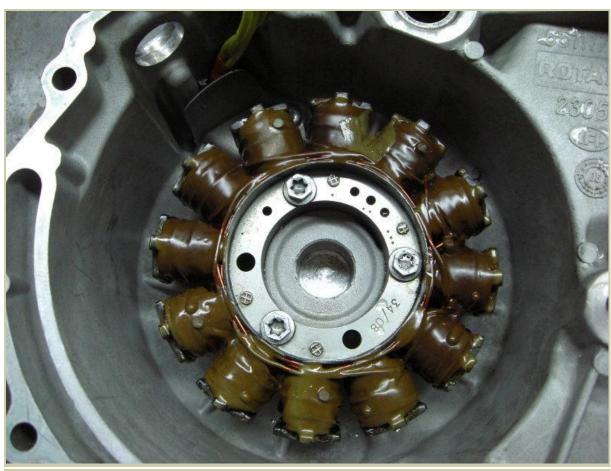
I had a little oil mist leak around where the additional thermocouple wire exited the ignition cover. It had also been about 5000 miles since I rewound the stator, so I figured it would be a good chance to fix the leak and inspect the stator. My charging system is still working great. The voltage doesn't dip quite as low at long traffic lights since I've had my BatteryMINDer 12248 charger/maintainer/desulfator, so I think a weak battery was related to that. As you can see in the following photos, the J-B Weld is still discolored about the same as it was when I had the short to ground around 200 miles. I lightly sanded it again to verify that the discoloration is still only on the surface of the epoxy. The J-B Weld certainly wasn't designed for this application, but aside from the surface discoloration, it seems to be holding up great. The exposed polyimide insulation I can see still looks like new with no discoloration. I now have 1000 more miles on the rewind, air-cooling rotor, and series regulator than I had on the original charging system.
