# Agua Dulce Landscape Background and Guidance

Revision 1.08  
Last Updated: 10/25/2025

Prepared for the Association by Landscape and Community Volunteers

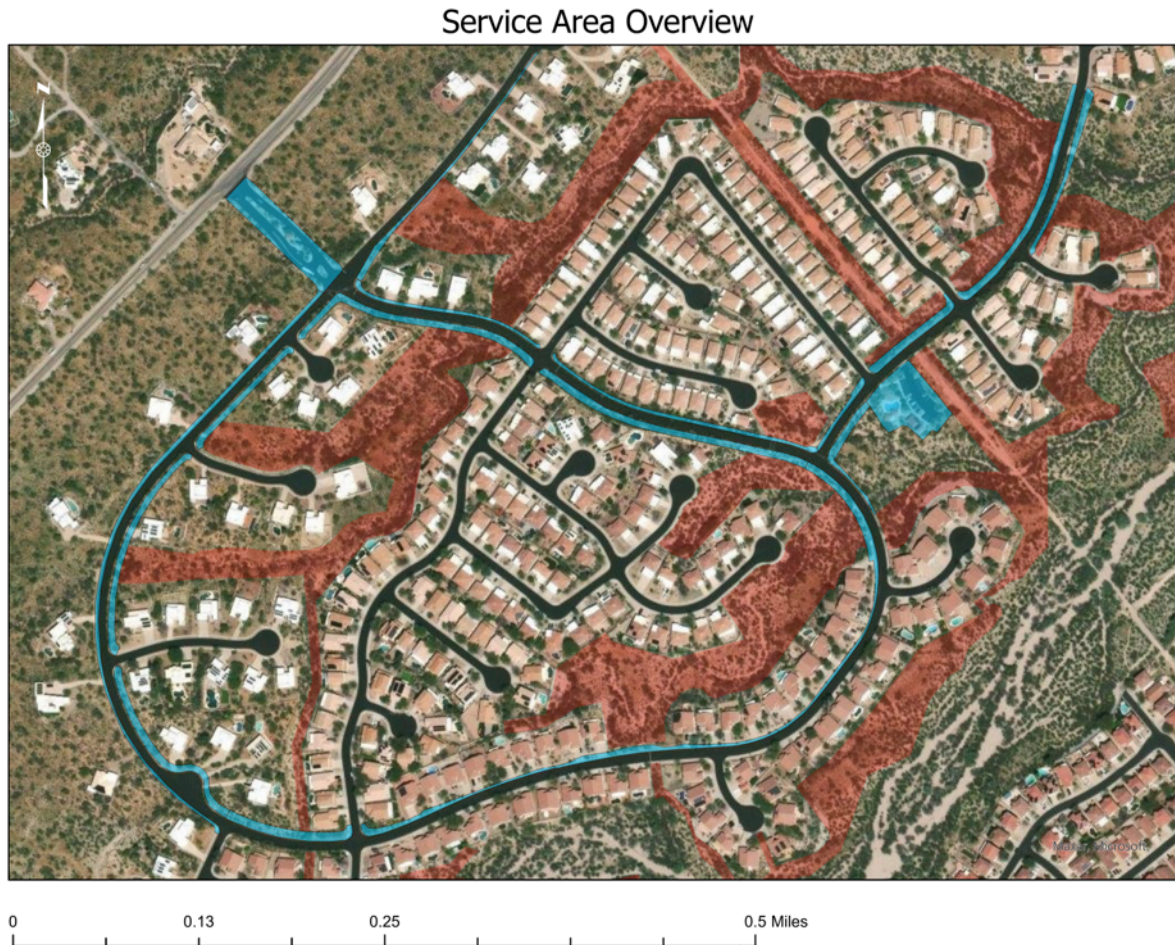
This document outlines recommended practices for managing the Association’s common areas in regards to landscape and irrigation. These recommendations are specific to the areas shown in blue and red below with some exceptions.

- Areas shown in blue are the primary focus areas for our contracted landscaper. The blue areas host community assets such as walking paths, our community pool and our community entrance. Cadence for management of these areas is summarized in the section of this guidance entitled “Landscape Maintenance Service Areas”.
- The areas shown in red are designated Common Area B and D (open space and drainage) by Pima County and in our CCRs. These areas are maintained on an as-needed basis in line with restrictions summarized in the section of this guidance entitled “Common Area Restrictions”.

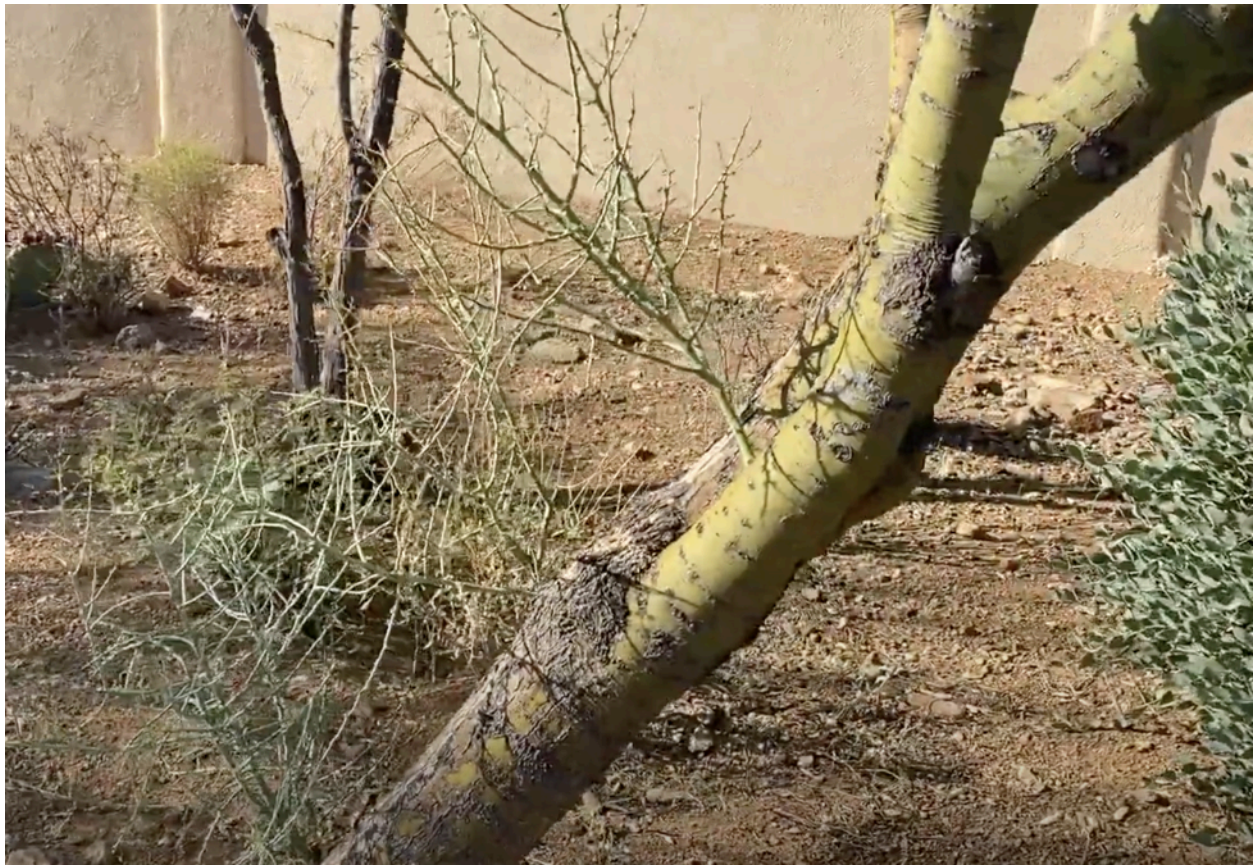
Agua Dulce is following the advice of both arborists with the goal of returning our native trees and bushes/forbs back into correct sync with the seasons, with pruning only occurring at the correct time of year and only as needed. In response, common area trees are now hosting small sprouts on trunks where they are not being maintained which is in turn realizing shade on sunburned trunks and soil. Here's an example of trunk with exposure to the sun that is now realizing new growth to the benefit of the tree:

This growth is intentional and indicative that respective trees are healthy, vigorous, and recuperating in line arborist recorded comments available here: <https://youtu.be/xFLoueCfGZs>.

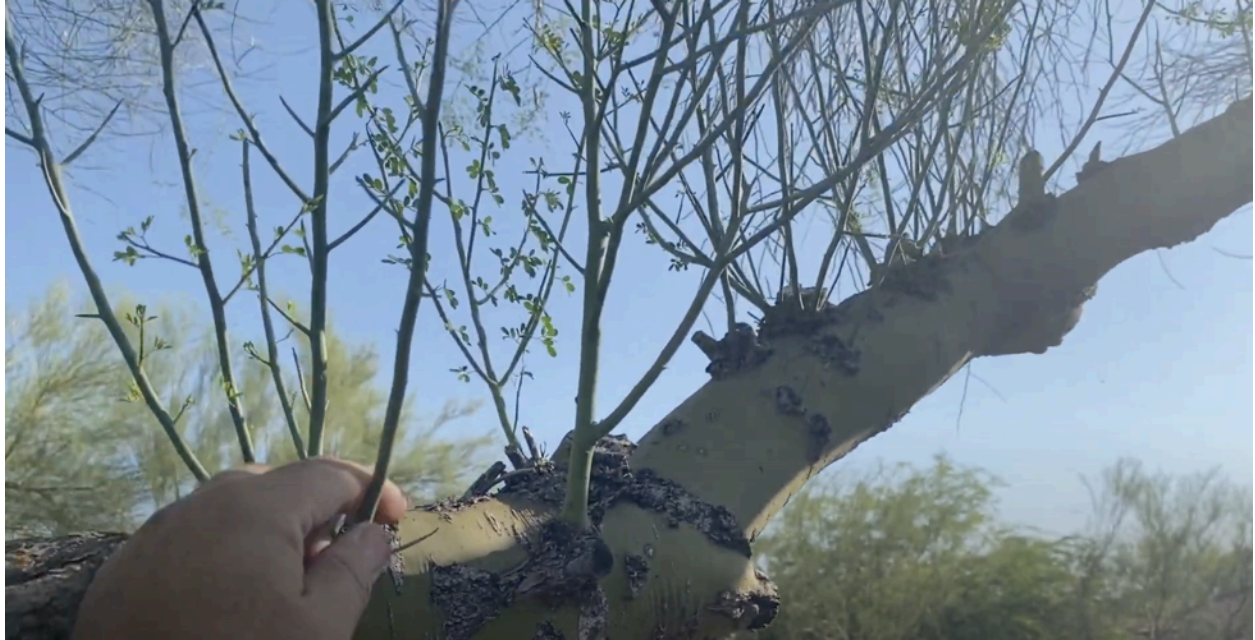
In addition, we are now seeing new growth on long limbs. In line with ISA-certified arborist recommendations, this growth will add girth to limbs thus making them more resistant to breakage in high winds while creating shade for walkers:

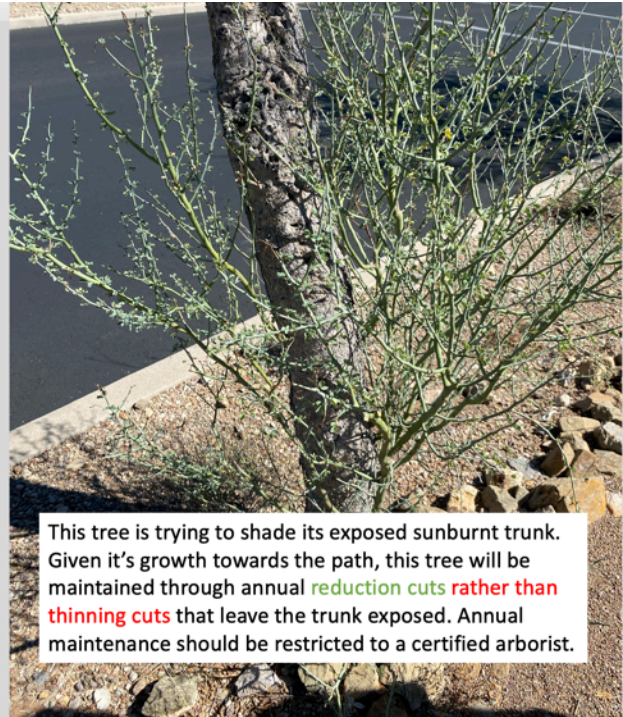
This tree is trying to shade its exposed sunburnt trunk. Given it's growth towards the path, this tree will be maintained through annual **reduction cuts** rather than **thinning cuts** that leave the trunk exposed. Annual maintenance should be restricted to a certified arborist.

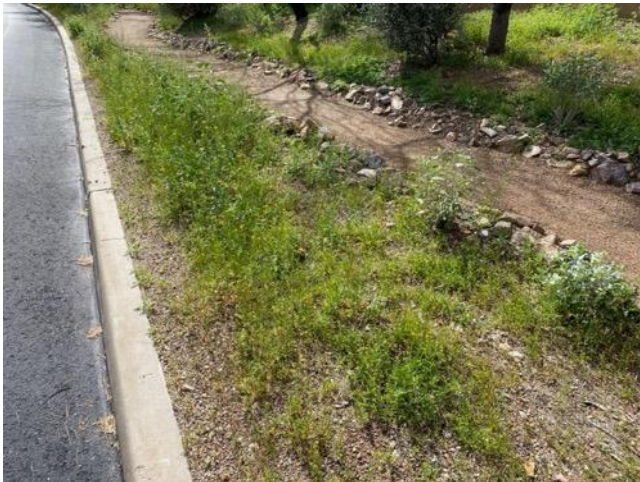
This photo shows an area on Pallasite between Banner Mine and Magnetite that was overtaken by London Rocket after the significant rain witnessed in early 2024.

Volunteers and landscapers subsequently removed this stand by hand with the goal of allowing brittle bush seedlings in the same area have an opportunity to compete.

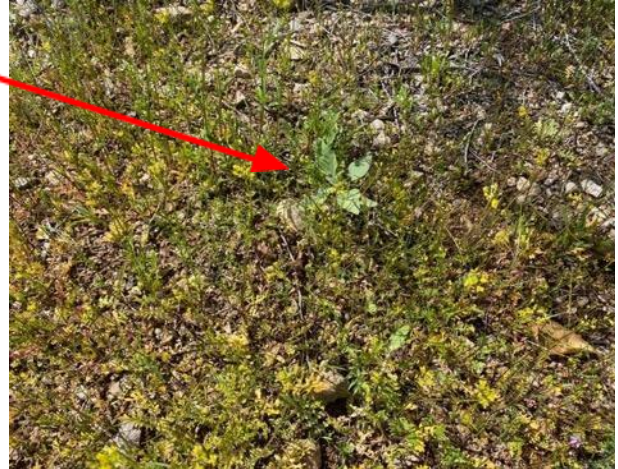
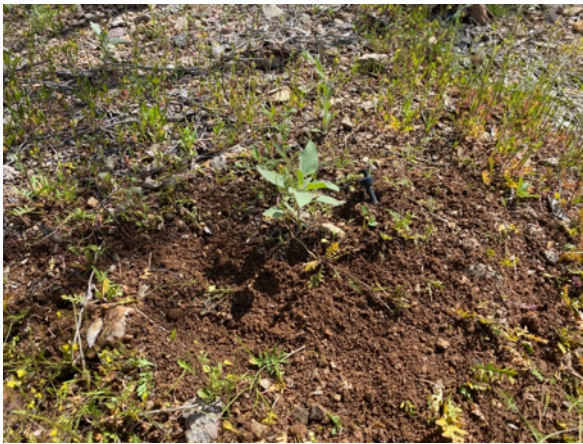
Note the small brittle bush seedling trying to compete for light in a stand in an emerging stand of London Rocket.

If left unchecked, the invasive may have outcompeted this seedling for light and water resulting in a mono-culture landscape.

London Rocket was removed by hand from around the emerging brittle bush. Had mechanical means been used, this seedling would likely have been lost.

For this reason, string cutters are only to be used as a last resort in areas that have already been completely overtaken. The Association should work with landscapers to avoid this from happening and emphasize judicious use of string cutters only when absolutely necessary.

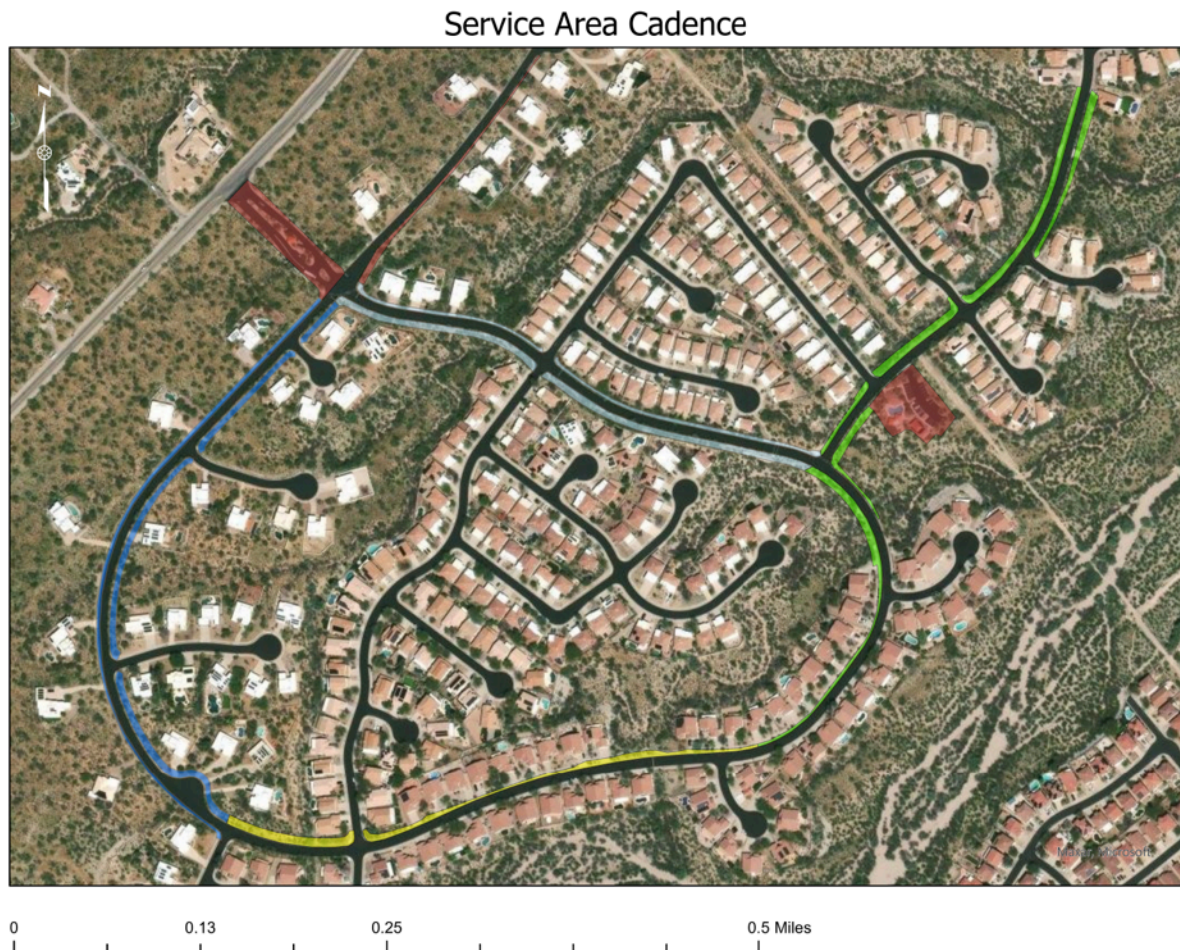
This map summarizes the cadence of service to be provided by our landscape contractor. Of greatest importance is the red zone associated with the community entrance and pool area given its first-impression and high-visibility impact for residents and prospective home buyers. All paths are to be raked weekly regardless of color. The remaining zones are to be focused on in line with the schedule shown below.

**Red** zones are maintained **weekly**

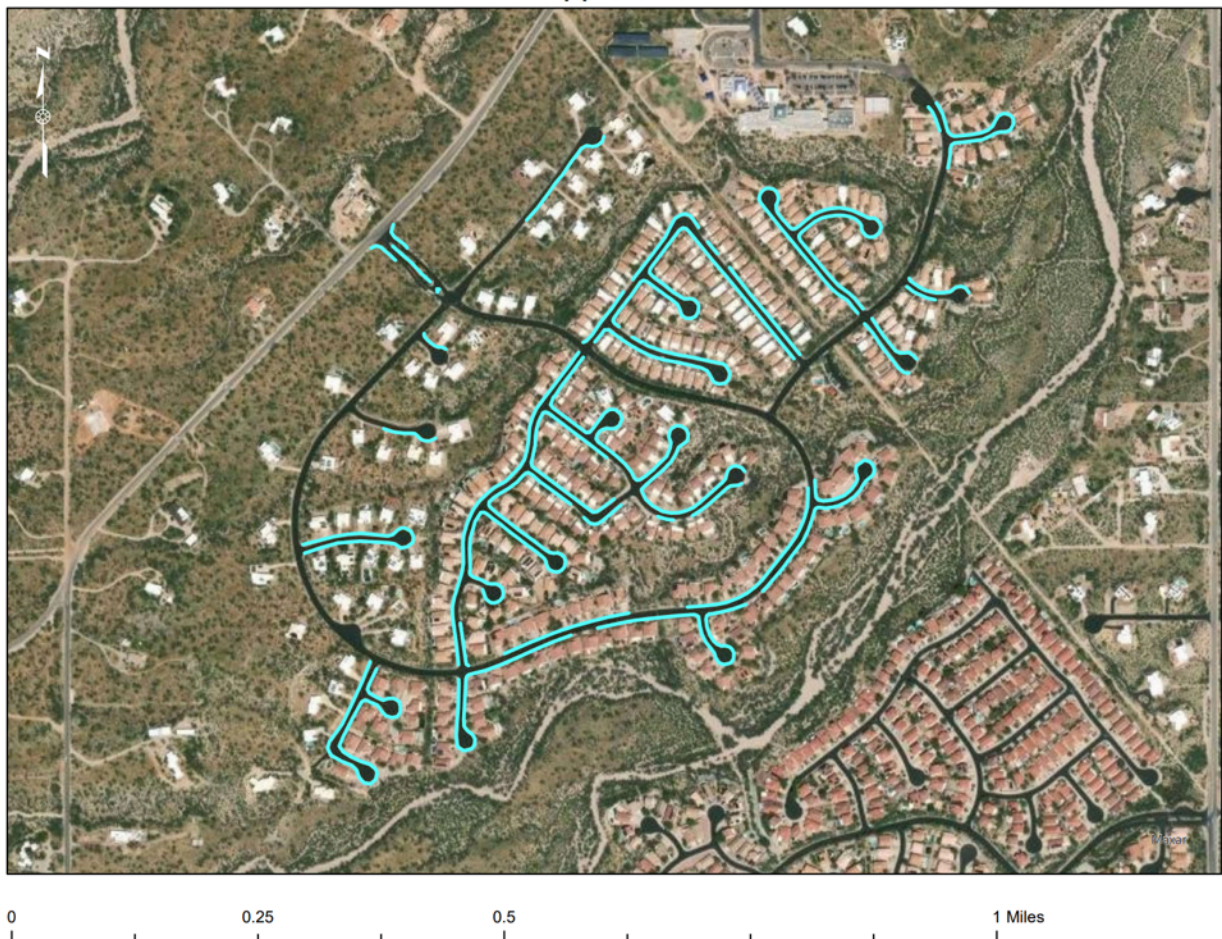
Herbicide Application Zones

In 2022 and 2023, we encountered challenges as it relates to areas being improperly treated both with respect to common area and residential court strips. In response, a new map was created in 2024 capturing both common areas as well as the wishes of Association members that don't wish to have herbicide in the vicinity of their homes. The map is presented here to facilitate improved accuracy in regards to treatment and is also available in Google Earth format via this link:

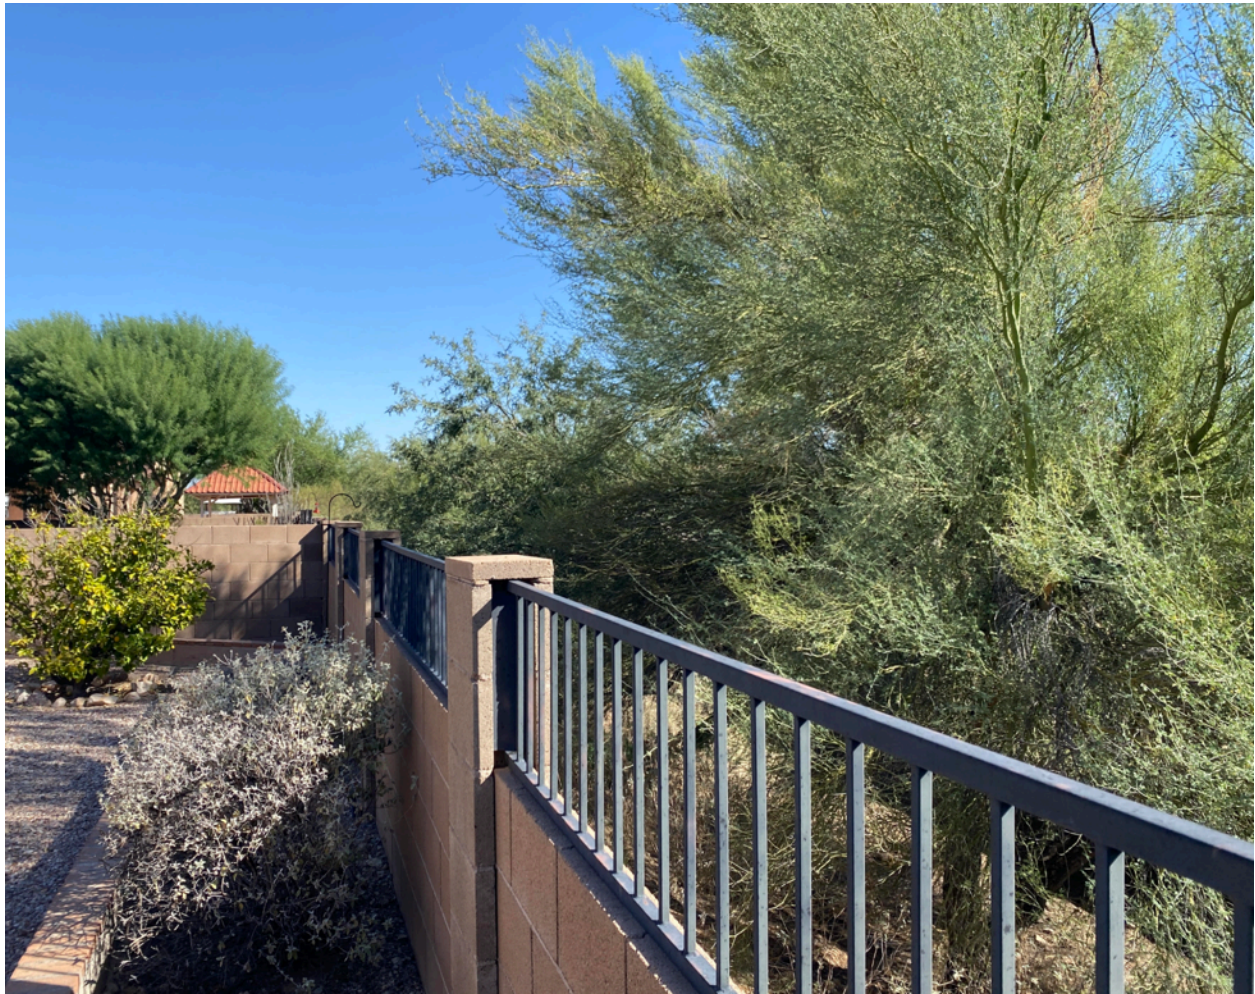
Here is a photo of the properly pruned tree relative to the property boundary:

Should concerns come up again, it is recommended the site be evaluated and our landscapers contracted for branch removal only as necessary. **Residential claims that trees are non-viable and should be removed need to be corroborated by an expert such as an ISA-certified arborist to avoid violating our CCRs.** Since evaluation, pruning and/or removal realizes costs for the Association, photographs should be taken **before and after** to (1) document that the concern is legitimate and (2) demonstrate it was addressed responsibly and in line with ANSI-A300 pruning standards.

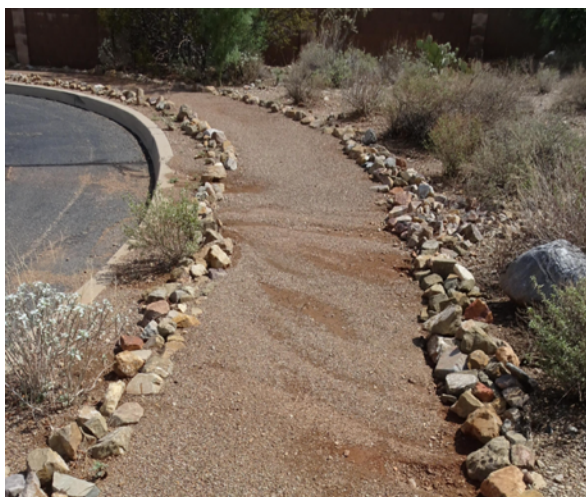
This is an opportunity for Rainwater Harvesting Identified by Volunteer Observations. Specifically, sediment and erosion across paths points to opportunities for upstream water harvesting. Consider working upstream to slow down stormwater before it realizes downstream impacts.

Per the Landscape Committee charter, if repairs require movement of less than 1-cubic yard of soil, they may be addressed immediately by registered volunteers without board consultation. (Registered volunteers have filed a volunteer liability waiver form with the HOA). This will ensure headcuts can be remedied immediately before they realize further damage rather than waiting for board review and approval on a monthly cadence. If repairs require movement of more than 1 cubic yard of soil, respective details should be communicated to the board with a plan for remedy.

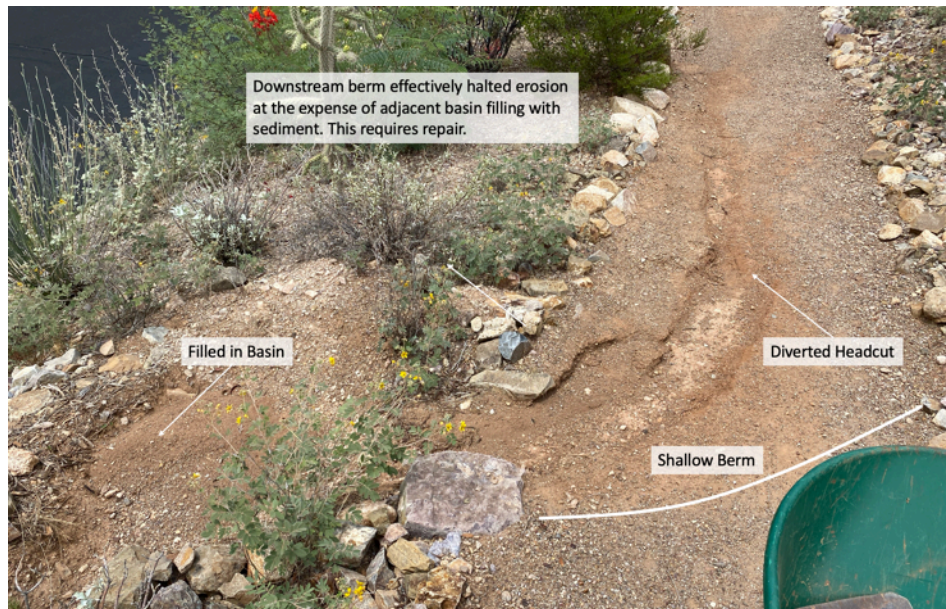
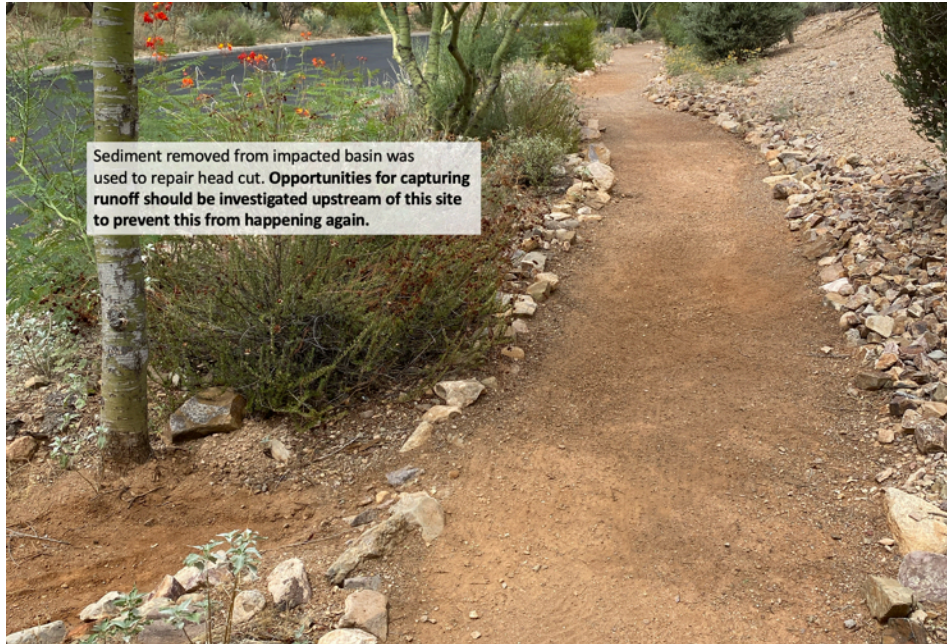
As summarized in the section entitled “Water Harvesting Features”, stormwater impacting common area paths is currently directed to shallow basins along walking area paths. This ensures stormwater is put to beneficial use rather than contributing to unsustainable cycle of erosion and repairs. This strategy has worked well for Agua Dulce but does require some incidental maintenance. Over time or in response to extreme storms, paths may still erode and basins fill with sediment thus losing their effectiveness. In response, volunteers dig sediments out and use the same to repair upstream paths. The following two figures demonstrate the repair.

When this occurs and repairs are needed, opportunities for installing new basins upstream of impacted areas should be investigated in order to relieve pressure on downstream features.

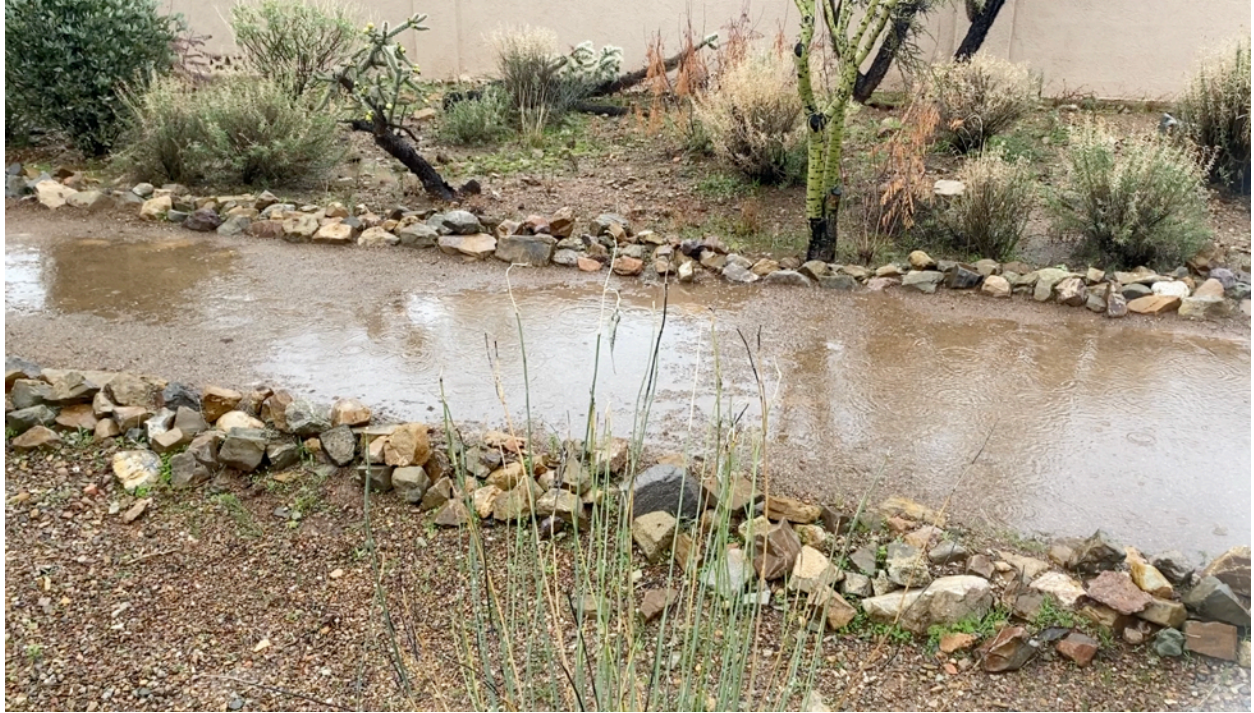
Here is an example of an area on Pallasite that is hosting standing water on a walking path. Although this water will quickly infiltrate to for the benefit of adjacent plants, some may find it a nuisance when walking the paths after a storm.

In response, the resident the who identified this as an issue stepped up to be part of the solution. Here is a general summary of how the work was realized by the volunteer in coordination with the Landscape Chair.

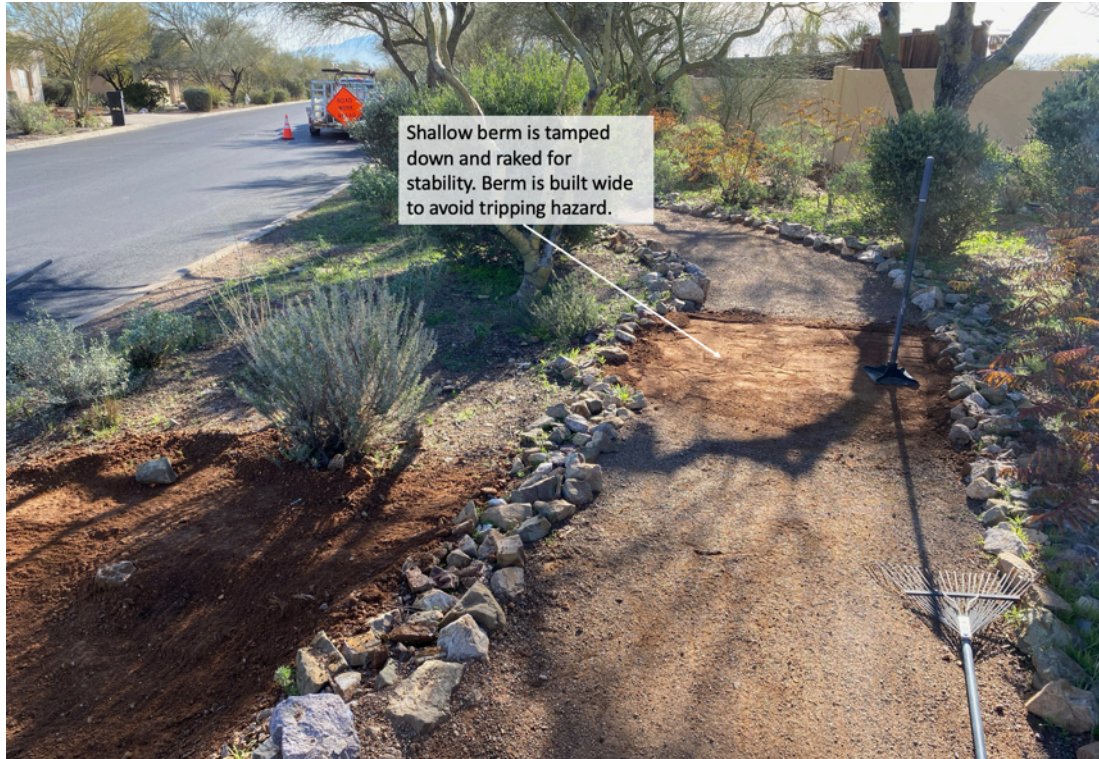
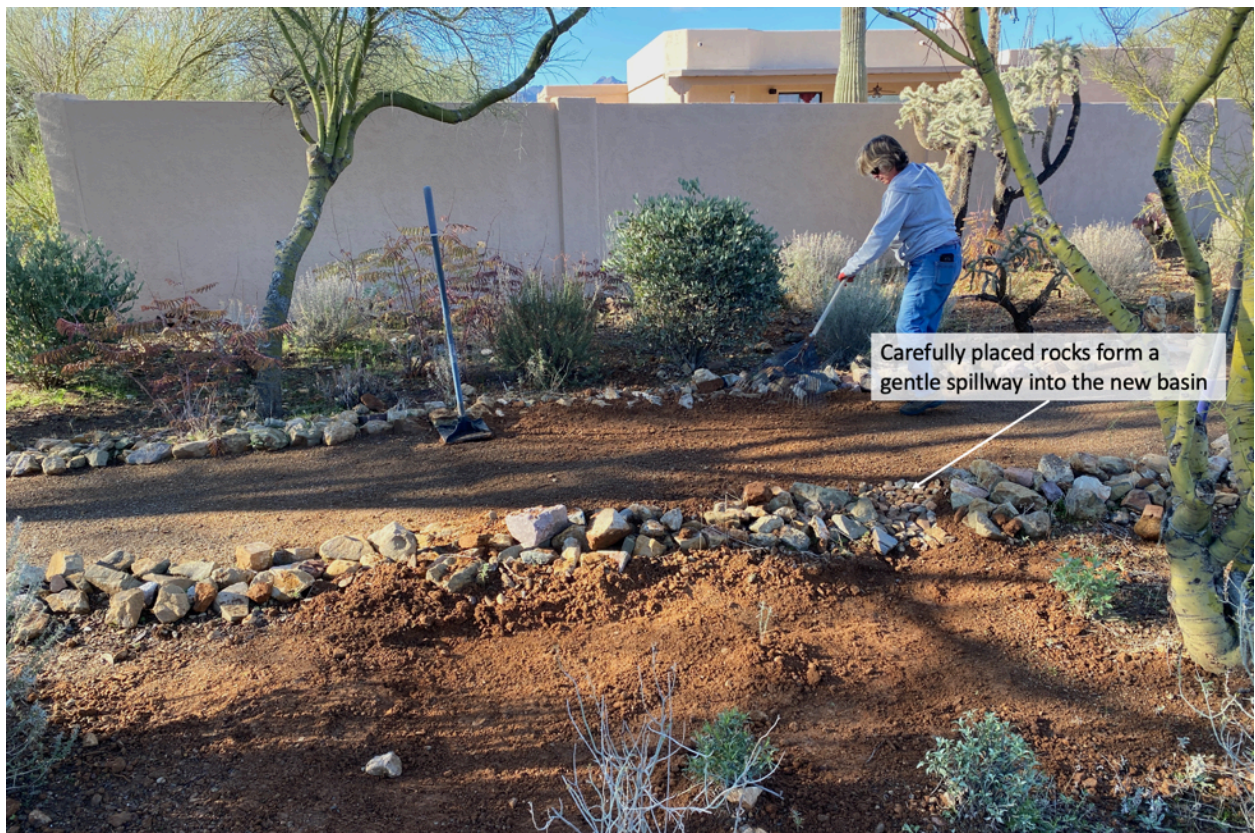
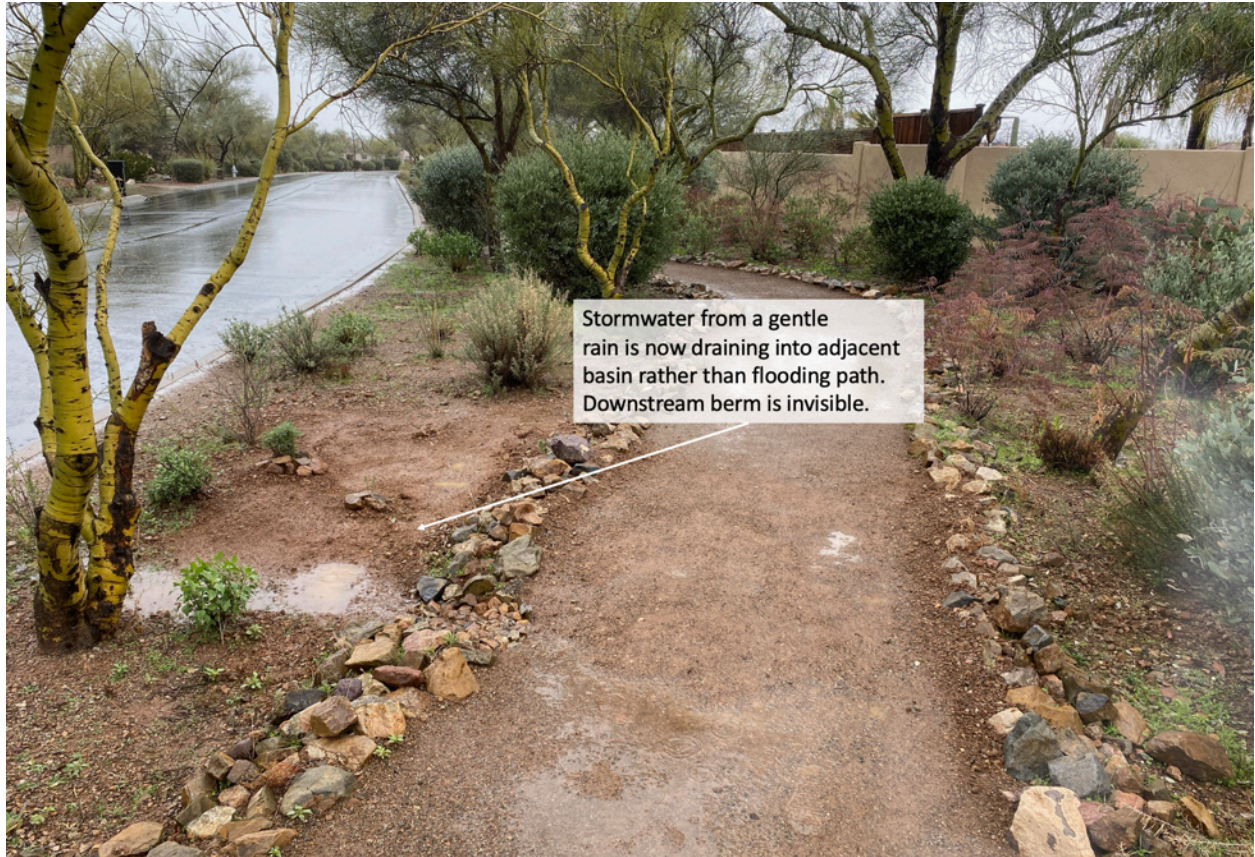
The following photos summarize how a new basin was developed to build the first of two ponds just south of Pallasite and Robert Daru now affectionately known as “Shavon’s Ponds”.

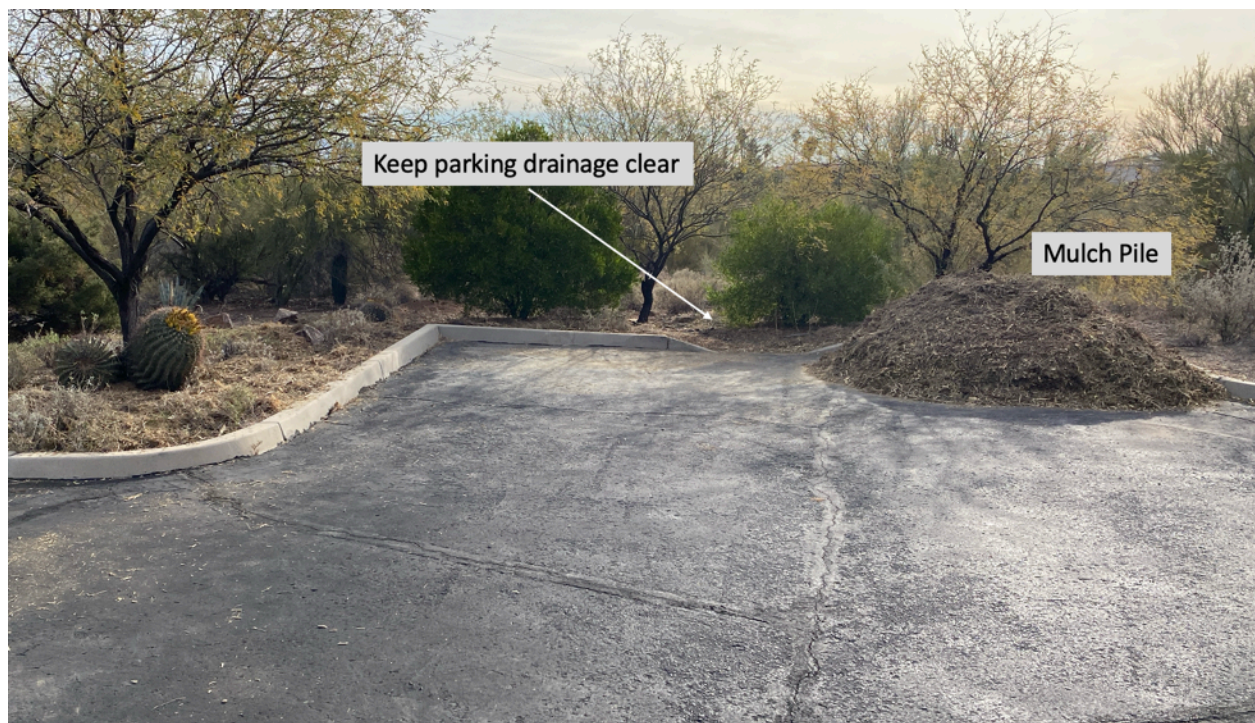
Mulch donations are stored on the south end of the parking area and may be allowed to ferment as needed for several weeks. Try to constrain placement to no more than once parking space without block in the parking area drainage.

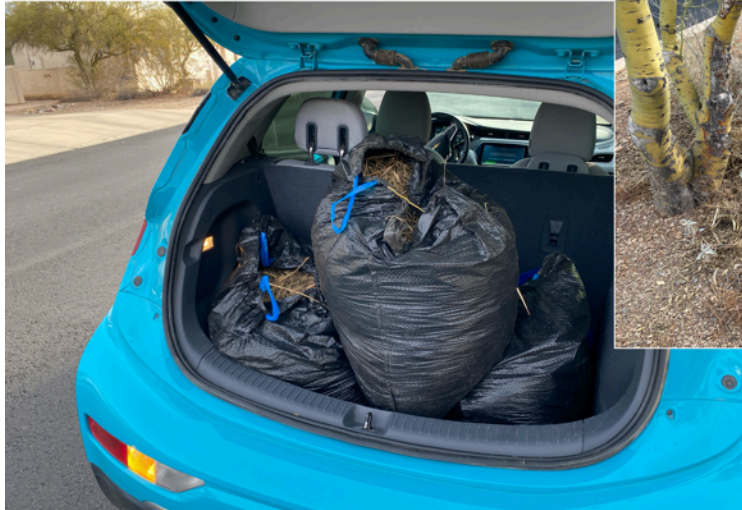
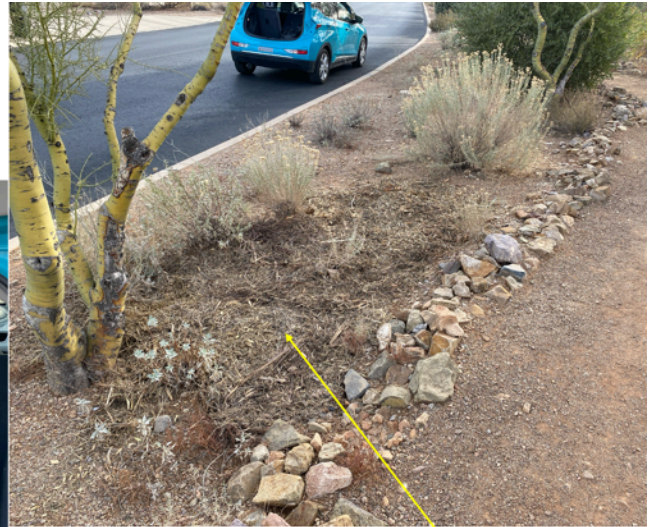
Mulch used to top off a water harvesting feature to a depth of 2-3" on Pallasite

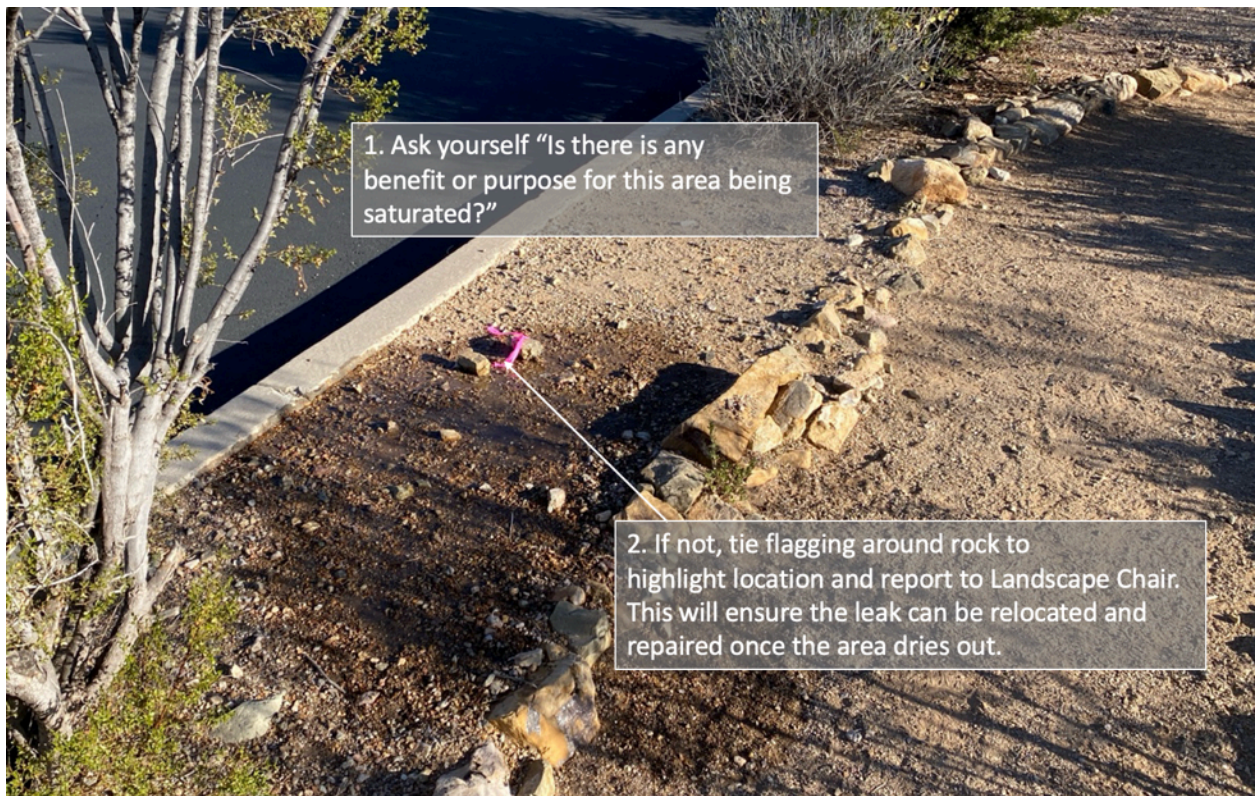
Below is an example of saturated area along the path that is providing no benefit given its location relative to established plants. Specifically, there are no trees nearby and the adjacent creosote requires no irrigation. This is likely sourced to an old spaghetti emitter that was damaged or removed by wildlife. Volunteers who have received training may flag and communicate the location to the Landscape Chair for follow-through.

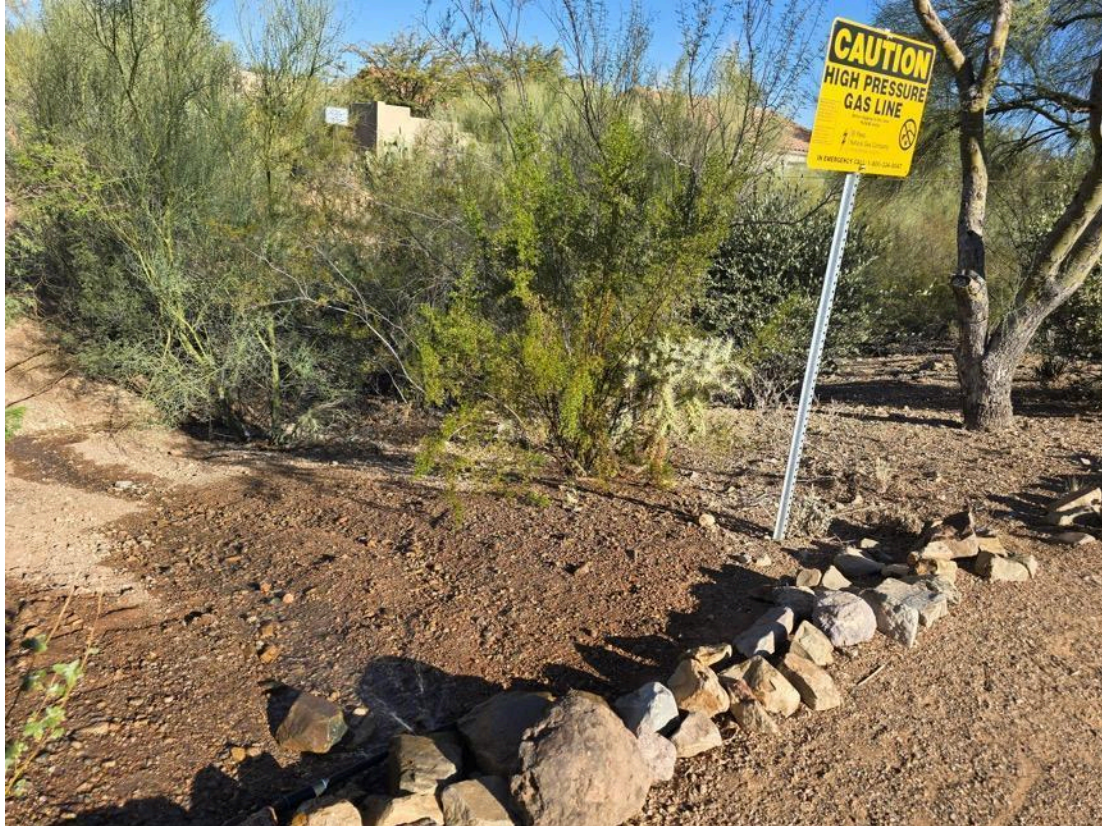
As walking this morning I saw a big leak in the polyvline where the gasline drops down to the north. This was at 9:30 this morning. I tagged it with pink ribbon. The line is exposed as you go down to the north (west). See attached picture.

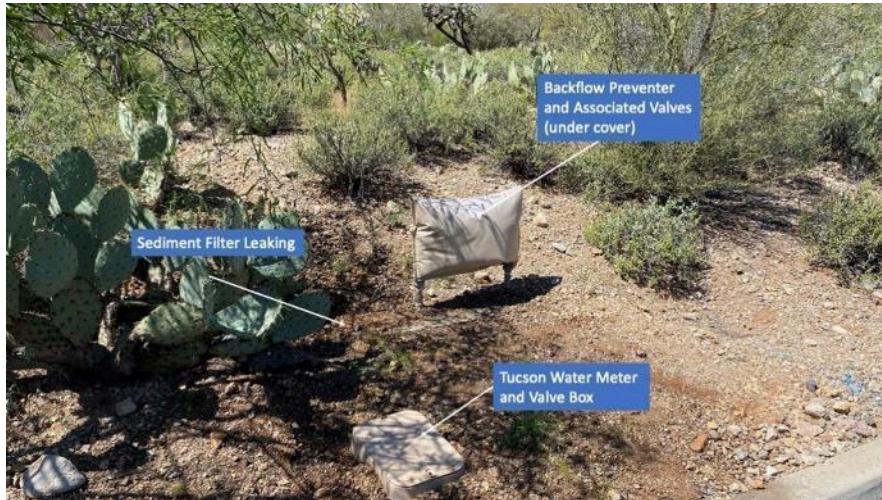
This photo shows a leak downstream of backflow preventer at the sediment Filter upstream of the Tucson Water Meter and Valve Box. This requires turning water off upstream of Tucson Water Meter. This will require turning ball valve on backflow preventer upstream of Tucson Water Meter to the OFF position.

**When turning ball valve to OFF position, due so very slowly to avoid water hammer which can damage delicate glands in the backflow preventer.**

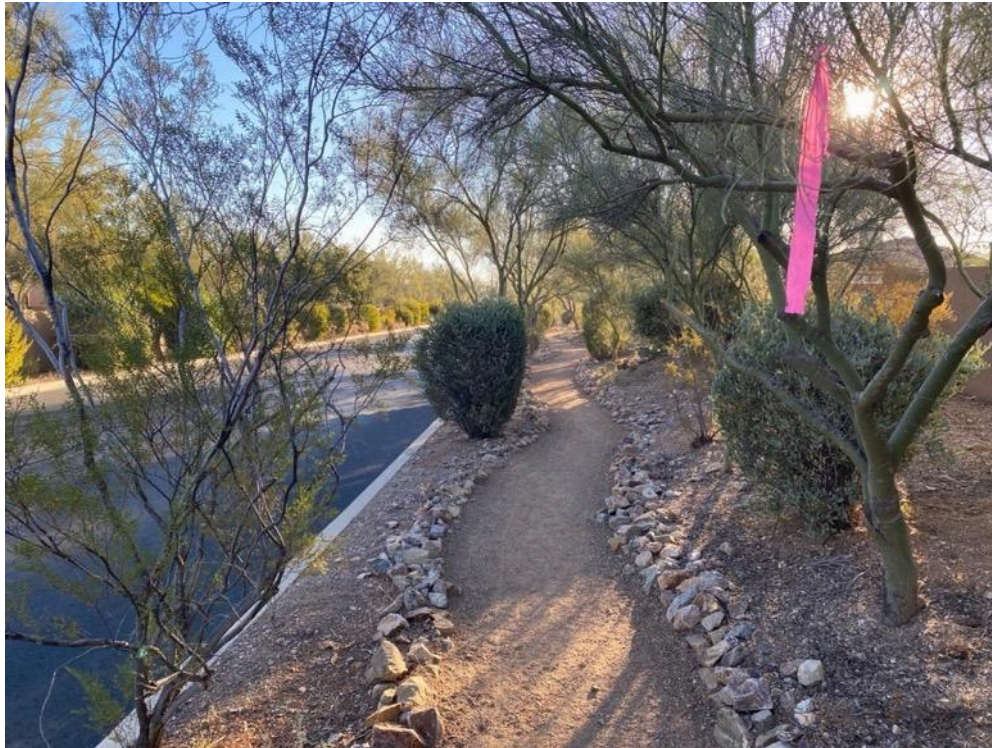
Low hanging branch that needs to be judiciously reduce (NO THINNING CUTS!)

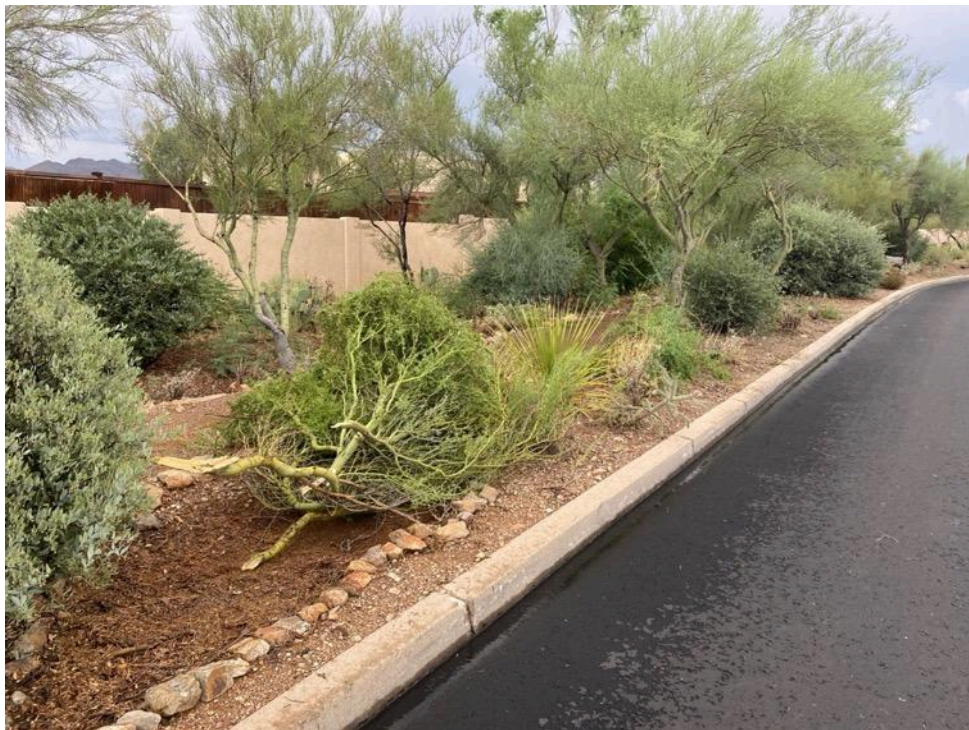
Broken branch hanging off tree can be gently removed and placed on ground and out of the way for collection by landscapers. DO NOT remove branches that are still partially attached to a tree since you might damage the tree by pulling on the same.

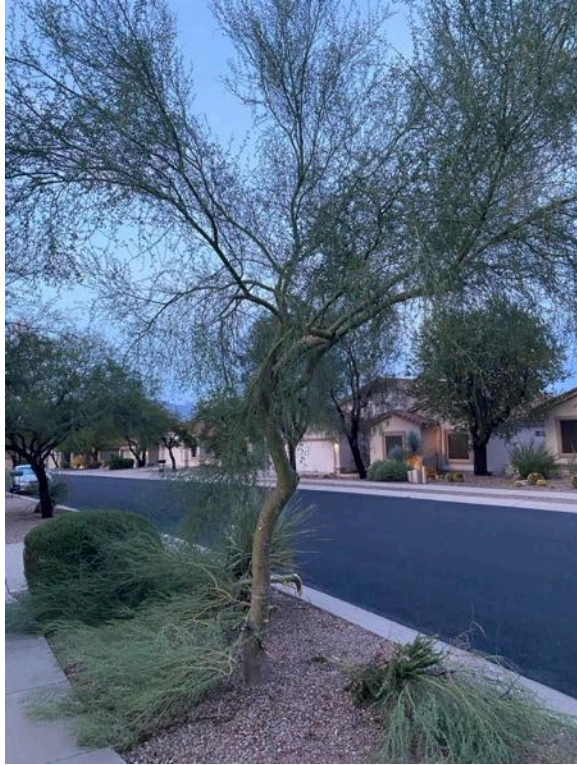
If a branch is hanging and cannot (or should not) be removed by hand, a cone can be placed under the same to flag walkers regarding the same until the landscapers can address it properly.

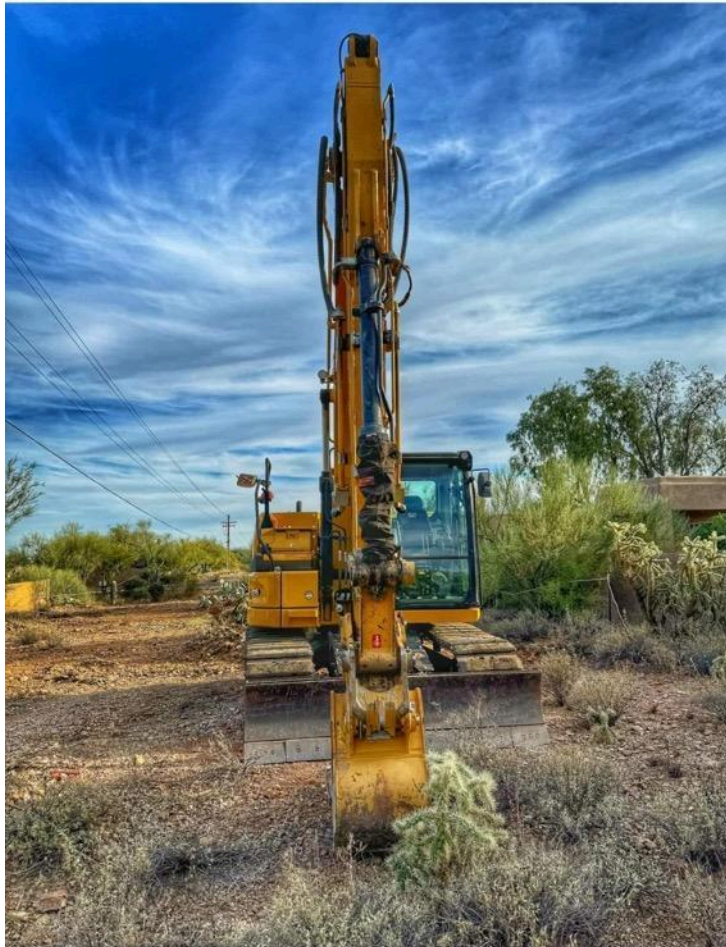
if you're still a kid at heart like me and have to explore "what's goin' on" I offer this bit of advice...this piece of machinery has dug up and spread bits and pieces of cholla across the gas line north of Magnetite...it was like a game trying to avoid stepping on and having your shoes impaled by those nasty bits...
