Auto 132 Lab Experience Report

2011 RAM 1500

Losing coolant. Ticking noise - possibly from the exhaust manifold gasket.

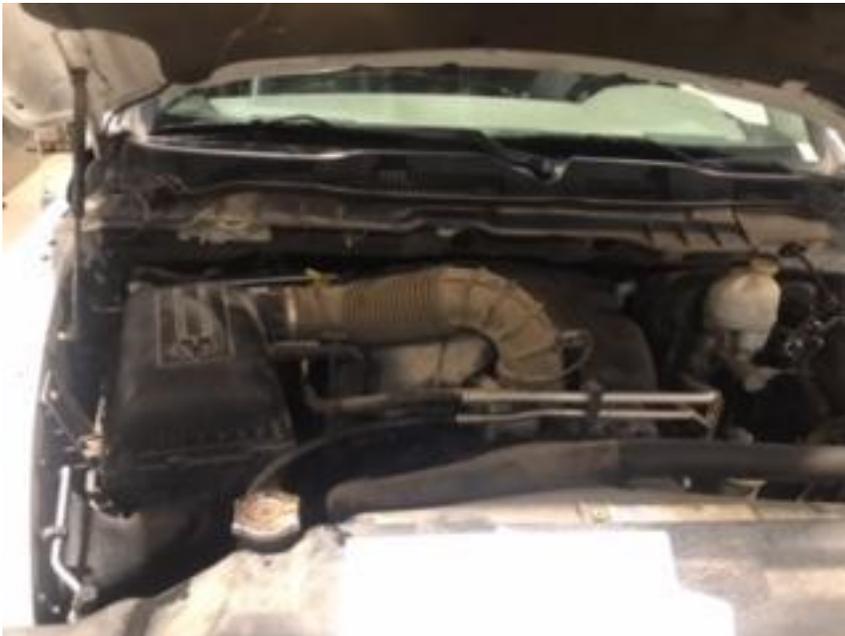
The first thing my lab partner and I did was perform a visual inspection inside the engine bay to see if we could find any noticeable damage around the cooling system. We wanted to find the cause of the problem for the coolant leak first before diagnosing the "ticking noise." We inspected the upper and lower hoses, as well as the overflow reservoir, but couldn't find any damage. We did notice that there wasn't any coolant in the overflow reservoir. We also noticed some coolant leaking on the floor in the shop, so that verified for us that the customer was losing coolant. Here's a photo of their engine bay:

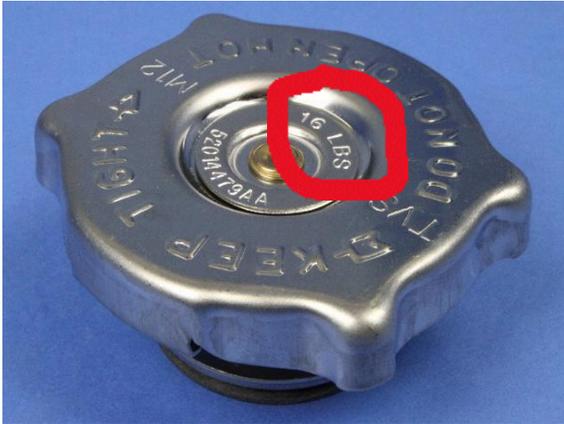
Since we were able to confirm the vehicle's coolant was leaking, we decided we needed to perform a coolant pressure test. This test enables us to find the source of the leak, but we need to know what pressure to set the test at. We looked at radiator cap and the cap shows that it requires about 16-lbs of pressure:

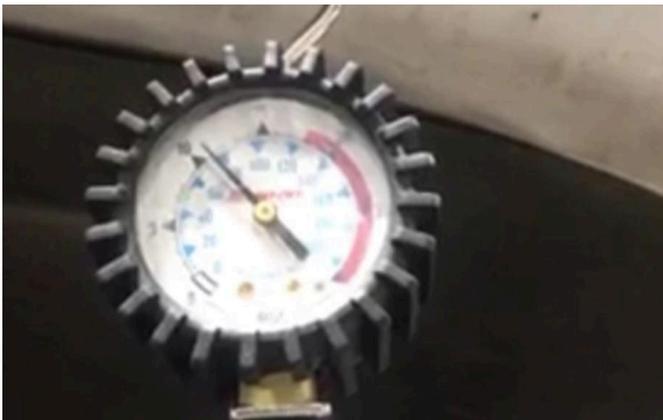
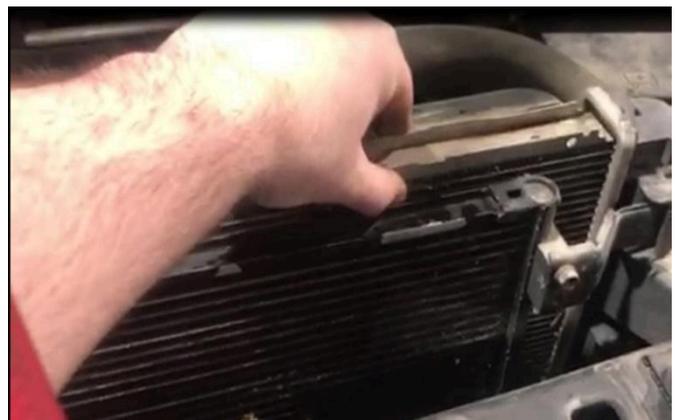
We set the pressure tester to 16-lbs, and we noticed that not only was it not holding pressure, but we could hear air coming from the engine. After listening and feeling around, we found that the air was coming from underneath the cover of the radiator. We removed the cover, and we were able to see immediately that the leak was coming from the radiator. A hole had punctured through the radiator and that's what was causing the coolant to leak. The photos below show the pressure test gauge and the hole in the radiator. Where my thumb is on the radiator is where we found the puncture:

After performing the test and finding the problem, we searched in Omnique for parts to replace the radiator, upper & lower coolant hoses, and thermostat. Once we found a quote for all of the parts from O'Reilly, we called the customer to inform what we found and gave him a quote for the needed parts. He approved the necessary repairs, so we asked O'Reilly to deliver the parts and we got started on removing the radiator and the other parts. At first, we were going to use the instructions found on ProDemand, but some of the instructions weren't clear. Instead, we found a video on YouTube by 1A Auto that was able to give us step-by-step instructions on how to remove and replace the radiator. Here is a copy of the link: www.youtube.com/watch?v=OGAotgXfbkw.

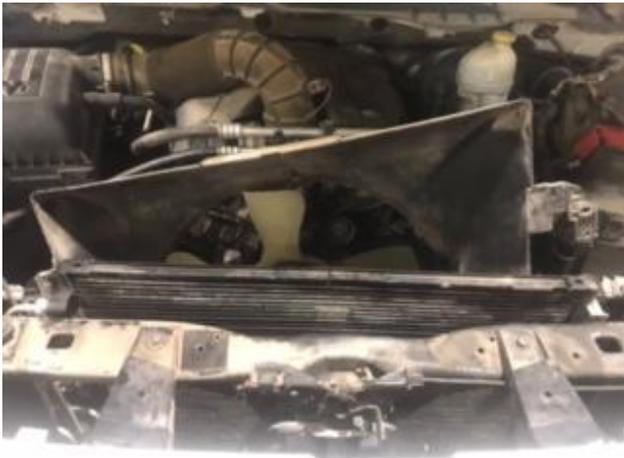
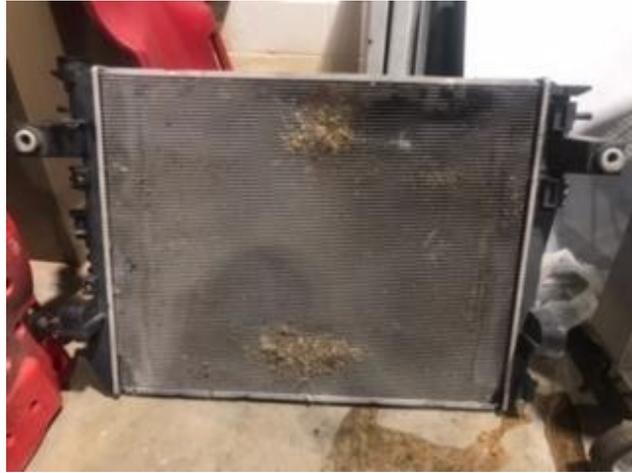
The first step we took was to drain all the coolant by removing the drain plug from the radiator. We had to remove the skid plate covering the radiator below in order to remove the drain plug. Once the coolant was drained, we were able to remove both the lower & upper coolant hoses. After that, we started removing the radiator. It was a difficult process to remove the radiator, but as we removed all the necessary bolts and got the fan covers off, we managed to remove the radiator. Here are some images from after the removal:

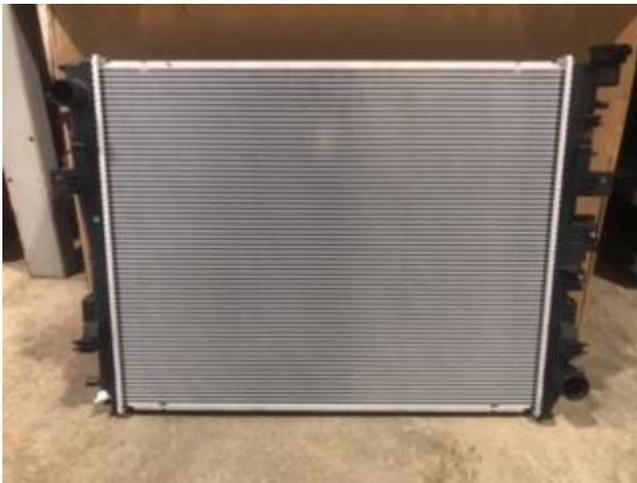
After removing the radiator, we got the new radiator and compared it with the old one, to make sure they matched the same specs. They were a match, so we removed all the bolt clips and rubber bushings from the old radiator and attached them to the new one:

While we had the radiator out, we went ahead and installed the new thermostat. Once that was installed, we started on attaching the new radiator. It took a bit of time for us to get it installed with all the small spaces we had to work with. After we got it installed, we were able to attach the new upper & lower radiator hoses, and install the skid plate and top covering for the radiator.

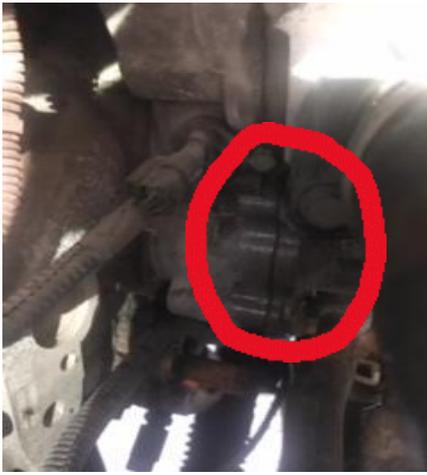
Before we added coolant to the cooling system, we performed the same coolant pressure test to confirm that there were no other leaks. Unfortunately, we did find another leak coming from the water pump gasket. Highlighted in red in the picture below is where we found the leak:

The other bad news is that we ran out of time for class, so we weren't able to replace the water pump and gasket for the customer. We weren't able to diagnose the "ticking noise" for the customer as well, so we only managed to solve one problem for the customer.
