Biomass Gasification Research Research Blog

Started: September 24, 2014

Leaders: Chirag Pansuriya, Ernest Echefu, Dr. Jerry Cloward, Dr. Bai, Chengdong Hu,

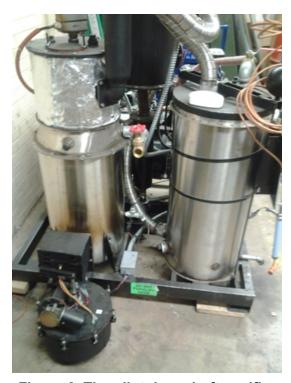
Figure 2. The pilot downdraft gasifier

The experimental study in conducted in the gasification lab in EIU's Technology Department. Figure 2 shows a lab scale downdraft gasifier produced by ALL Power Labs manufacturer (http://www.allpowerlabs.com/) considered as the pilot gasification setup in the experimentas study.

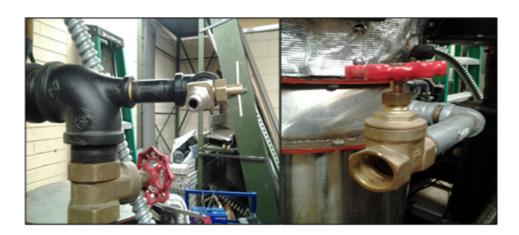
By providing a negative pressure inside the downdraft reactor caused by a venturi (figure4- left), the Air/Oxygen needed for the gasification is sucked through the gasifier and regulated with a globe valve (figure4-right).

Figure 4. Left-venturi. right- air inlet valve

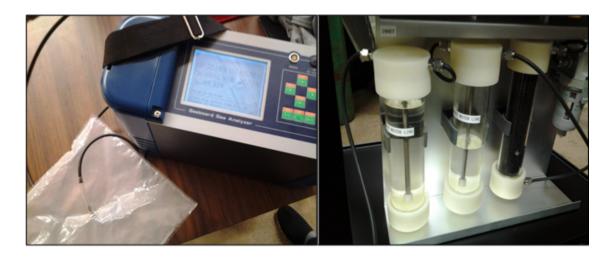
The analyzer is set to determine syngas compositions and related HHV simultaneously based on the NDIR and Thermal Conductivity detectors. Syngas is passed through a pre-filter (figure 7- right) in order to absorb tars and moisture before entering the analyzer.

Figure 7. The GASBOARD—3100P Portable Infrared Syngas Analyzer and the pre-filter setup

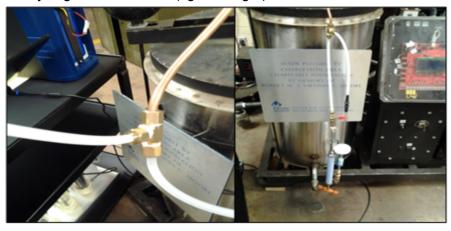
In order to connect the GASBOARD—3100P to the gasifier we considered a T-Connection (figure 8-left) after the copper pipe. Therefore, he can have both hand-pump sampling for GC and inline gas analyzing in a same time (figure 8-right).

Figure 8. A separate line is considered for the GASBOARD—3100P

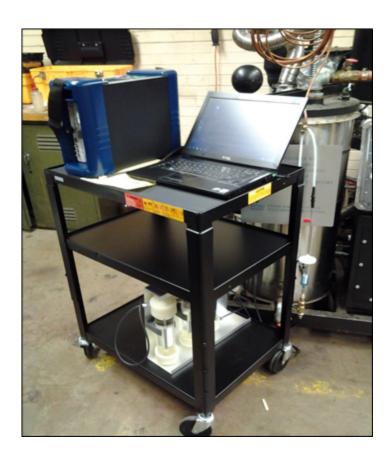
Figure 9. GASBOARD—3100P is added to the downdraft gasifier setup

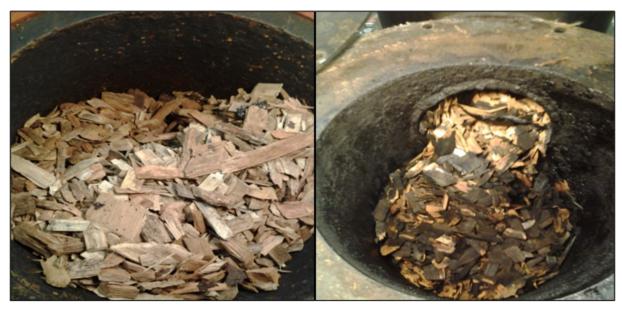
Note 1: After around 55 minutes the feeder auger stopped working. Therefore, we had the feeder hopper almost full of wood chips (figure 2-left) while the top of the reactor was empty (figure 2-right). In addition, the wood chips at the top of the reactor were tarry.

Figure 2. Wood chips at the top of feeder hopper and reactor

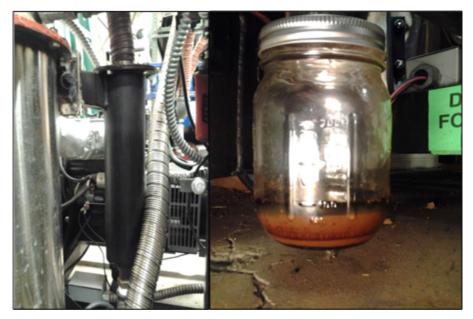
Note 2: Almost (30 ml) of tars and moisture (figure3-right) are drained in the collector jar installed at the bottom of the cyclone (figure 3- left) during the experiment.

Figure 3. the cyclone and the collector jar

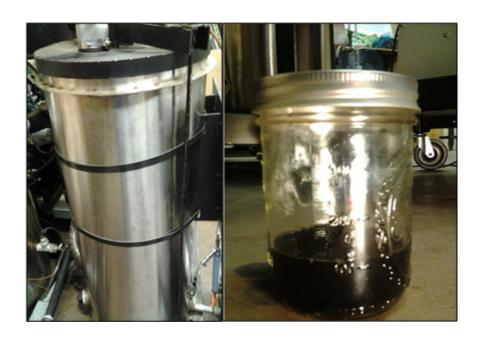
Note 3: Almost (110 ml) of tars and moisture (figure4-right) are drained in the jar installed at the bottom of the charcoal filter (figure 4- left) during the experiment.

Figure 4. the secondary filter and the collector jar

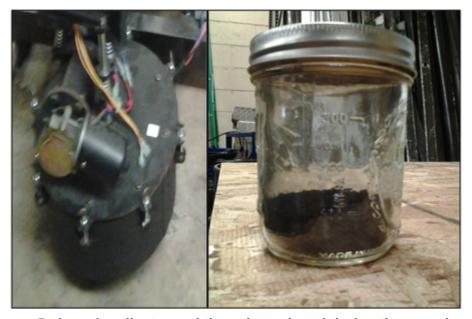
Note 4: Almost (110 ml) of ash (figure3-right) are removed by the ash collector (figure 3- left) during the experiment.

Figure 5. the ash collector and the ash produced during the experiment

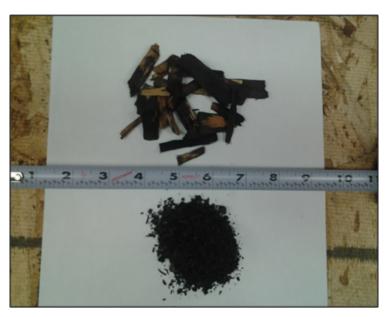
Figure 6. Ashes are compared to the wood chips collected at the bottom of the reactor

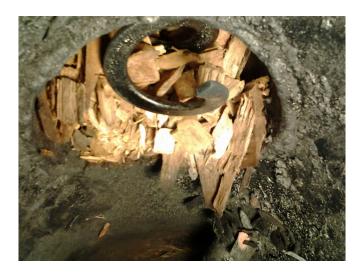
Figure 3. the auger stopped working

- The tar and moisture collected in cyclone and filter were almost 170 and 140 ml respectively (fig. 6 and 7)
- The auger was stopped working again (fig. 3)
- Due to the auger's problem and the gap appeared at the top of the reactor (fig. 4) , oxygen caused complete combustion at the top of the combustion zone (fig. 5)
- The average percentage of the gas elements in the syngas was lower than the previous experiment (table 1)

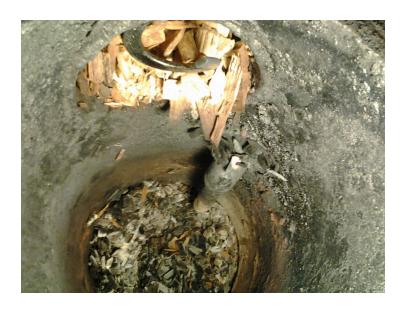
Figure 4. the gap between fuel entrance and top of the reduction zone

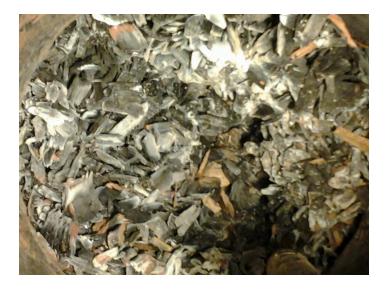
Figure 5. complete combustion at the top of the reduction zone

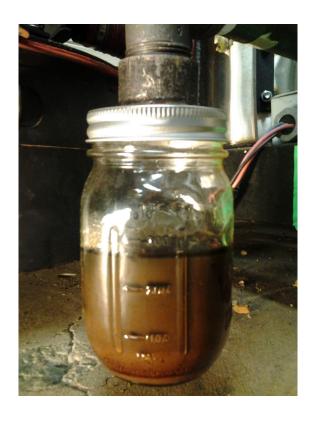
Figure 6. tar and moisture collected by the cyclon

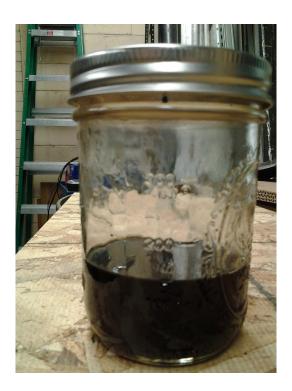
Figure 7. tar and moisture collected by the charcoal filter

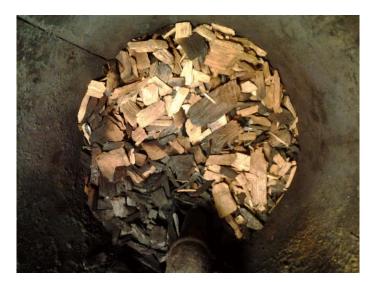
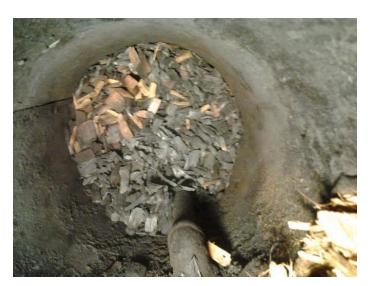
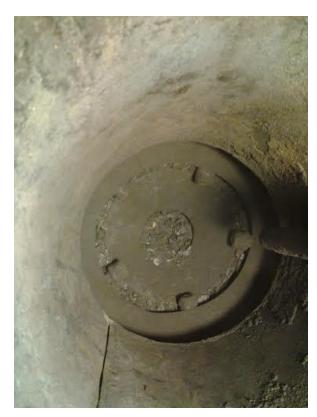
During the third experiment, we noticed that the pressure difference between top of the reduction zone and charcoal filter were significantly high. In addition, we could not able to increase the top of the reduction temperature higher than 700 C. therefore, we decided to stop the experiment and inspect the entire system in order to find the problem. Basically, two possible problems were suggested: block and leakage. Thus, we started to check the possible problems. First of all, we opened the reactor and we removed the feedstock inside the reactor. Then, we cleaned the reactor with a vacuum cleaner. figures 1 to 4 show the feedstock conditions during the cleaning process.

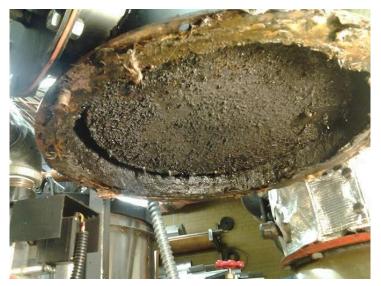
Figure 7. Bottom of the Fuel Hopper

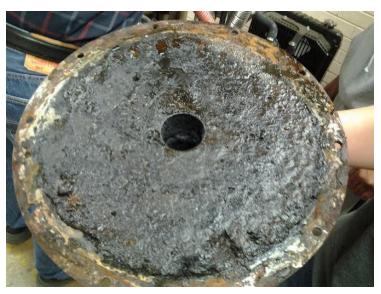
Figure 8. The connection plate between the Hopper and the Cyclone

At the end, we changed the gasket between the cyclone and the reactor. In addition, we added a new gasket between the cyclone and the hopper connection.

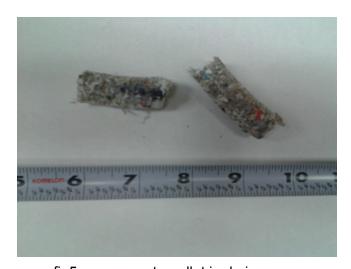
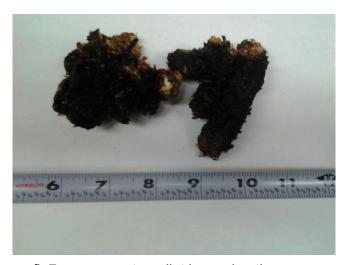
fig5. paper waste-pellet in drying zone

fig7. paper waste-pellet in combustion zone

- Pellets were tarry in drying zone
- Some pellets were turned to small pieces in pyrolysis zone
- Melted plastics, as binders, had attached the pellets and pieces together in pyrolysis zone
- Combustion zone was attached to pyrolysis zone as a big piece of burned feedstock (see fig 4)
- It seems that the ignition port was blocked and the diesel could not reach the feedstock during the ignition process

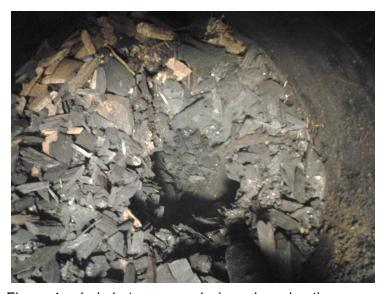
Figure 4. a hole between pyrolysis and combustion zones

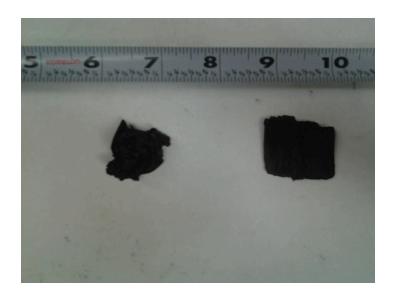
Figure 5. left: pellet char, right: woodchips char

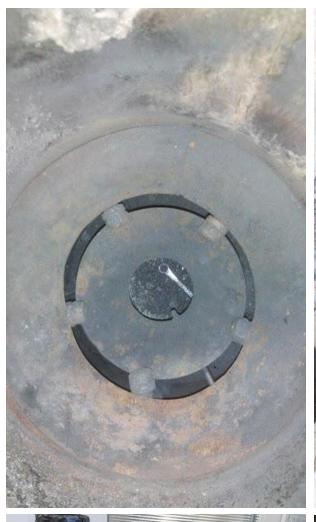
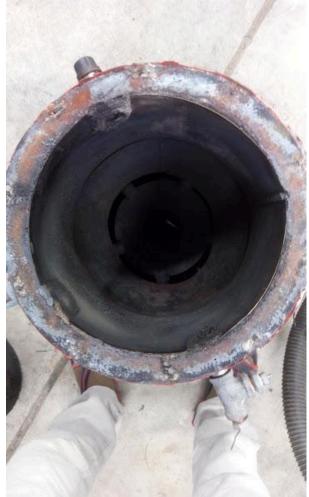
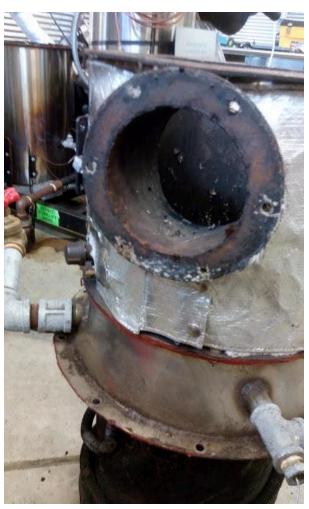
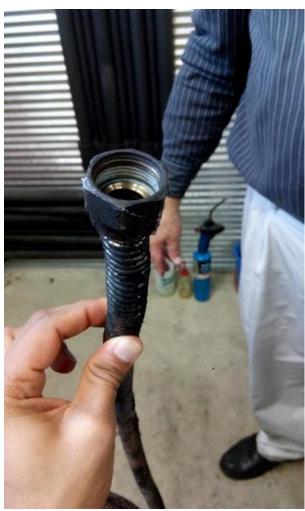
At the end of the spring semester 2016, the issue with the proper combustion in the gasifier was identified. After disassembling the gasifier unit, it was proved that the part of the problem was associated with the stainless spiral tubing outside of the combustion chamber which was partially burned out. The spiral tubing is used to collect the syngas from the gasifier unit and transmit it to the collector. After brainstorming, it turned out that there may be two possibilities as the reason for the problem: 1) The extremely high temperature of the gasifier unit especially outside the combustion chamber would have caused the spiral tubing to be burned out. 2) Operating span of the gasifier unit is already about five years. Due to wear and tear, spiral tubing might have been damaged.

The below figures are showing the combustion chamber of the gasifier before the cleaning. The inner body was full of ash and tar which was removed after the removal of the spiral tubing.
