POST-GRADUATION IN SIX SIGMA BLACK BELT

Lean Six Sigma in Mold Making Industry

Data Validated Investigation for Enriching Workplace

(D-VIEW)

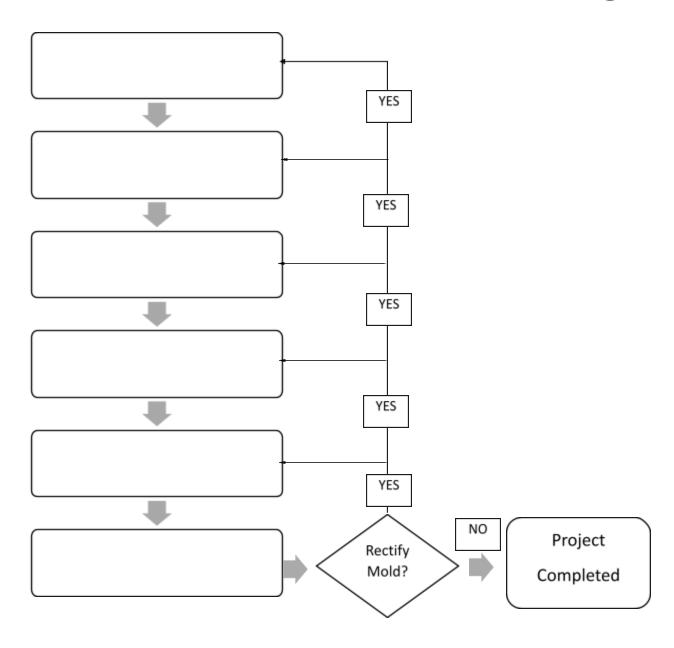
Figure 2: Process flow chart of manufacturing of an injection mold

An injection mold can be explained as a set of functional elements that assist in production of injection molded plastic parts. The standard components of a mold are the clamping plates, extraction system, core and cavity plate (two halves of the mold), spacers and supports. The number of plate and components depends on the type of mold. Every mold is a type of its own and has its own unique manufacturing procedure. The figure below demonstrates a template process flow of production of mold.

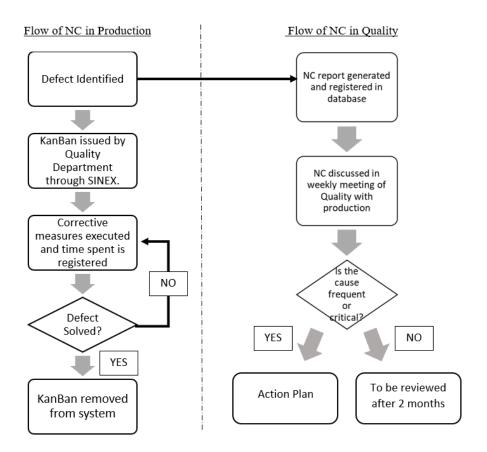
Figure 3: Process Flow of NC

A process flow map (figure3) was established with the Production and Quality Department to organize the flow of information.

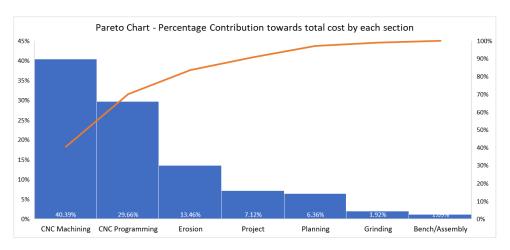
Figure 4: Pareto Chart - % Contribution by each section towards total NC cost

The NCs from January 2018 to August 2018 were considered for analysis. A total of 125 occurrences were recorded costing 28,241.71€. Figures 4 and 5 below shows cost and occurrences of NCs as a percentage of contribution by each section.

As we can see, CNC Machining and Programming have the highest cumulative impact on the occurrences and the cost. Due to failures in process in these sections, 19782.46€ was spent on solving 67 cases of defect or defective parts at an average of 295.26€ per NC. This prompted the management to decide that maximum attention is needed towards CNC section to find the causes to the problems and subsequently the solutions.

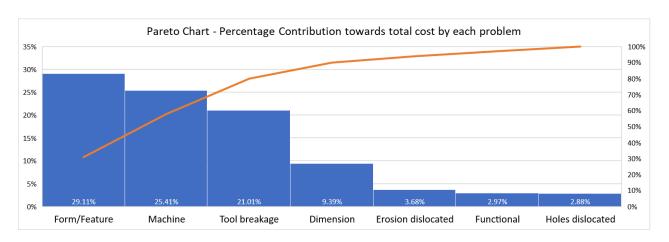
Figure 6: Pareto Chart - % Contribution by each problem towards total NC cost

Figures 6 and 7, represent the cost and occurrences of NCs as a percentage of contribution by each problem.

From figure 6, we can see that the problems related to dimensional failures, form/feature failure, tool breakage and machine were contributing to 84.92% of total cost of NCs. The occurrences of NCs for form/feature failure, dimensional failure and tool breakage are significant according to figure 7. These problems were selected to be worked out.

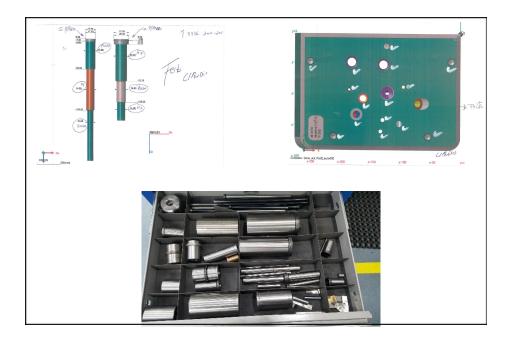
Figure 8: Auto Control Checklist and Calipers

a. Workers were provided training of design viewer software. Along with the part, they were given a checklist of dimensions to be verified and calipers were used for checking.

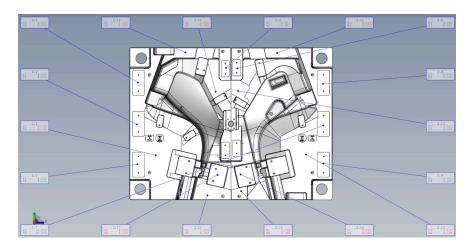
Figure 9: Auto Control Form/Feature

b. The software for measuring form of the part would detail the deviations from the 3D. This helps in identifying the mistake before the part is delivered to assembly. The software was validated through MSA which is explained in section 4 of the report.

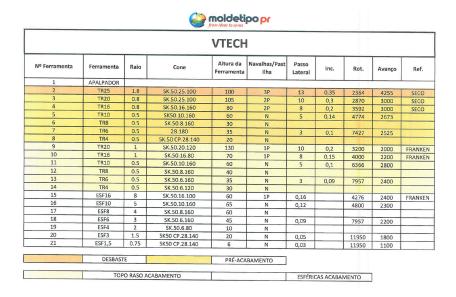
Figure 10: Standardization of Tools in the Machines

c. The tools and the cones were standardized in the carrousel of the CNC machine. The list of tools was prepared for each machine and programs were made according to the tools available in the machine rather than tools available in the production. To reduce the

movement of the operators, the workplace was organized with the required tools and accessories near the machines (5S is discussed in section 3 of the report).

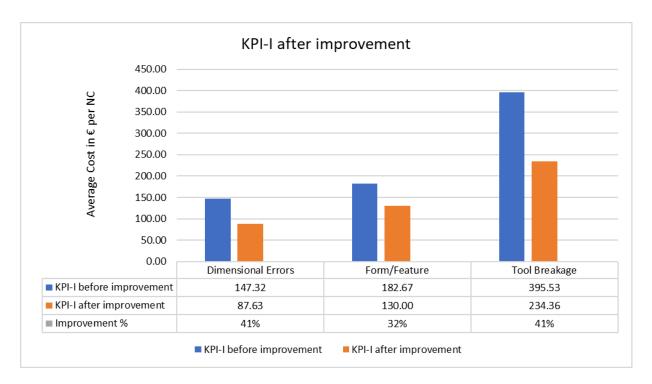
Figure 11: KPI-I before and after improvements.

All the above points, other than TPM were implemented by the end of Oct 2018 and the NCs were measured to look for impact of the improvement till May 2019. Figure 11 demonstrating the improvements in the KPI-I.

With above improvements in place, for every 10 NCs of each problem, there will be a reduced production cost of approximately 2,726€.

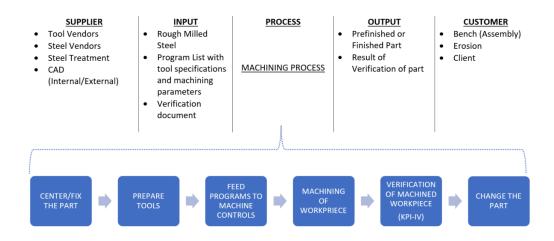
Figure 12: SIPOC of CNC Machining Department

The SIPOC map was created to understand the process in interest. This map was also used for identifying process failures in NCs.

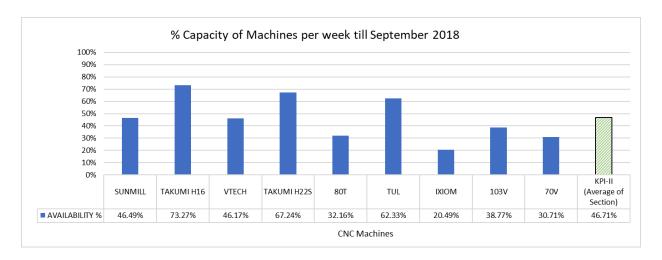
Figure 13: KPI-II before improvements

The KPI of percentage machining capacity of section per week was established. This is the KPI-II of the project. The objective of the project is to have the percentage capacity of section above 60% per week by May 2019. The KPI was measured from August 2018 to the end of September 2018. Figure 13 shows the KPI-II for this duration.

At the end of week 46, it was observed that the section of CNC machining was delivering at 46% of its capacity. To understand the reason for low machining capacity, a study was conducted for 3 weeks in September. Each hour, the state of the machine, when machine was not working, was noted. The study was conducted for 3 weeks to reduce the error of consideration that the machine would stay in the same state for the next hour from the moment the status was noted. The statuses of the machines were classified as shown in table 8 and the analysis of the study is represented in figure 14.

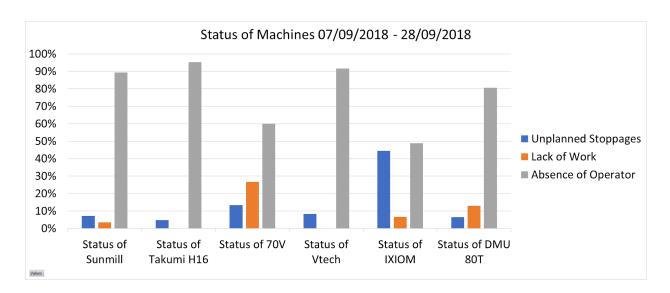
Figure 14: Status of Machines 07/09/2018 to 28/09/2018

The study of state of machines gave us first insights of the machining process. The absence of operator is the biggest contributors to the machine being stopped. A spaghetti analysis was made with operators to understand their movements when the machine was stopped.

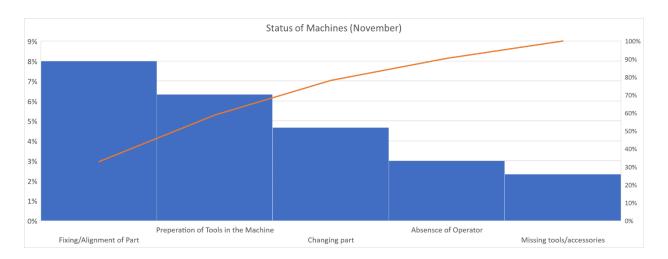
Figure 16: Status of Machines (November)

The graph in figure 16 clearly shows that BNVA tasks are the most time-consuming operations of the process, followed by the machine being stopped due to absence of operator and missing tools and accessories.

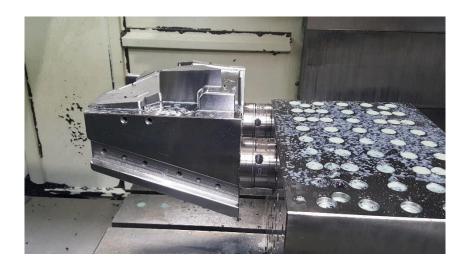
Figure 17: SMED

a. SMED – The implementation was made in Jan-Feb 2019. The SMED system was acquired to reduce setup time and to eliminate mistakes in fixing the parts which would reduce NCs.

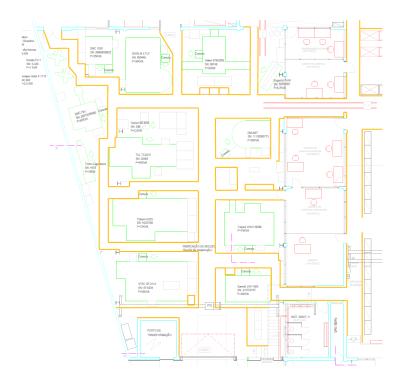
Figure 18: Shop floor after 5S

- b. Standardization of tools in carousel This point is already discussed in section 2.3 of this document.
- c. 5S It was built around the problems identified during analysis of NCs and absence of operators. The primary objective was to reduce miscommunications by creating teams of operator and programmer for the machines (shown in Annexes-II). The shop floor was redesigned, and the machines and tool placements were reorganized.

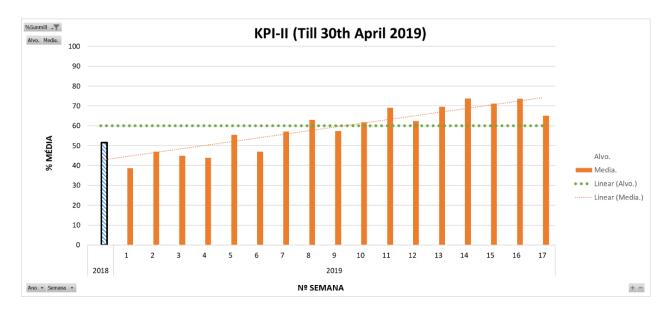
Figure 19: KPI-II until 30th April 2019

All the discussed points were implemented by February 2019. The KPI-II was being followed all through the process and significant changes were observed.

The goal of increasing the average percentage of machining capacity to 60% was achieved by March 2019. As of June 2019, the CNC section is operating at a capacity above 75%. This KPI is reviewed in the production meeting held every Friday the format of which is shown in Annexes II. The responsible of the section justifies the performance of the machines which is noted in the document shown below.

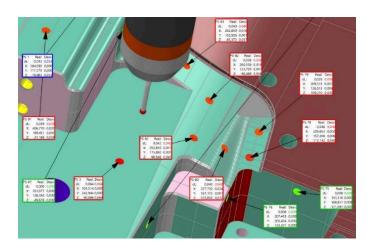
Figure 21: Sample report of measurement software

The software for measuring the deviations of steel was tested in Takumi H22S, a CNC machine, from May 2018 to December 2018 and was finally acquired in the end of January 2019. The software works with probes which measure the machined part and compares to the 3D file. The sample report generated by the software is shown below.

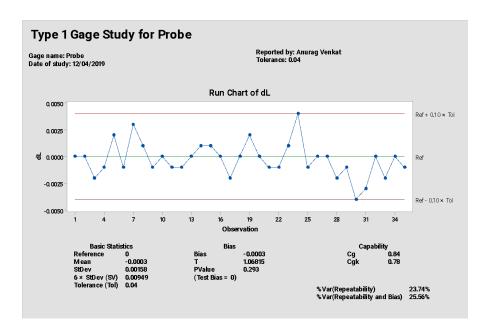
Figure 22: Type 1 Gage Study of Probe

Probe, being a measuring device, was validated with a sphere of 12mm diameter which had 0.000mm as the reference value for deviation. Type 1 Gage Study in Minitab was used for analyzing the bias and repeatability of the system. The graph in figure 22 shows the details of the analysis.

For the study, a sample size of 35 random data points was considered, and all the deviations were measured in the normal direction to the surface (cumulative deviation of X, Y and Z axis). The mean bias in the system is -0.0003mm and the p-value of the test shows that the bias is not statistically significant. Cg and CgK values are not up to the benchmark value (automotive industry -1.33) (Montgomery, 2013), the repeatability of the system in under control statistically.

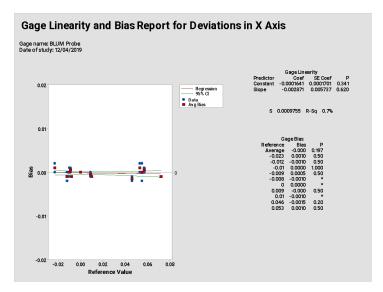
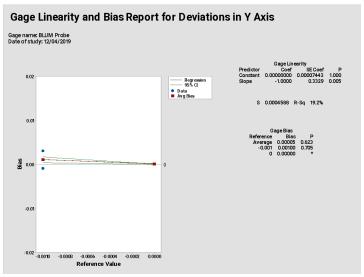
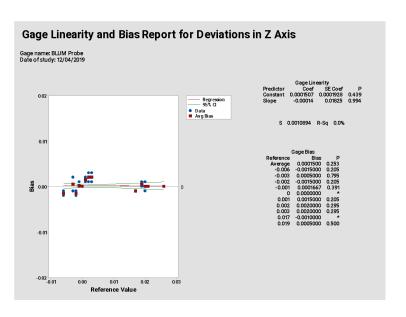
Figure 23: Gage and Linearity Study for Probe

The second MSA was made for the software that is used to measure the part with the probe. Having validated the probe, the results generated by the software would not be inducing the errors of the probe. A part (validated by a certified laboratory) was measured twice in the CNC machine and then Gage Linearity and Bias Study was conducted in Minitab. The data had a sample size of 20 measurements with deviations in X, Y and Z axis.

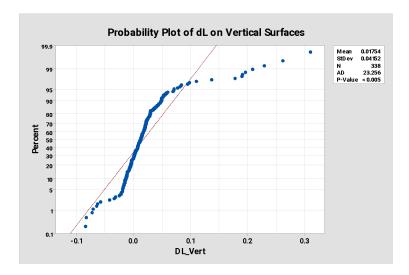
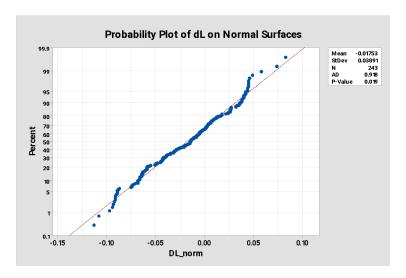
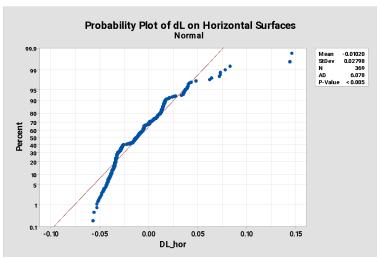
Figure 24: Probability Plot of dL on a) Vertical, b) Normal and c) Horizontal Surfaces

The data were sub-grouped according to the parts from which they were obtained, subgroups having unequal sample size. The normality test (figure 24) shows that dL of each surface does not follow a normal distribution.

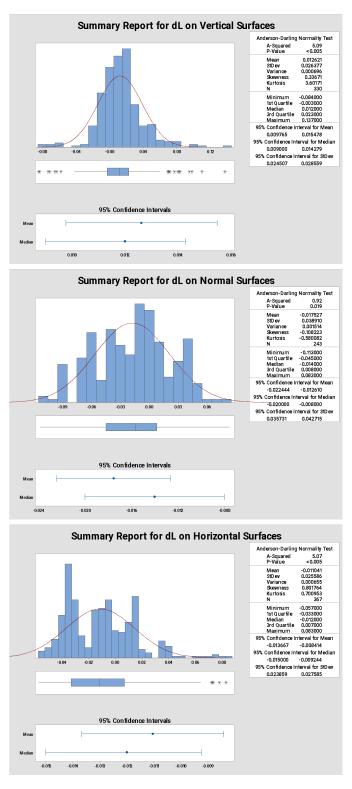
Figure 25: Graphical Summary of dL on a) Vertical, b) Normal and c) Horizontal Surfaces

To visualize the spread of the data, below is shown the graphical summary of the distribution after the outliers were eliminated.

The bimodal behavior in the spread of distributions on normal and horizontal surfaces is caused by the data from different subgroups. This can be understood by the Individual charts of dL shown below.

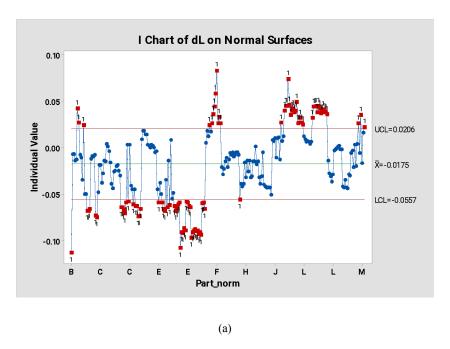
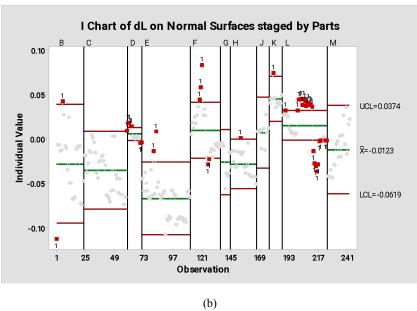
Figure 26:Individual Chart for dL on Normal Surfaces (a) for all subgroups (b)staged by subgroup

The figure 26(a) shows that the process is statistically out of control and the deviations on normal surfaces vary from part to part. Figure 26(b) displays this variation with changing means for each part. Since data from different parts were used for analysis, the deviations were affected

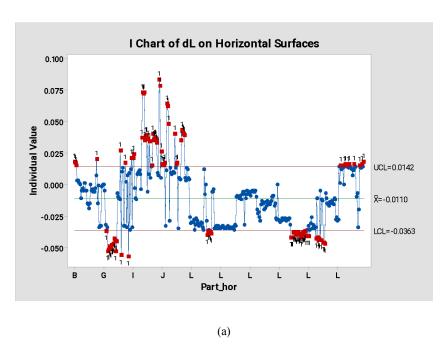
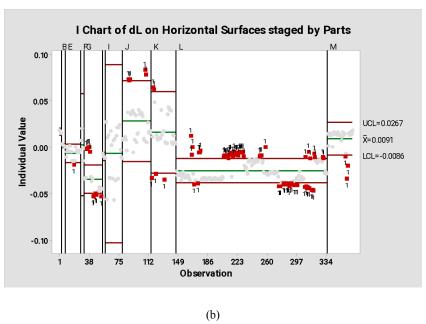
Figure 27: Individual Chart for dL on Horizontal Surfaces (a) for all subgroups (b)staged by subgroup

by variable causes for each situation. The variation between the parts is more significant than the deviation within the part. Even on horizontal surfaces, the variation between the parts is much significant than the deviation with in the part. *Having said that, it is important to note that the subgroup size plays an important role in determining the width of the control limits.* Figure 27 represents the information for deviations on horizontal surfaces.

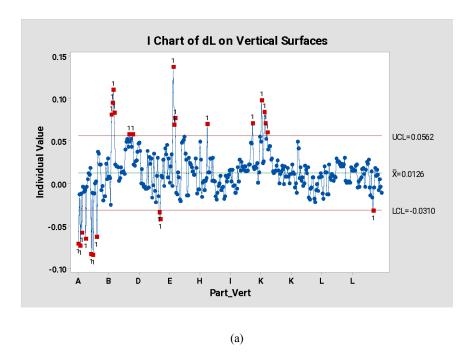
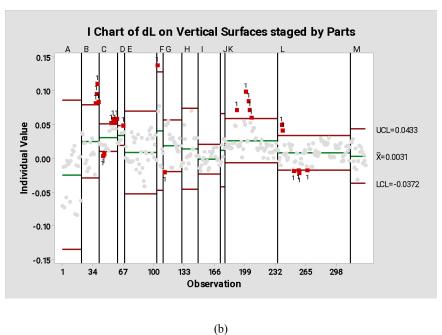
Figure 28: Individual Chart for dL on Vertical Surfaces (a) for all subgroups (b)staged by subgroup

However, unlike the deviations on normal and horizontal surfaces, the figure 28 shows that the deviations on the vertical surfaces are not as signification between the parts. This can be observed from the following Individual Chart.

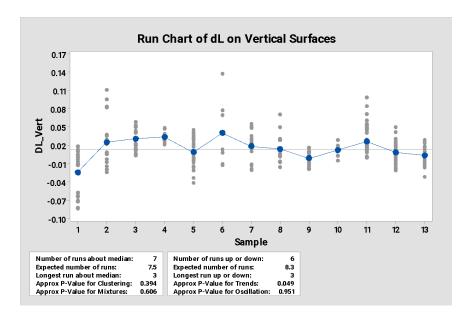
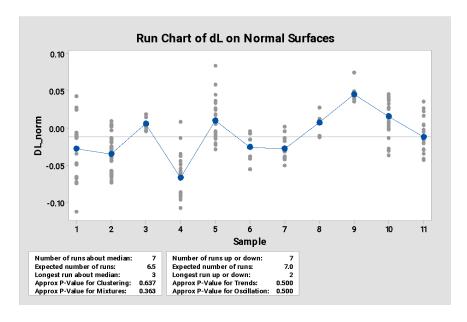
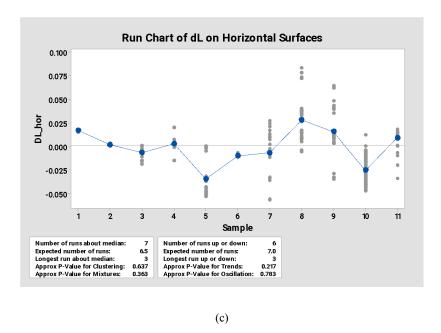
Figure 29: Run Chart of cumulative deviations on (a) Vertical, (b) Normal and (c) Horizontal Surfaces

The Individual Charts do not provide detailed insights of the patterns in the data such as oscillations or trends which can cause variation due to special causes concerned with between parts (part to part) variation. For this purpose, the Run Chart analysis with subgroup mean was conducted for cumulative deviations on vertical, normal and horizontal surfaces. The Run Chart offers understanding of behavior of means of deviations between parts which help us to identify the probable problems.

The data of deviations on vertical, normal or horizontal surfaces do not show significant clustering, mixing or oscillation of data but the deviations on the vertical surfaces do exhibit tends. This deduction can be made by verifying the p-values of each hypothesis test made in the graphs above.

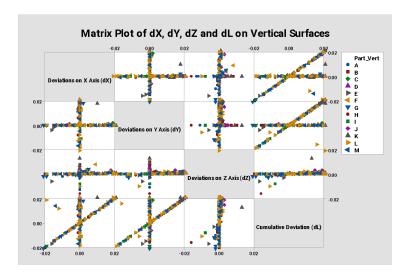
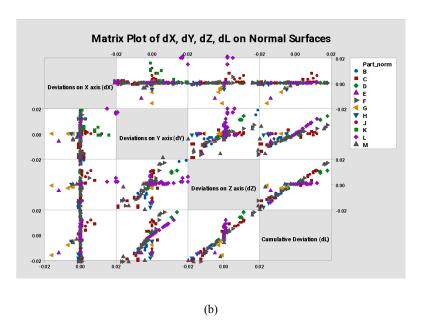
As mentioned earlier, the data used for the analysis is a cumulative deviation of X, Y and Z direction. It is important to study the relation between deviation in X direction (dX), deviation in Y direction (dY), deviation in Z direction (dZ) and cumulative deviation (dL) for vertical, normal and horizontal surfaces which can be best described by the matrix plot of Minitab.

- On the normal surfaces, it can be noted that the deviations on Z axis has a linear positive correlation with the cumulative deviation (dL) and deviations on Z axis influence the deviations on X and Y axis. However, there is no correlation between the deviations of X and the Y axis.
- On the horizontal surfaces, there is no significant deviation on X and Y axis. The deviations on Z axis are linearly and positively corelated to the cumulative deviation (dL).

To summarize the investigation of Matrix Plot, the deviation on Z axis is the key contributor to the deviations on X or Y axis and subsequently to the cumulative deviation. Having said that, the trends observed in the Run Chart of vertical surfaces needs to be scrutinized and the cause of special variation must be identified. One of the possible causes of variation can be tool wear. Currently the height and radius (wear) of tools for machining is measured with a laser system which is sent to the control of CNC. Measurement System Analysis must be made for the laser system to ensure that the tools are being measured correctly.
