Accessibility on wheelchair @ IITK

Report submitted as community service towards CDAP

## **Lift Inaccessibility @ IITK**

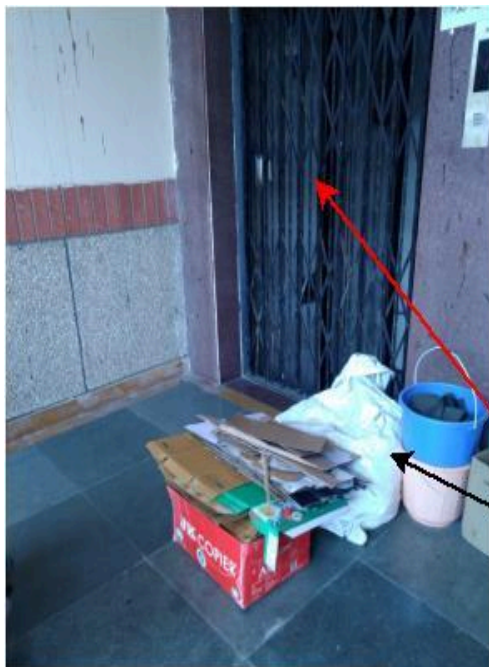
Lift at second floor in DOAA building

Issue:- In the DOAA building currently a manual lift is installed. This kind of lift gets stuck when it's the gate is left open while leaving it and this issue is frequent. Secondly, a lot of cleaning material is blocking the way on the third floor of this building.

1. Manual door lift is installed.
2. Lot of cleaning material is blocking the way to get inside the lift.

Automatic lift should be installed.  
Signboard should be there to avoid blocking.

Solution:- An Automated lift should be installed and the width of the wheelchair must be taken into consideration while construction.

A signboard should be present for avoiding the blockage of Lift by any kind of obstacle as shown in the above picture.

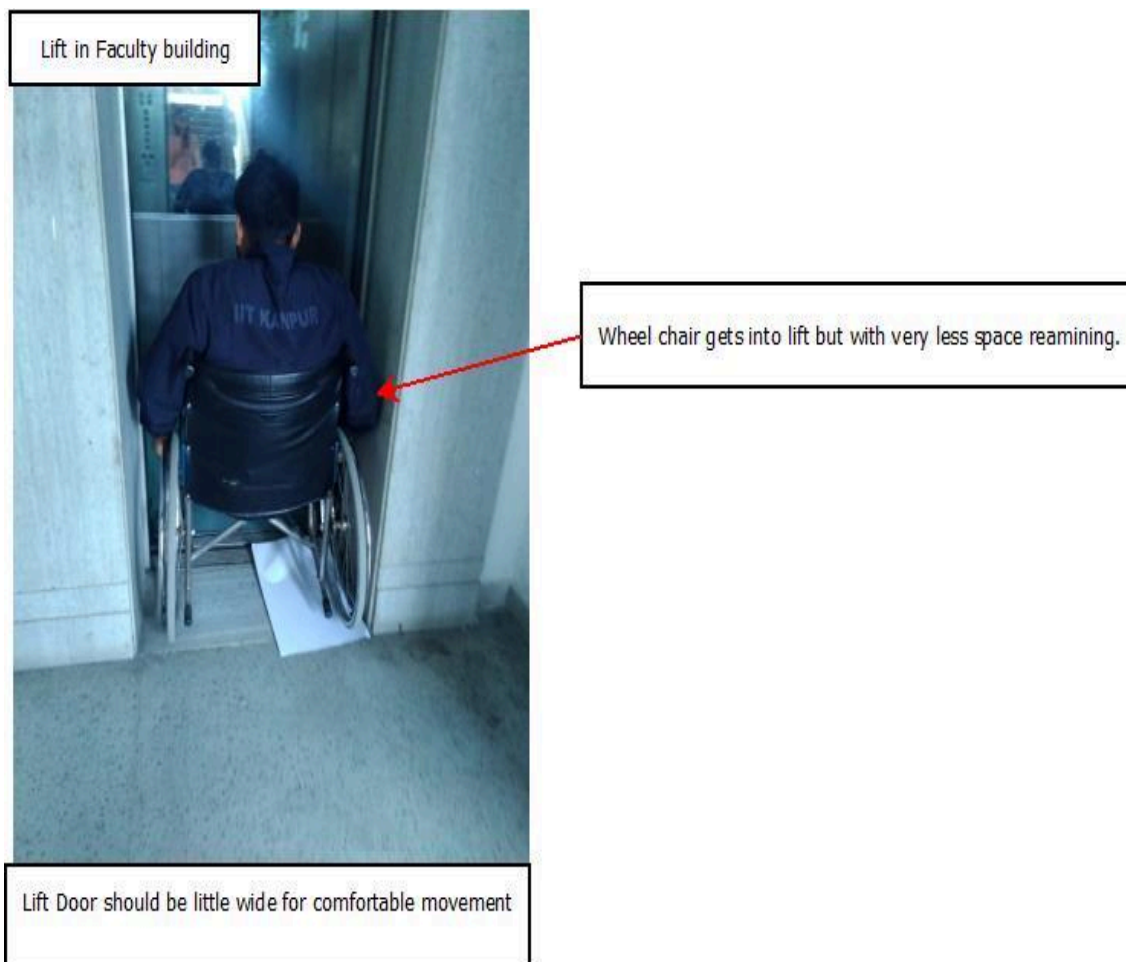
## Faculty Building

Issue:- Wheelchairs get into the lift but very less space is remaining so it's not possible to take electric vehicles inside this lift and in IITK students use electric vehicles.

Solution:- Lift door should be a little wide for an electric wheelchair to get inside comfortably.

Solution:- An alternative solution is that a mechanical wheelchair should be kept at the main entrance at all times so that any person needing it can borrow it and can access

the building and return it at the same place. IITK security guards can take care of this with proper entry in register.

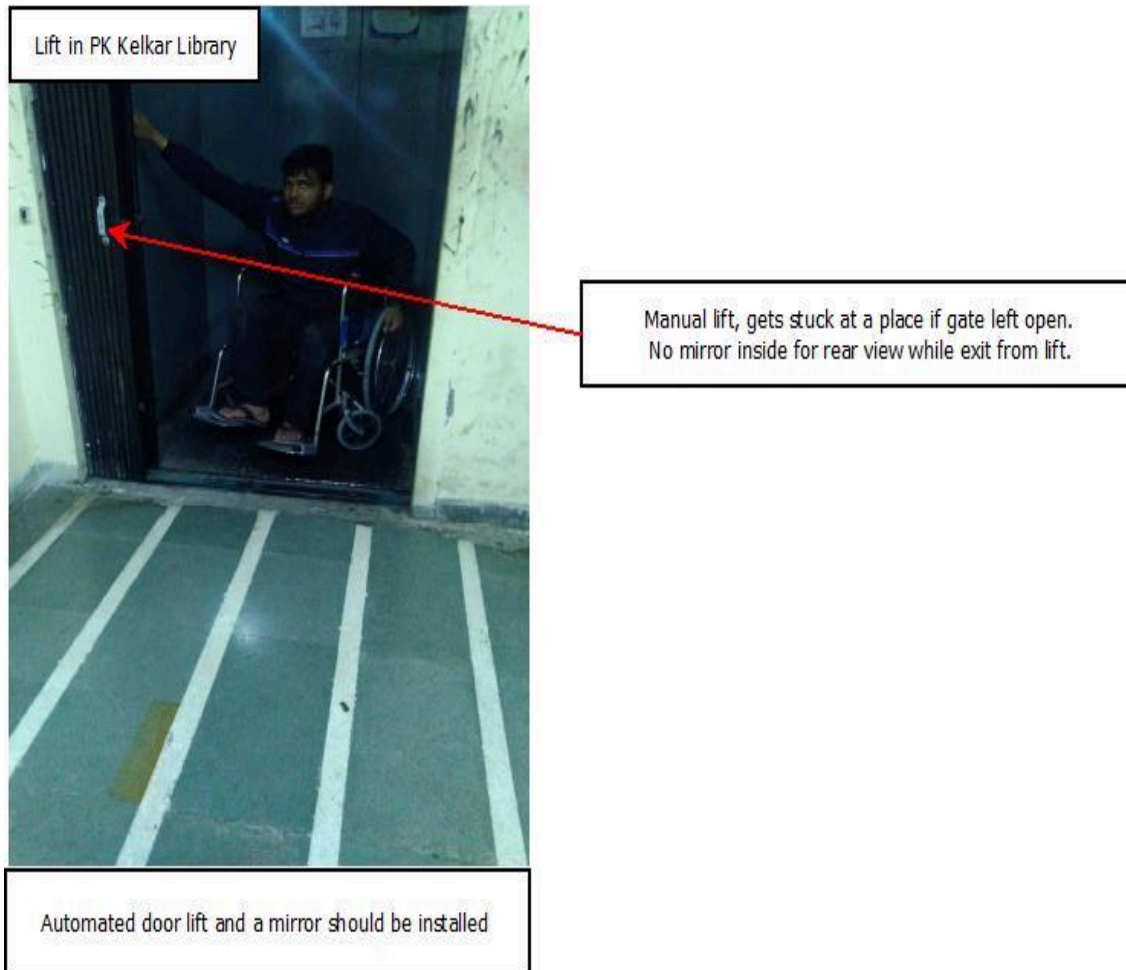
### **P.K. Kelkar Library**

Issue:- Issue:- In the building currently a manual lift is installed. This kind of lift gets stuck when it's the gate is left open while leaving it and this issue is frequent.

Solution:- An Automated lift should be installed and the width of the wheelchair must be taken into consideration while construction.

Alternate solution can be a sign board should be pasted near the lift on every floor requesting to close the doors of the lift. Along with that a mirror should be installed inside the lift so that a person can move backwards without any issues.

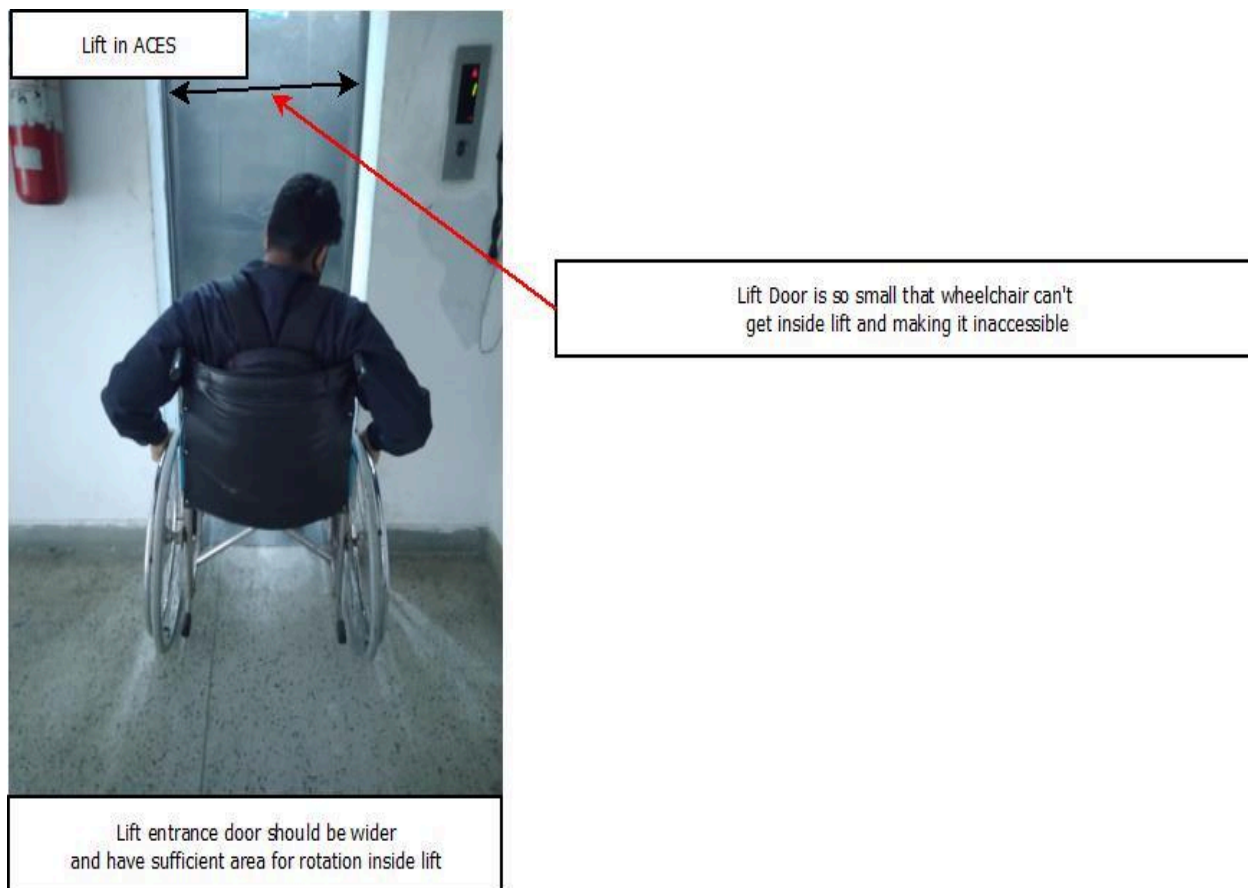
## ACES

Issue:- In the building currently the lift door is so small that a manual wheelchair can't get inside and this is a multi-storage building and requires lift for accessibility. Only the ground floor is accessible for a handicapped person rest floors he/she needs to use the lift without a wheelchair.

Solution:- A new and a wider dimensioned lift is needed in ACES in which an electronic wheelchair can also fit comfortably and one can easily access the building.

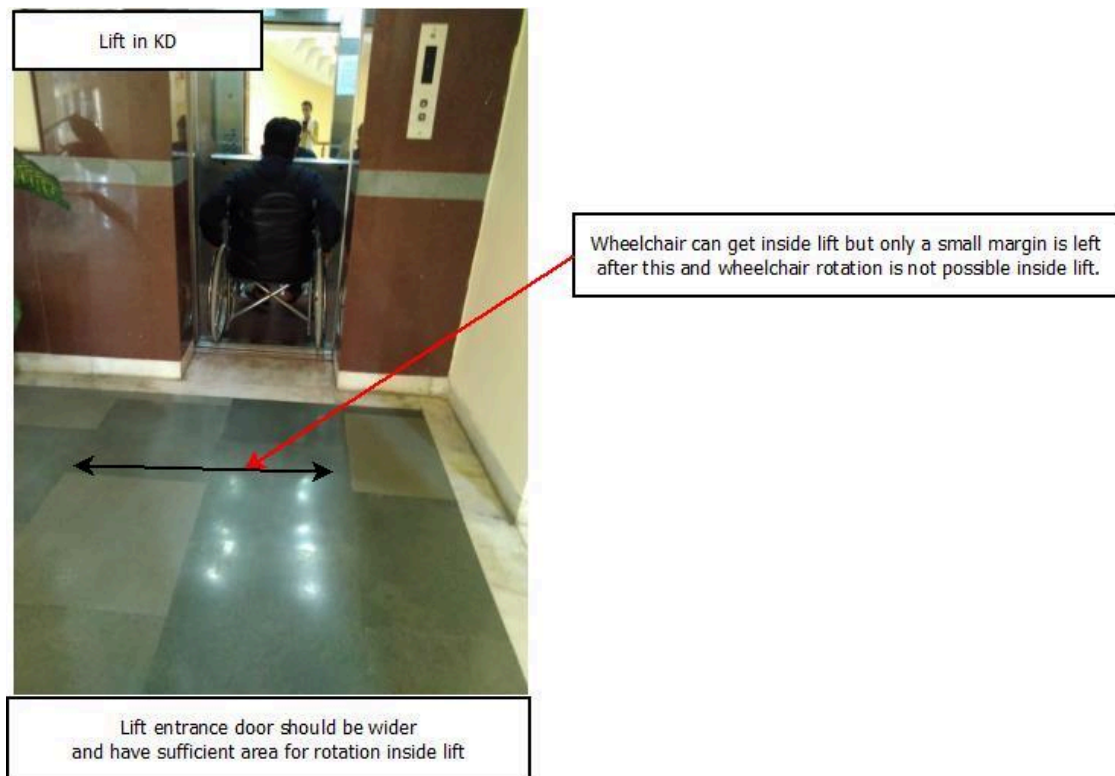
## Kadim Diwan Building

Issue:- Wheelchairs get into the lift but very less space is remaining so it's not possible to take electric vehicles inside this lift and in IITK students use electric vehicles.

Point to note:- In this lift a mirror is installed and with the help of this mirror one can easily access the lift without rotating the wheelchair inside it (if enters the lift on wheelchair)

Solution:- Lift door should be a little wide for an electric wheelchair to get inside comfortably or a mechanical wheelchair should be present at all the times in this

building so that a handicapped person can access this facility by using an alternative wheelchair.

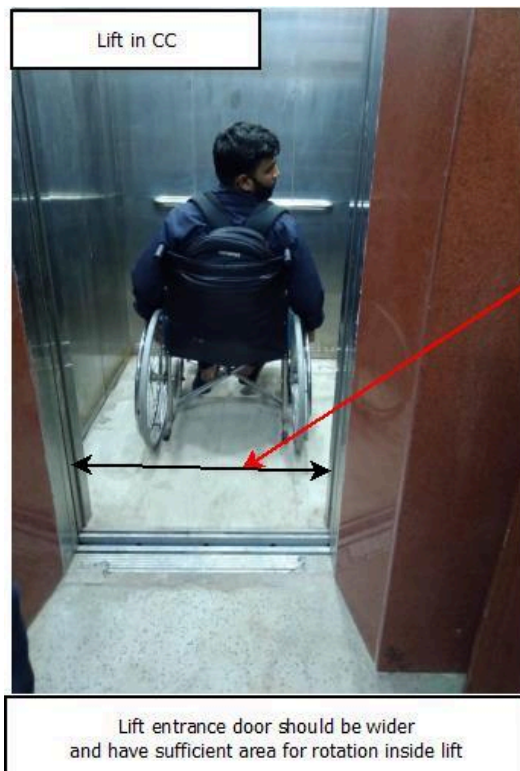
Issue:- Wheelchairs get into the lift but very less space is remaining so it's not possible to take electric vehicles inside this lift and in IITK students use electric vehicles.

Issue:- Lift is inside the computer center and **far from the main entrance** of the building and due to the **unavailability of signboards** it is difficult for anyone to find out where the lift is.

**Solution:-** Lift doors should be a little wide for an electric wheelchair to get inside comfortably or one mirror should be installed in the lift so that the wheelchair need not be rotated for accessing buttons inside the lift.

Sign Boards should be installed in the computer center with proper indication so that anyone can find lift easily.

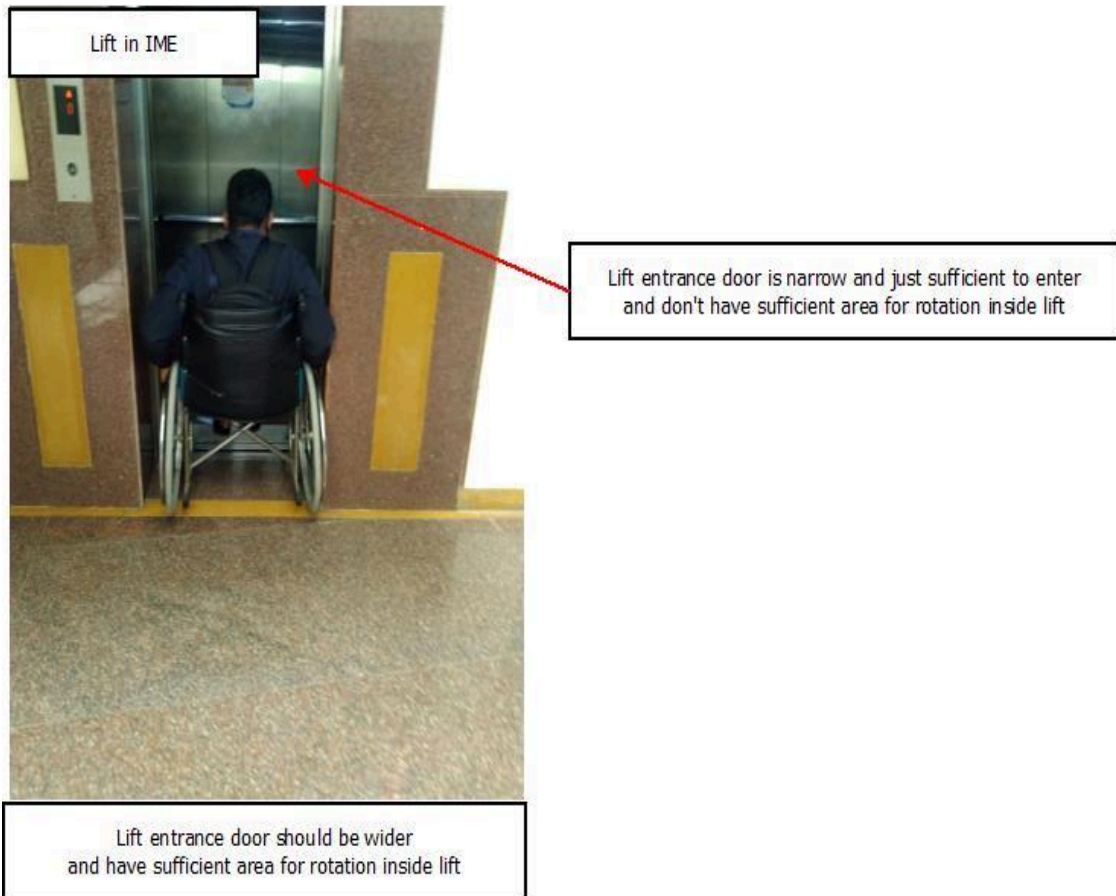
### **IME Building**

Issue:- Wheelchairs got into the lift but it was very difficult to get into lift while sitting on it my hands were touching sidewalls. So it's not possible to take electric vehicles inside this lift and in IITK students use electric vehicles.

Solution:- Lift doors should be a little wide for an electric wheelchair to get inside comfortably or a mechanical wheelchair should be present at all times in this building so that a handicapped person can access this facility by using an alternative wheelchair. Along with this a mirror should be installed inside it for helping people moving backwards.

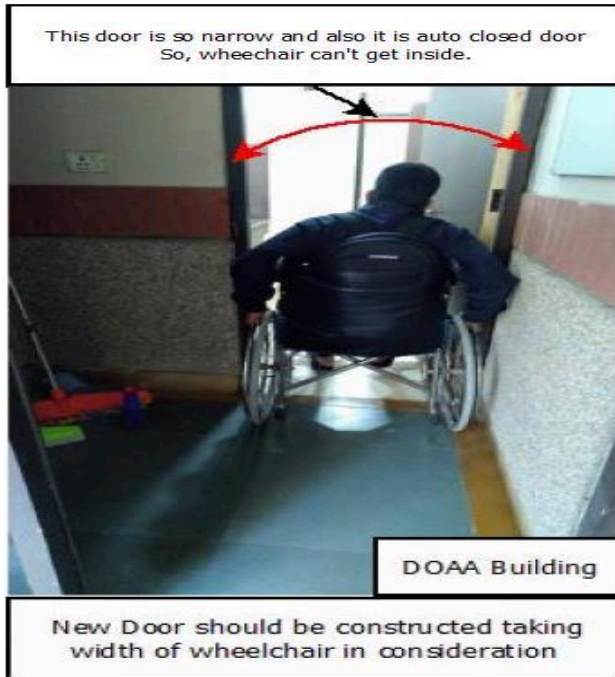
Washrooms in DOAA buildings have narrow doors and these doors get closed automatically. To enter one needs to PUSH so it's not possible to get inside. The new door should be constructed and that should be wide enough for a wheelchair.

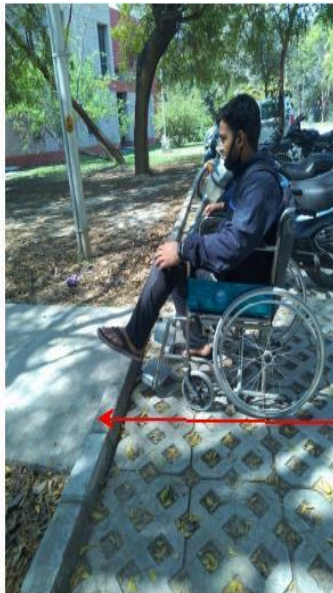
Road connecting DOAA building to road in front of NCL

1. Currently motorvehicles are parked here which is blocking the way and path is blocked by a the step as shown with the arrow. As a result wheelchair user needs to take a alternate path from side

1. NO Parking signboard should be installed.
2. This step should be levelled and a proper path should be constructed to the main building

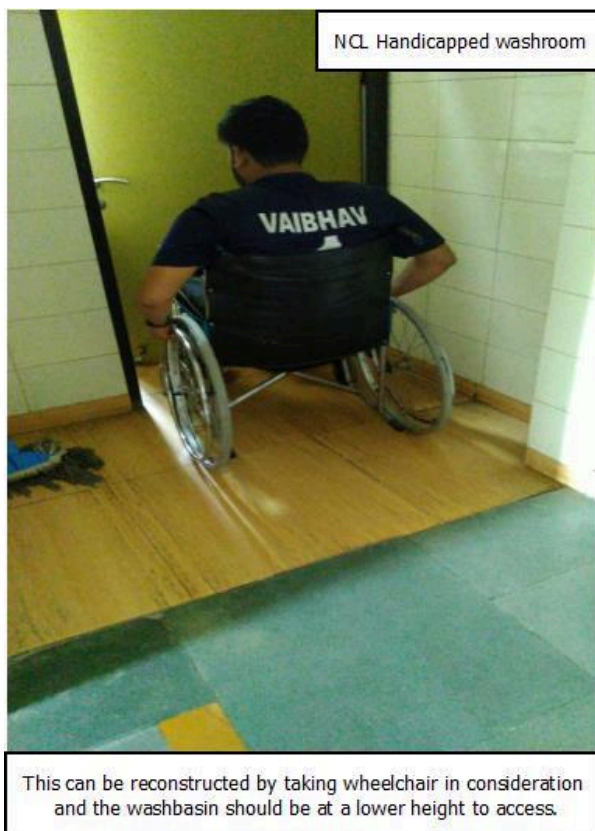
Issue:- This picture is of top floor washroom and as shown in this picture the door is very difficult to access and this is because the door needs to be pushed inside and inside the area is already small and one cannot enter inside comfortably on the wheelchair.

Door is wide enough for wheelchair but issue is that door is having hydraulic press which auto closed. Inside area is very small for a wheelchair and it makes very difficult to access this facility

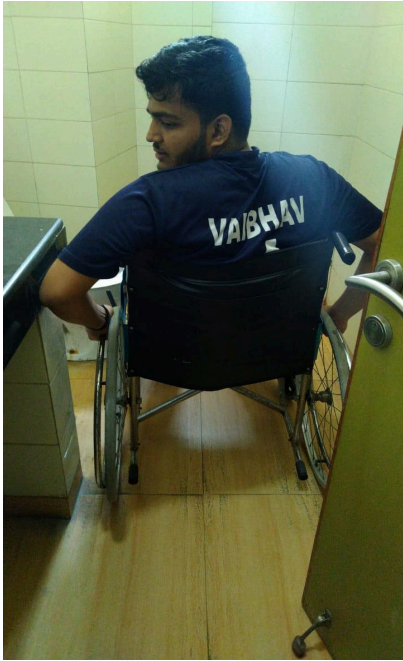
This picture is of the same washroom after taking a wheelchair inside the washroom (by lifting wheelchair) and it can be clearly observed that to come outside the area is not sufficient to rotate the wheelchair.

Solution:- This washroom should be reconstructed as the door is narrow to access and washbasin is inaccessible as one can't rotate the wheelchair inside it.

Alternate solution:- In gents washroom at least 1 western facility should be present which can be used by handicapped persons.

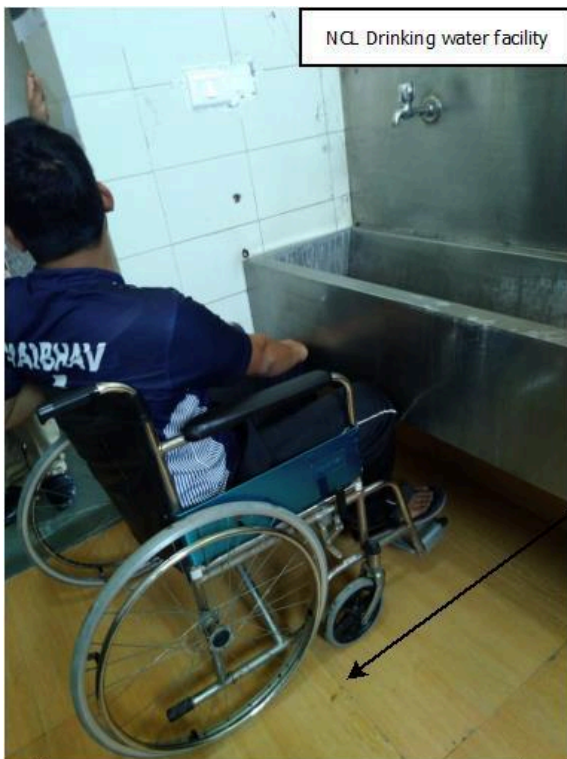
A step is present here so that water cannot spilt outside this area. Wheelchair gets stuck there and also the tap is out of reach of a person.

This steel frame should be replaced by a new one and taps should be at a lower height for proper reach

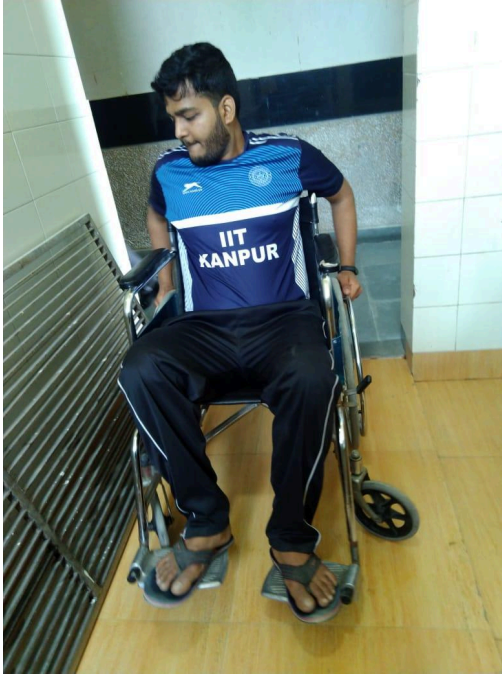
Here there are two major issues out of which one is common with most of the drinking water facilities at IITK which is the height and the reach of the water tap.

In this particular case, the tap is in the reach of hands but to drink water one needs to have either glass or a bottle with him.

The second issue is that a step is constructed for height difference to stop water from spilling in the outside area. This step is covered by a railing which is shown in this picture but this railing is removed for cleaning purposes and according to staff it should be at its place after cleaning.

But when we reached their this was not in place and as a result of this, I was not able to access this facility as the wheel got stuck in that step.

Solution:- A glass should be present at all times near this facility so that a person can fill water and access this facility. Otherwise, a new sink should be constructed in which the base level should be above knee height and taps should be at a lower height.

Secondly, clear instructions should be given to the cleaning staff of NCL that after cleaning the area this railing should be kept at its place so that no one faces difficulty in accessing this facility.

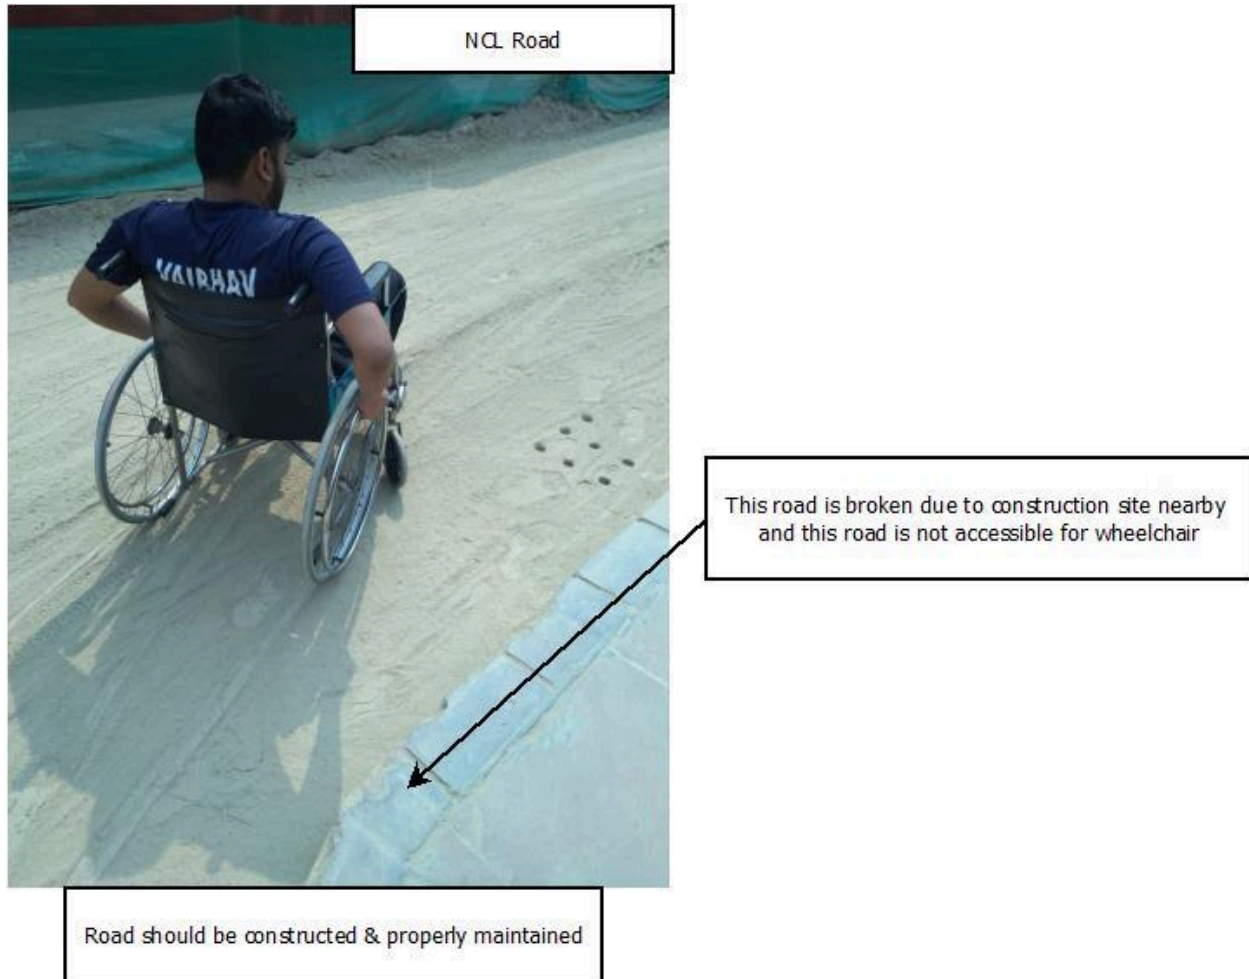
## Road in front of the building

This is the road in front of NCL and this road is used by everyone who enters the NCL building.

Currently, this road is in vulnerable condition due to the poor maintenance and the construction site nearby.

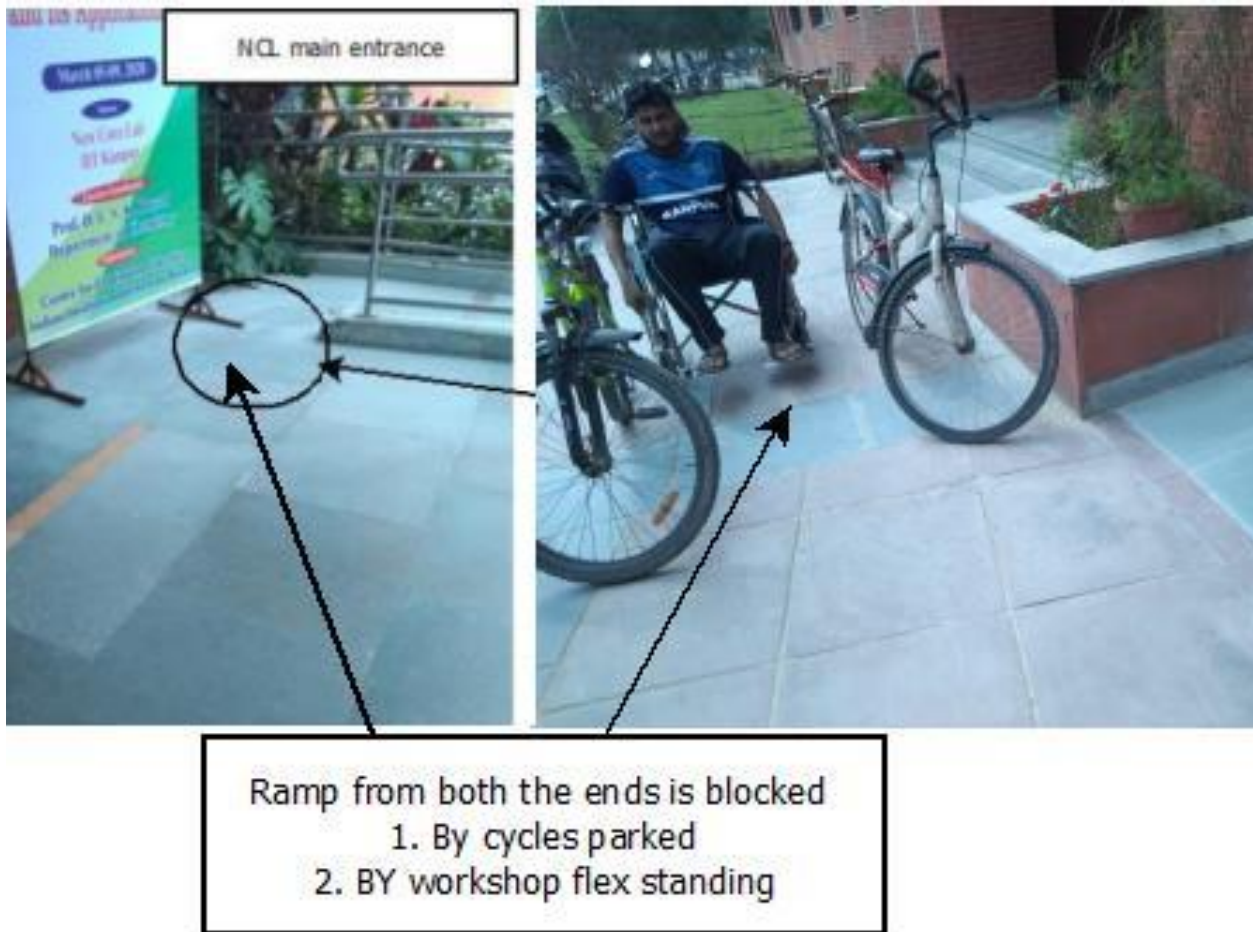
## Main Entrance of NCL

This is the main entrance of New core laboratory and a ramp is constructed here which is working condition and can be accessed but it is blocked from both the ends. From one end it was blocked by a banner for some workshop and on the other hand it was blocked by cycles parked by students. These cycles are parked every day in front of the ramp and no one is there to stop them and no instructions are given not to do so.

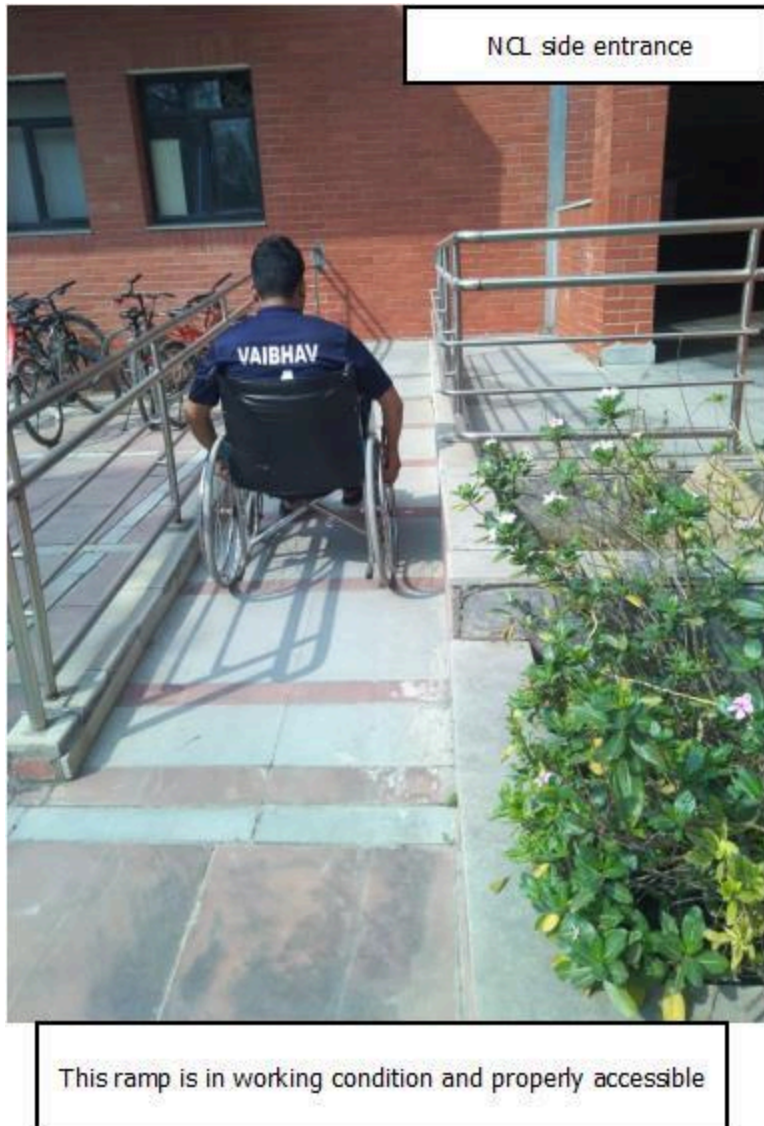
## Side Entrance of NCL

This is the side entrance of New core labs and this ramp is properly maintained and can be accessed by handicapped persons comfortably.

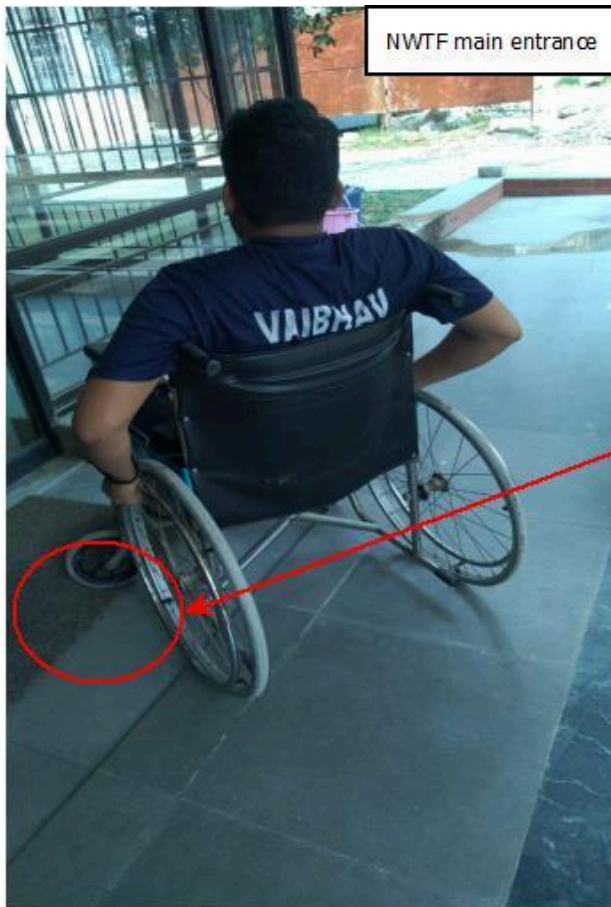
This main entrance have a mat of smaller size and it leaves a gap and a step in which the wheel get stuck

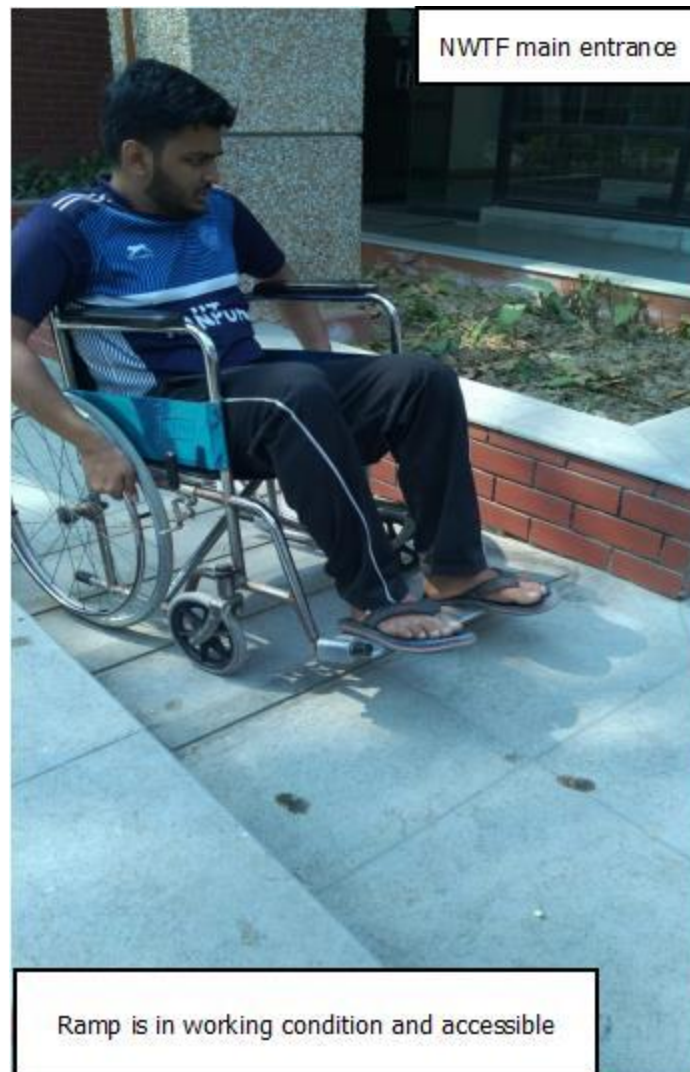
This ramp is at the main gate of NWTF and it is currently accessible for handicapped persons comfortably.

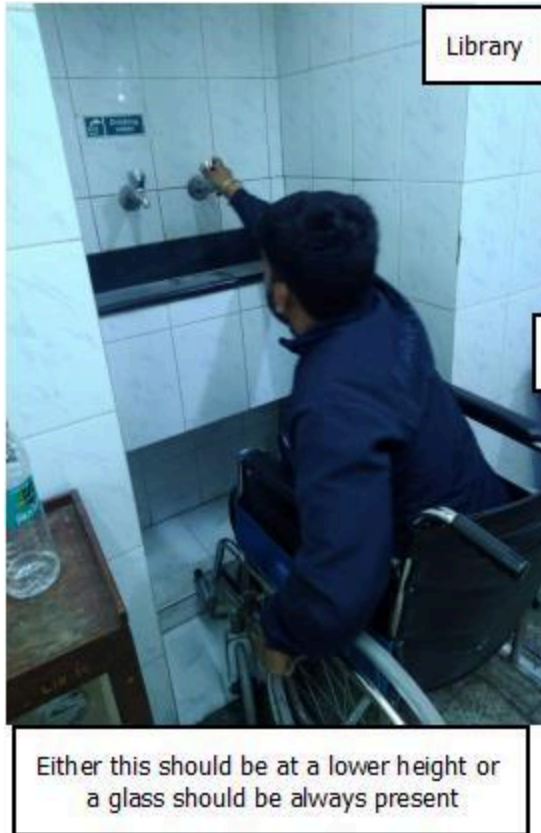
### Drinking water facility

In the drinking water facility, the tap is out of reach for drinking however it is in reach if someone wants to fill a bottle or a glass.

Currently, this is inaccessible as there is no glass present but if one or two glasses are kept here then this drinking water facility will be accessible to handicapped persons also.

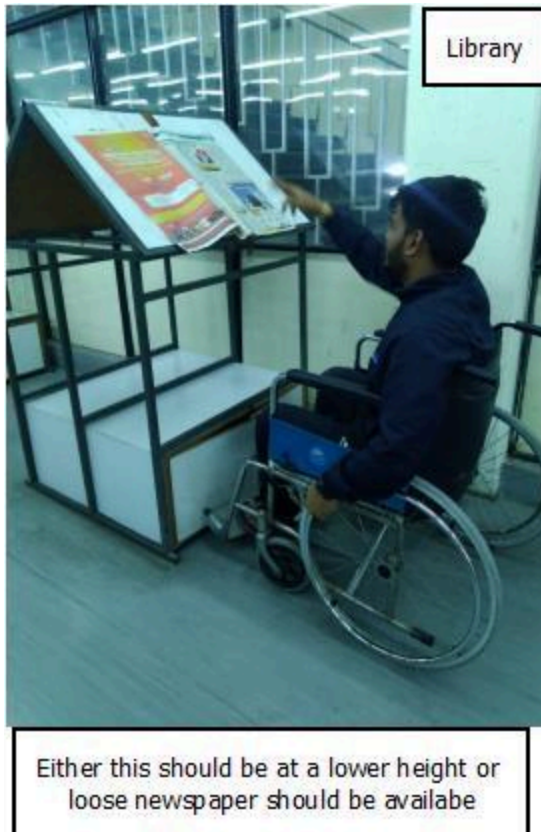
## Newspaper stand

More than half of the newspaper is not readable

This newspaper stand is within the reach of a person physically but when someone wants to read it then eyes are out of reach for most of the newspaper and this facility is inaccessible for a handicapped person.

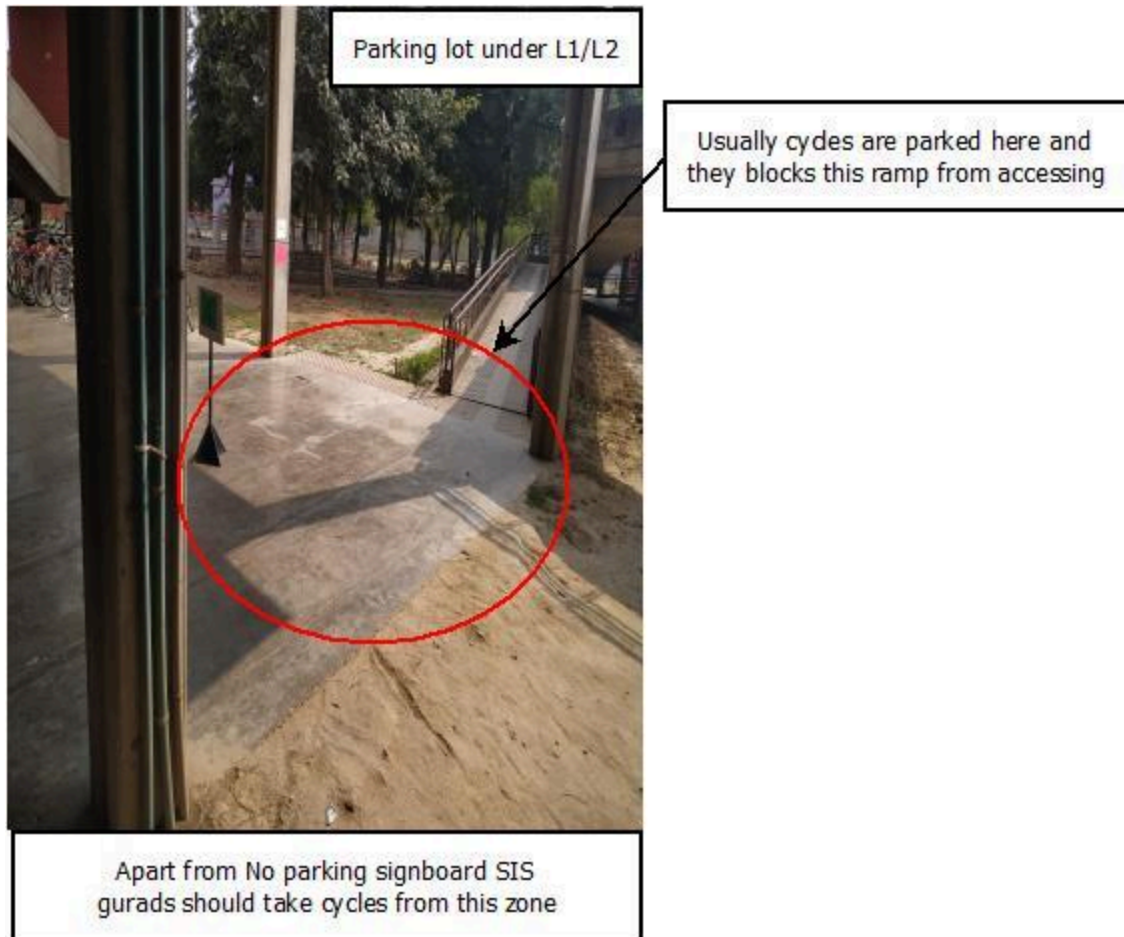
## Tutorial Block

This particular ramp is used for reaching out to maximum lecture hall complexes and this ramp is well maintained and is in usable condition right now.

The issue with this ramp is that during normal weekdays a lot of cycles are parked in front of this ramp as well even after putting a signboard for it no major change was observed. These cycles block the way for wheelchairs and for the electric vehicles they don't get much-starting speed to reach on the top of the ramp.

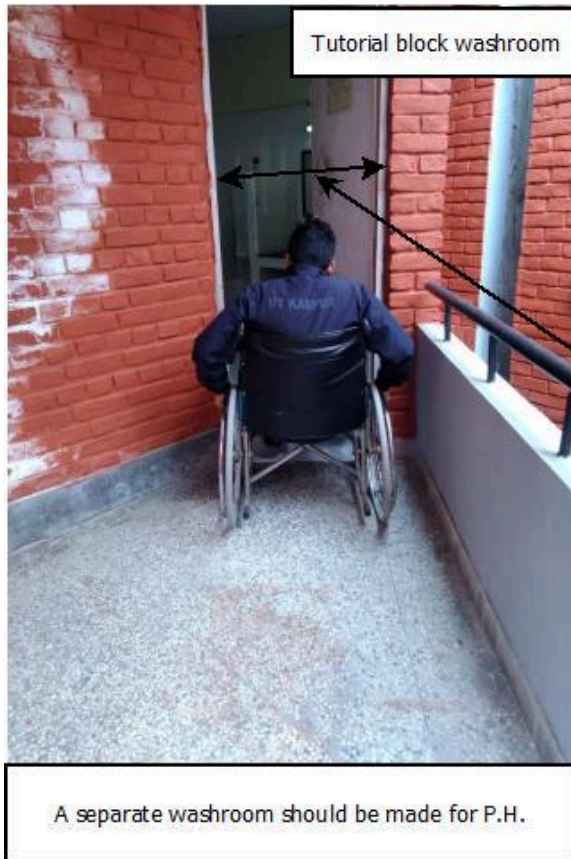
Tutorial blocks have 2 washrooms one on each floor(same situations on both the floors) but none of these washrooms have a separate facility for physically handicapped persons and even in male washrooms no western facility is available.

The second issue is that the doors of these washrooms are so small that this chair shown in the picture cannot get inside it thus even if we have a washroom inside a male facility then also it is not suitable for a handicapped person.

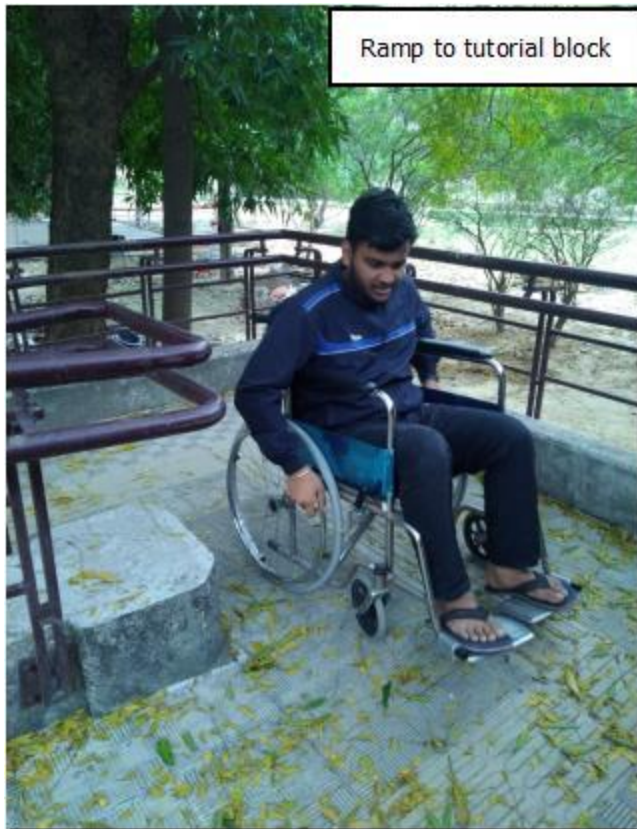
Ramp to tutorial block

This ramp is in good condition and accessible

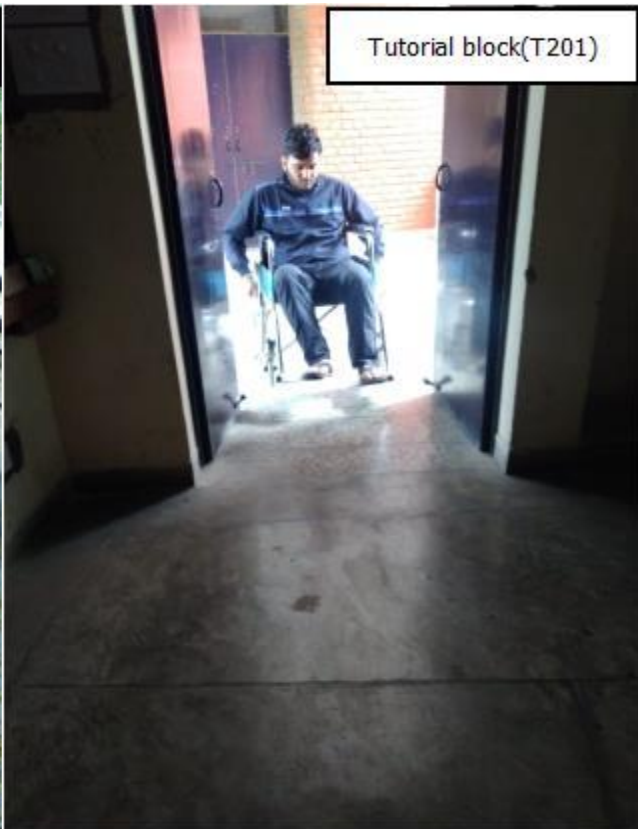
Tutorial block(T201)

Rooms are accessible and doors are wide enough

The second picture is taken while entering the tutorial block T201 and its entrance is sufficiently wide for the wheelchair to enter inside and also the chairs are not fixed so a person can adjust his/her wheelchair inside and can sit on it comfortably.

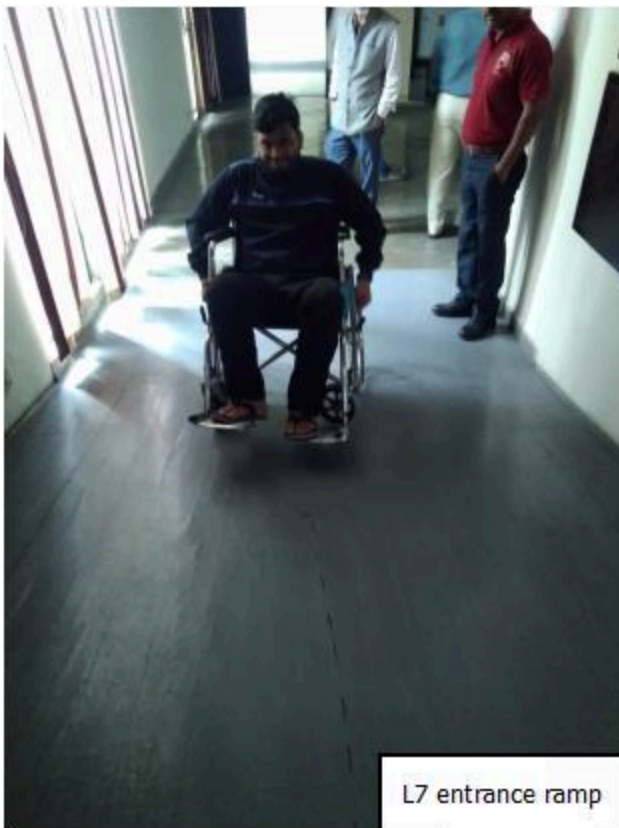
Very high steep and no hand railing which makes it riskier and inaccessible

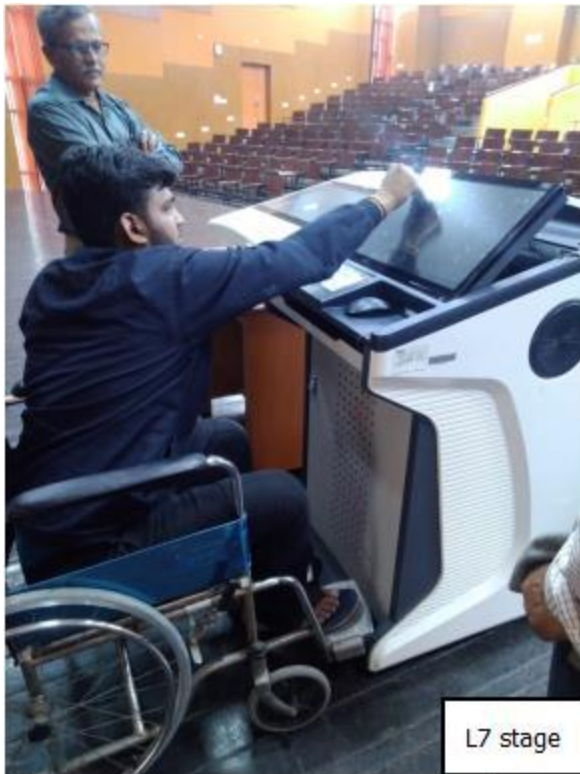
L7 stage

This device is easily accessible for people sitting in a wheelchair and it was tested during the survey.

Device is in reach and can be accessed

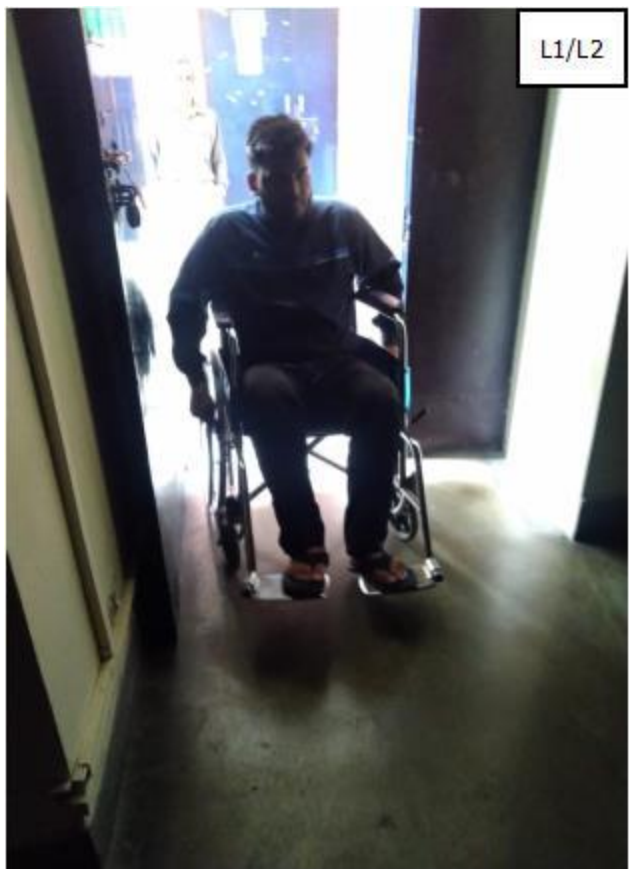
L1/L2

Inside these LHCs loose chairs are present that can be used according to the requirement by the handicapped person. Also the area in front of board is quite large for moving wheelchair around it due to which it makes quite comfortable for handicapped person to access these LHCs

L1-L6 are perfect for entering & sitting on wheelchair

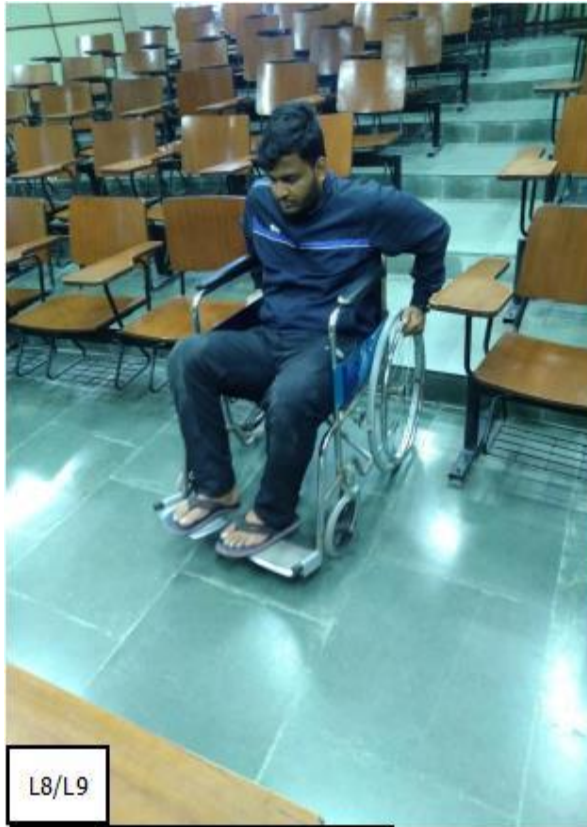
L8/L9

Accessible LHC for handicapped

Now L8-L9 are similar lecture halls and these two pictures above show that these LHCs are easily accessible and in picture 1 it can be observed that the area in front of the stage is quite wide for easy movement of the wheelchair.

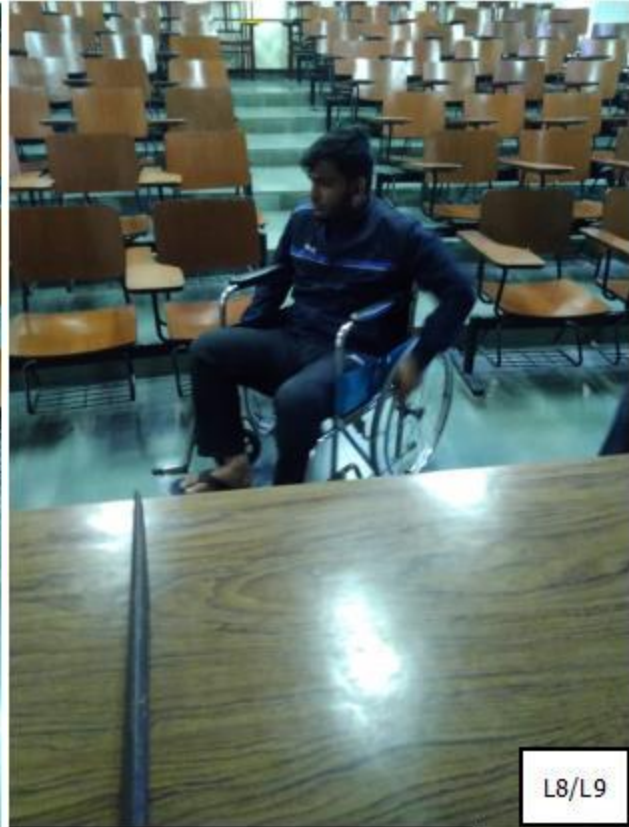
L8/L9

Enough space in front for wheelchair

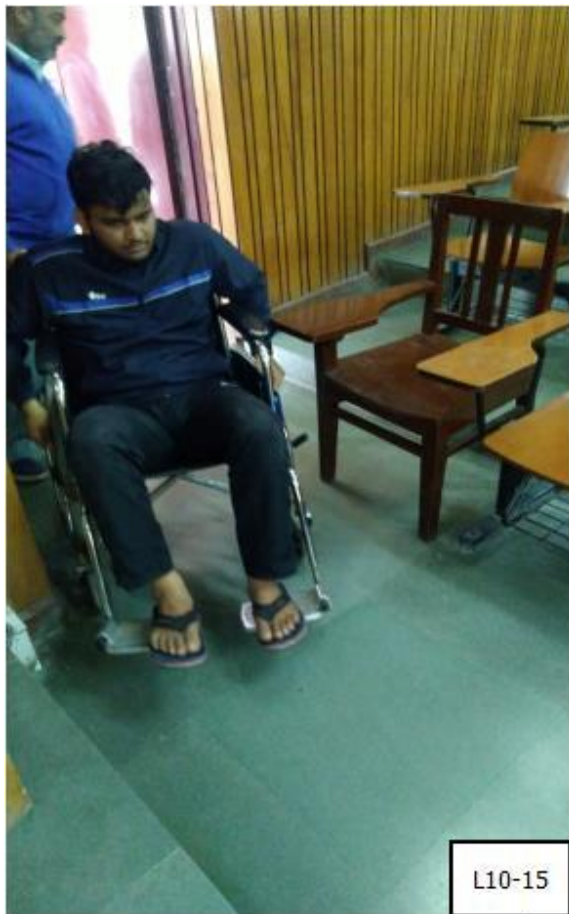
Loose chairs are used for sitting if needed

Now L10-L15 are similar lecture halls and these two pictures above show that these LHCs are easily accessible and in picture 1 it can be observed that the area in front of the stage is quite wide for easy movement of the wheelchair. In picture 2 it can be observed that one can easily enter these LHCs from the front gate.
