Accessibility on wheelchair @ IITK

Report submitted as community service towards CDAP

## **Lift Inaccessibility @ IITK**

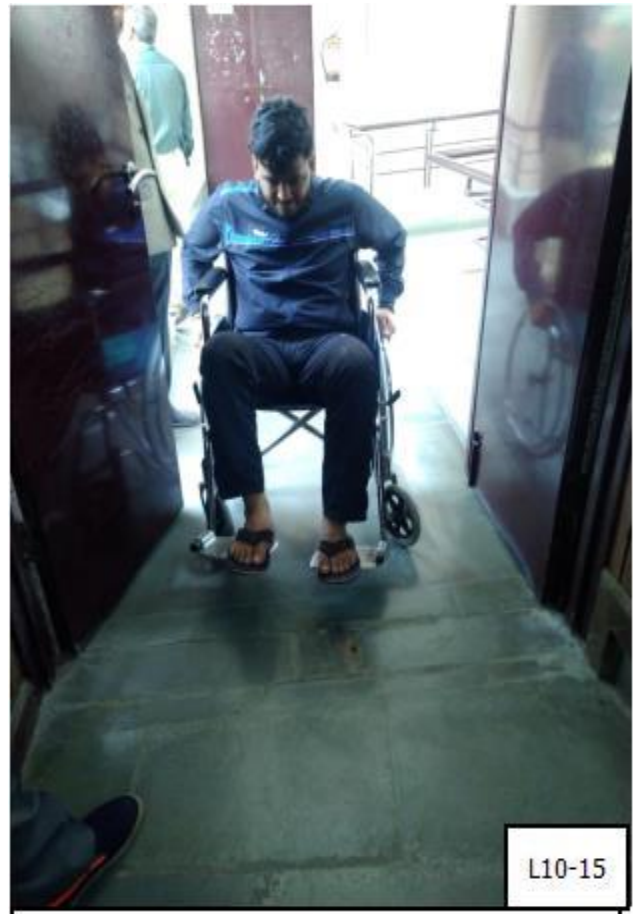
Enough space at door and in front for wheelchair

Now L10-L15 are similar lecture halls and these two pictures above show that these LHCs are easily accessible and in picture 1 it can be observed that the area in front of the stage is quite wide for easy movement of the wheelchair. In picture 2 it can be observed that one can easily enter these LHCs from the front gate.

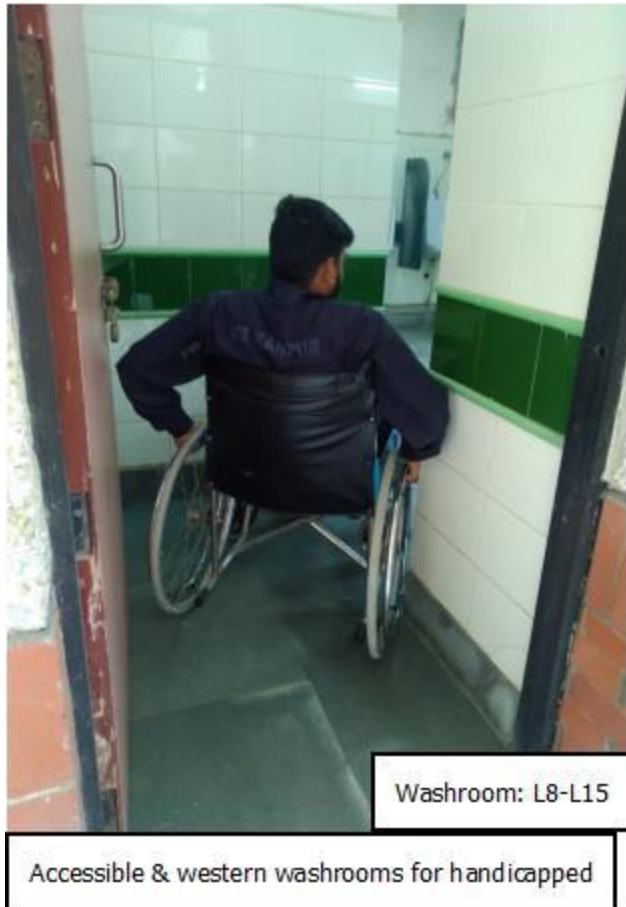
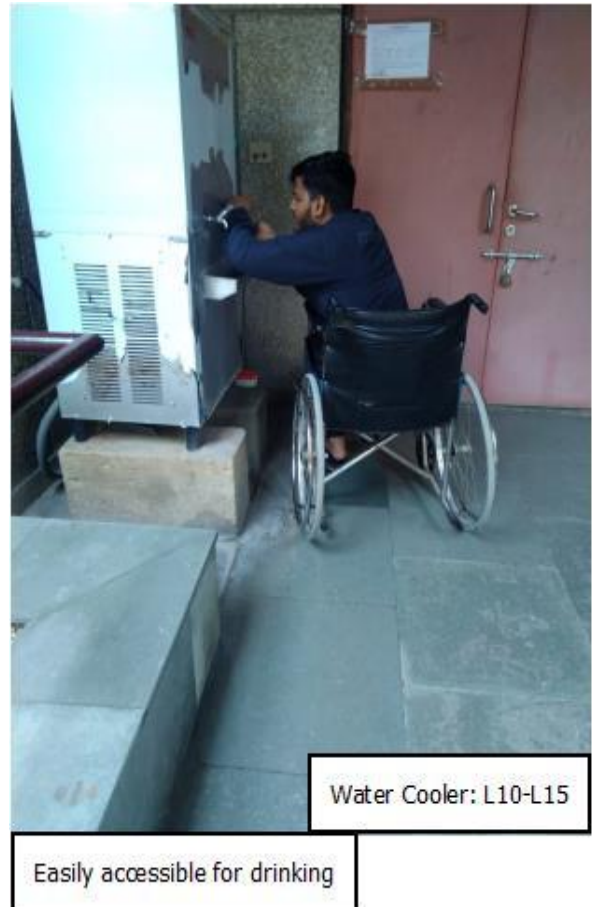
In picture 1 washroom facility for L8-L15 is shown, basically there are two men washrooms, one on ground floor and one on first floor and both of these washrooms are same in terms of structure and we checked the one on ground floor.

In picture 2 it can be observed that both mouth and hands are in reach to the tap on the water cooler and this water cooler located near L11 is easily accessed by handicapped students.

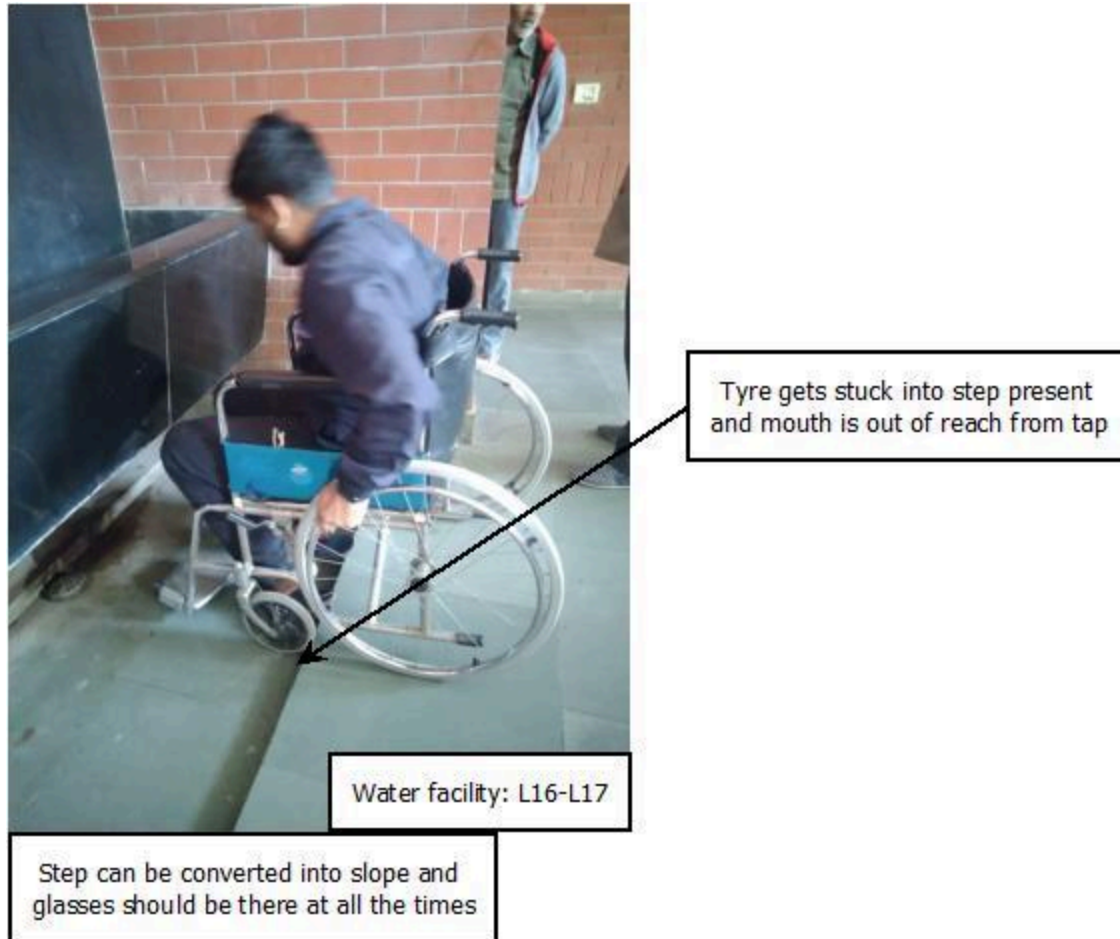
## Drinking Water facility under L16-L17:

As shown in above picture this facility has two major issues with it which are as follows:

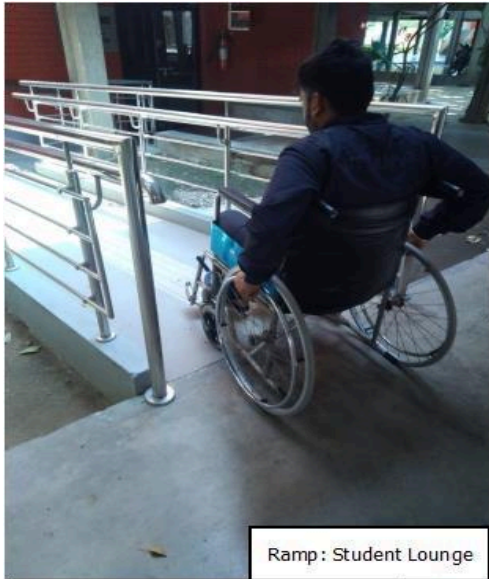
Ramp: Student Lounge

Ramp is made up of tiles which is slippy in rainy season and can be risky

Students' Lounge main gate is connected from a ramp and this ramp is recently constructed and is perfect for use but it was observed by staff of LHC that during the rainy season this ramp gets slippery and it may cause some serious injury to handicapped person. Along with this water removal is not proper on entrance of lounge and this makes the floor slippery during rainy season

This ramp should be covered with some kind of shelter so that rain drops can be avoided as much as possible. Also the drainage facility should be proper so that water doesn't spill on the floor.

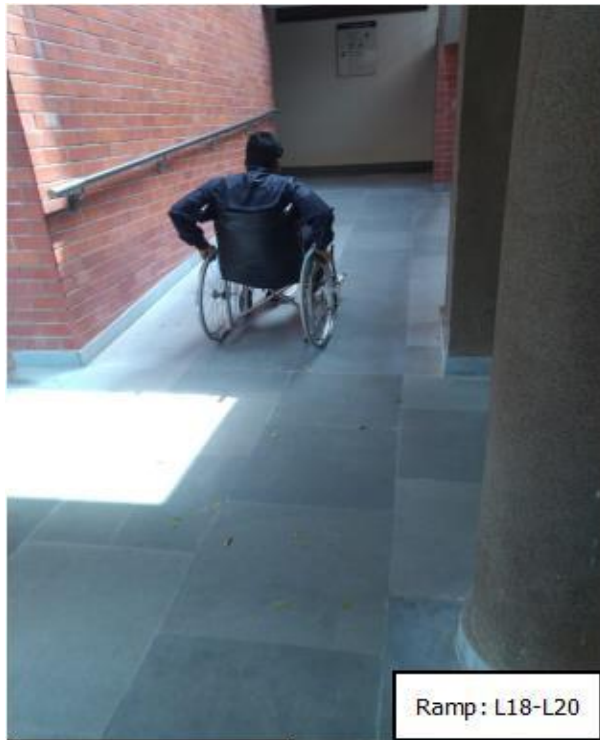
Ramp: L18-L20

Perfect ramp for using

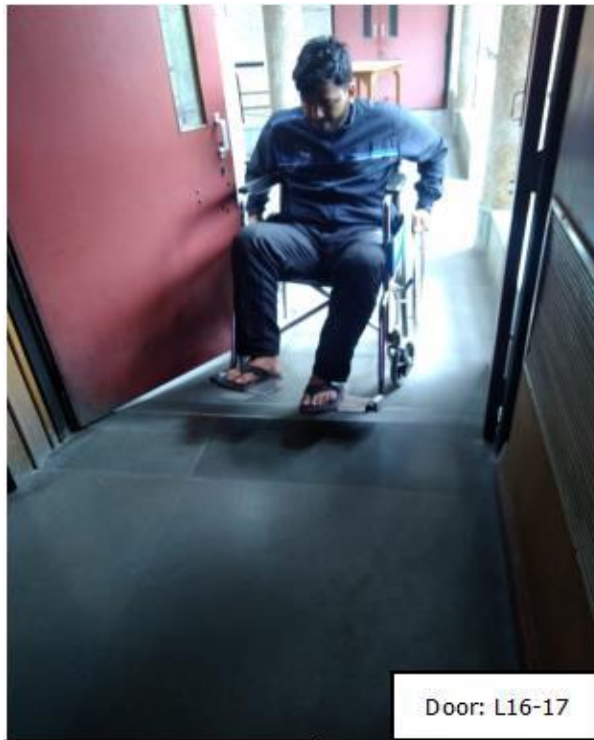
Door: L16-17

Perfect door for entrance

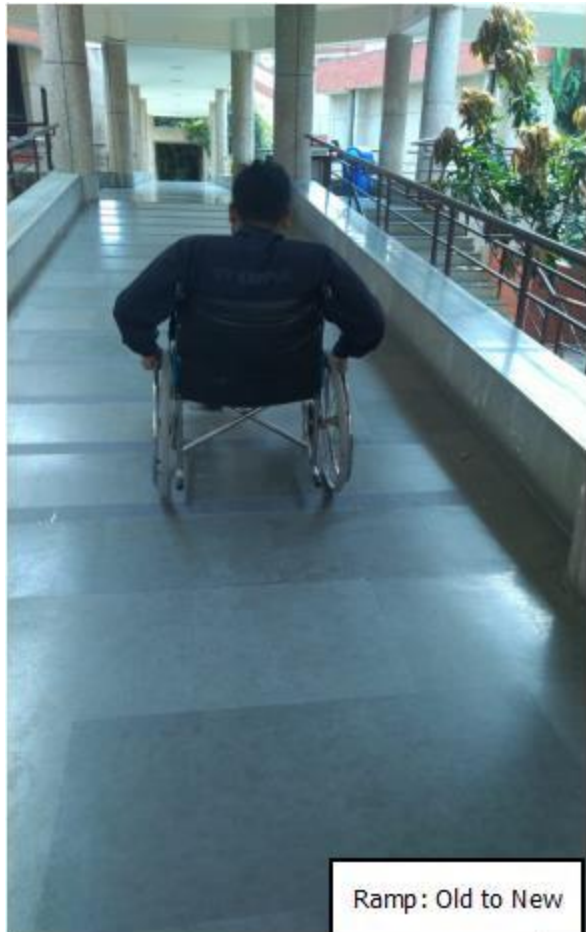
Ramp: Old to New

Ramp is in good condition and accessible

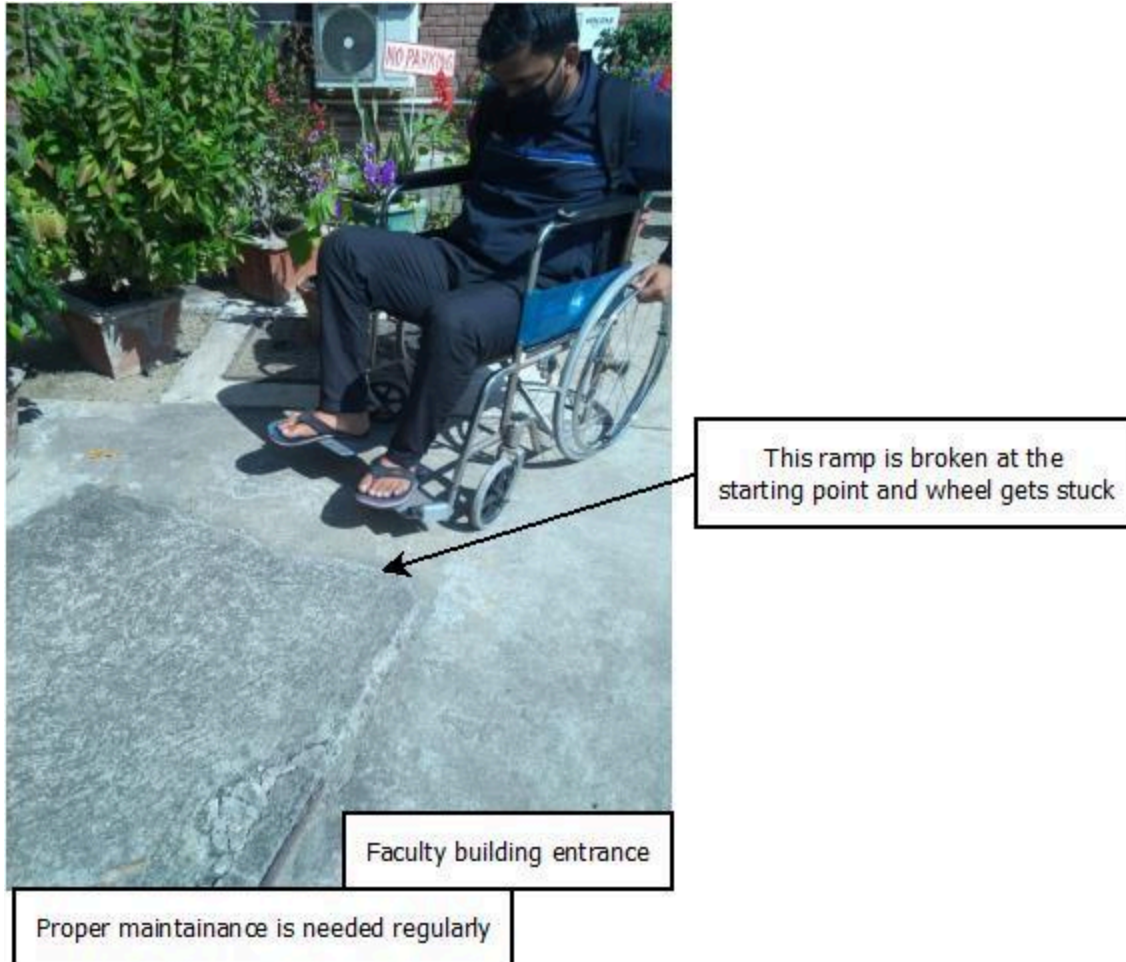
Entrance:

This is the entry or I can say starting point to enter the faculty building from the main entrance (front of Auditorium). This ramp is broken from the starting point and due to which the small/front wheels get stuck and the wheelchair can't be moved further. Due to this reason ramp is inaccessible.

This ramp should be properly maintained and should be repaired asap so that no one faces any kind of difficulty.

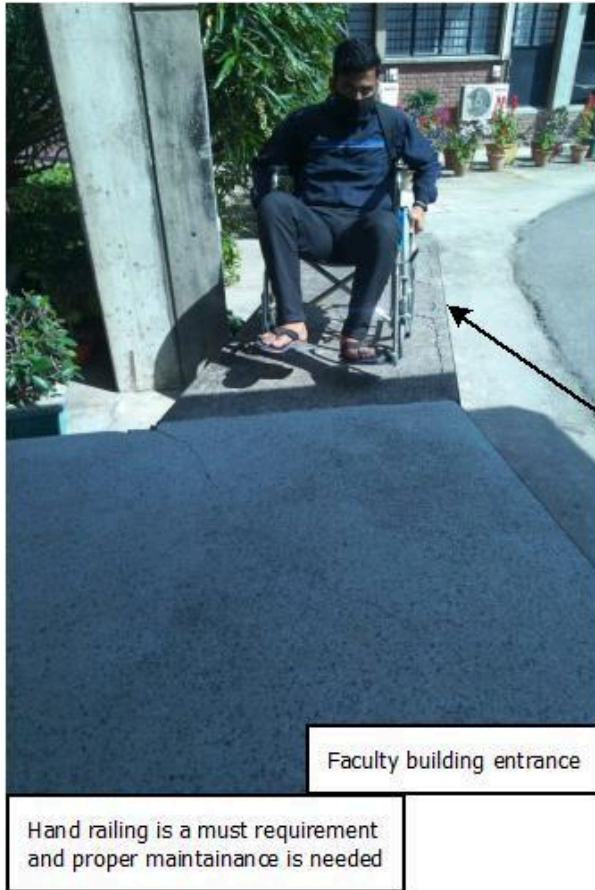
Entrance:

This ramp doesn't have a handrailing and it is very narrow.

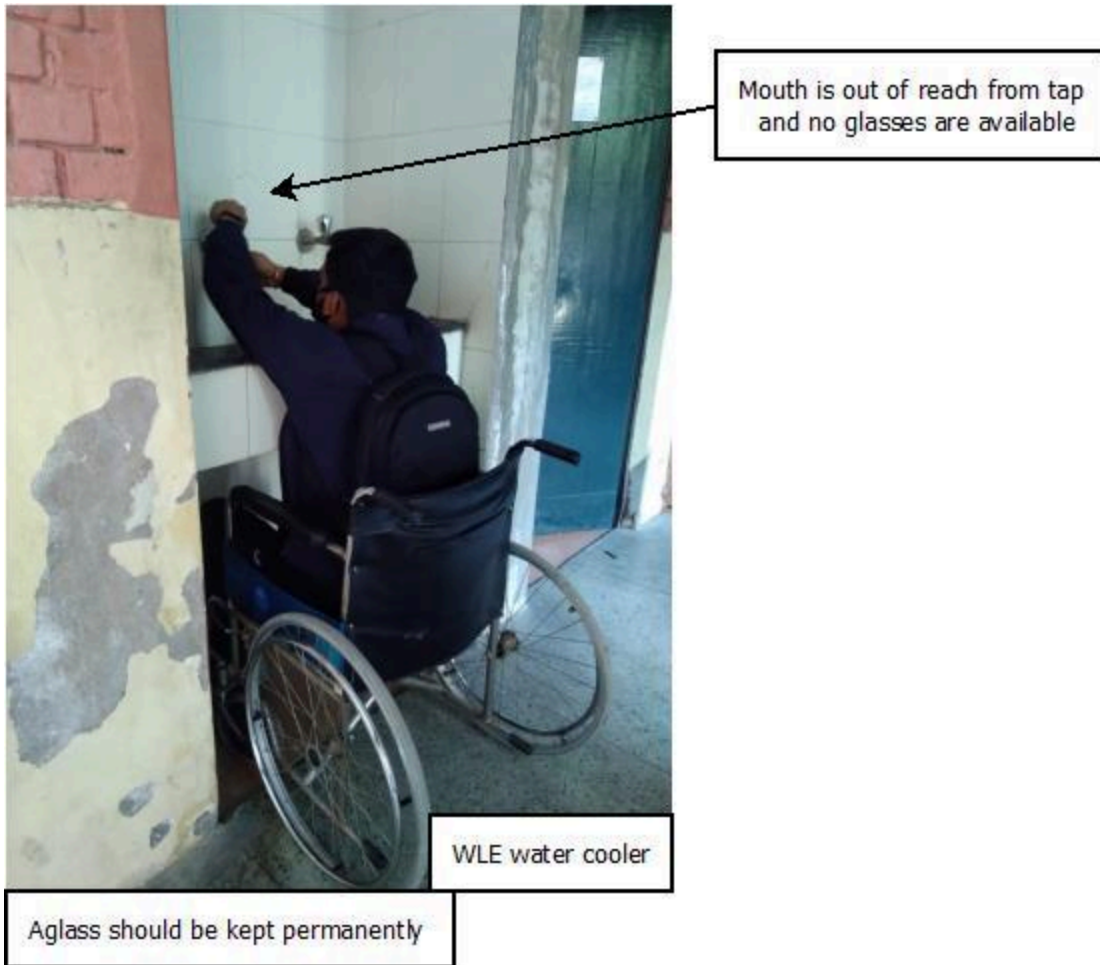
Drinking water facility:

Mouth is out of reach from taps and no water bottles or glasses are present near the taps so a handicapped person can't use this facility comfortably.

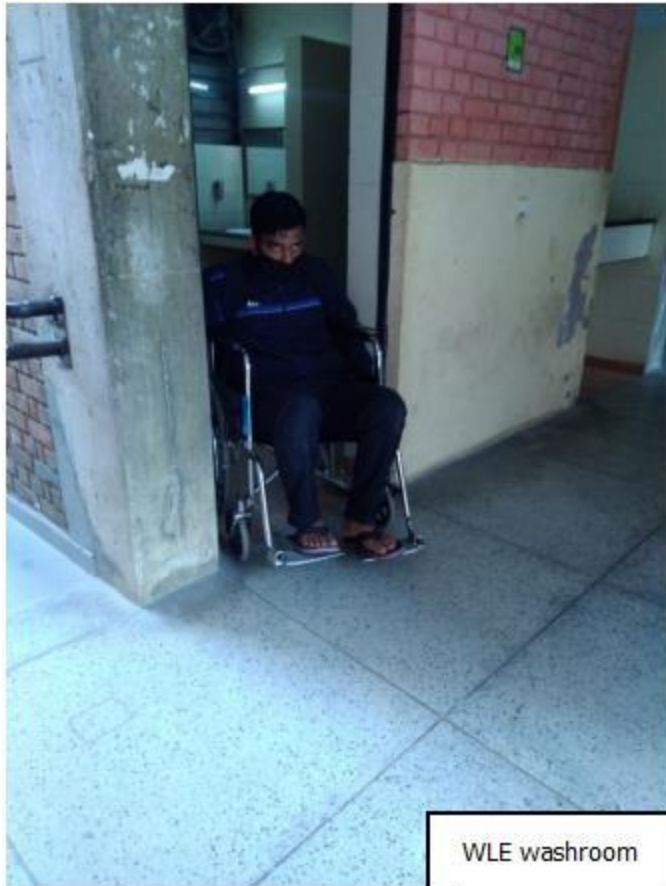
WLE washroom

Accessible for handicapped person

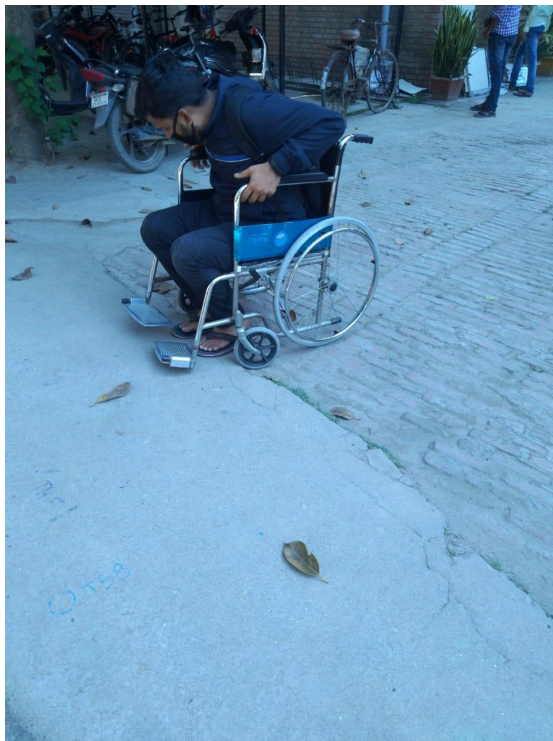
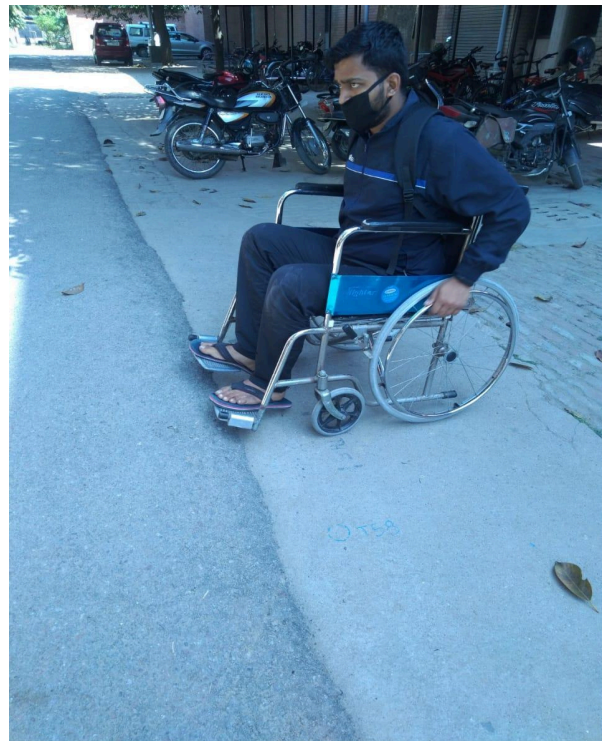
As it can be clearly observed from the photographs that the road is not in a good position to be accessed on a wheelchair.

In picture 2 it can be observed that there is a significant high step on the pathway and due to which this path is inaccessible for a person in a wheelchair.

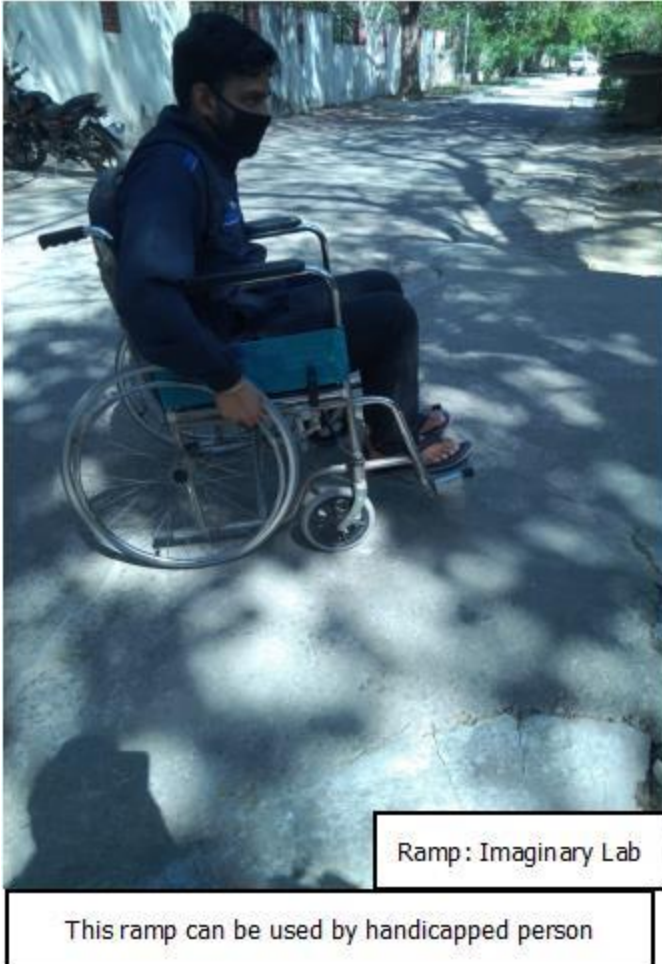
This is the main entrance ramp from the main road to the imaginary lab and this ramp can be used by handicapped person on a wheelchair to get to the main gate of this laboratory.

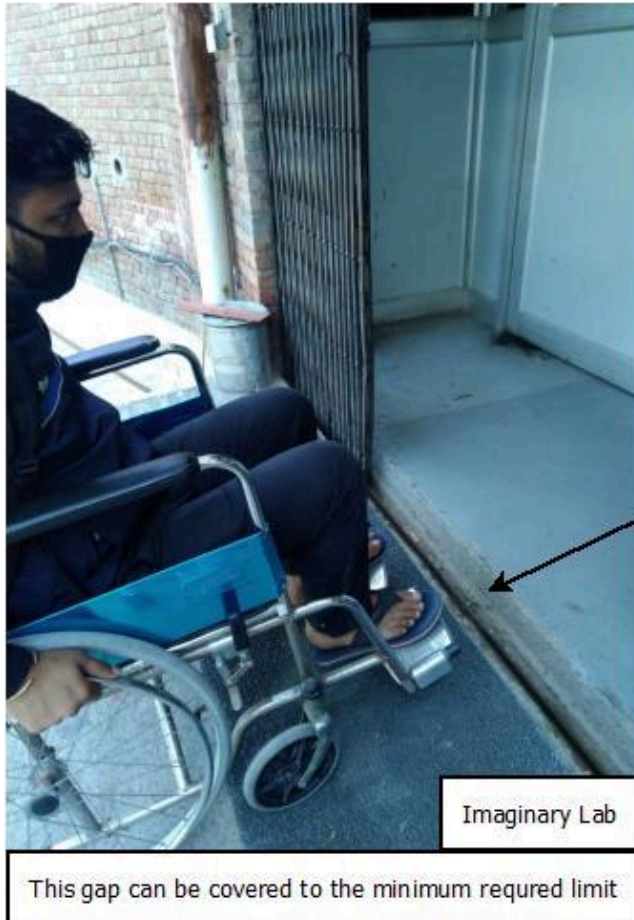
Entrance Gate(Front side):

This Gap is very wide and both the tyres sticks here and one can't move wheelchair further

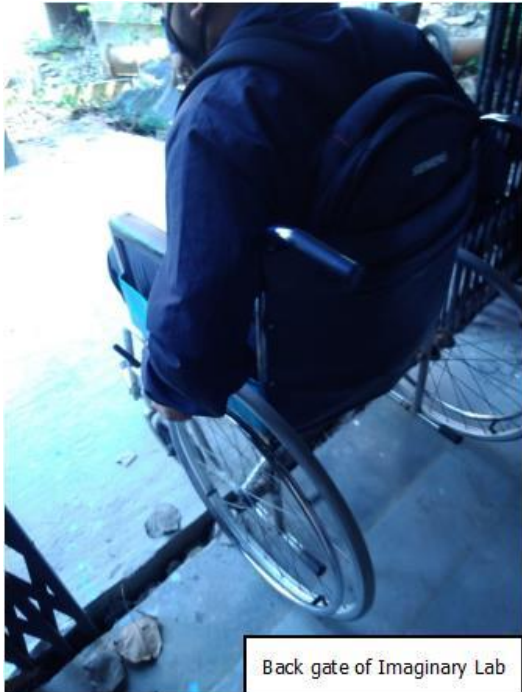
Back gate of Imaginary Lab

This gate has channel gate too but have minimum gap unlike the front gate and can be accessed easily

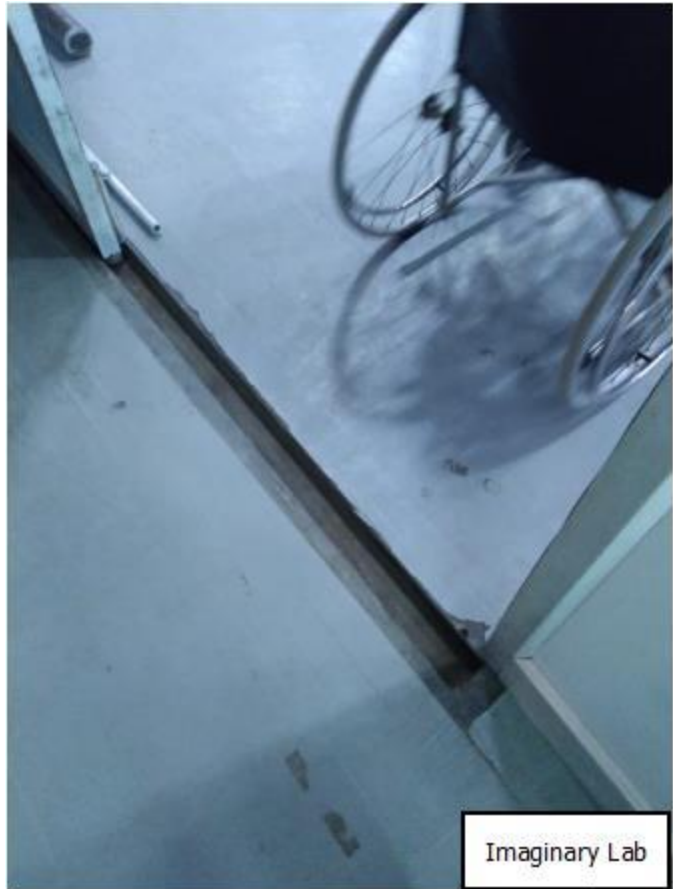
Imaginary Lab

This gap is not blocking the tyres of wheelchair and the lab can be accessed easily

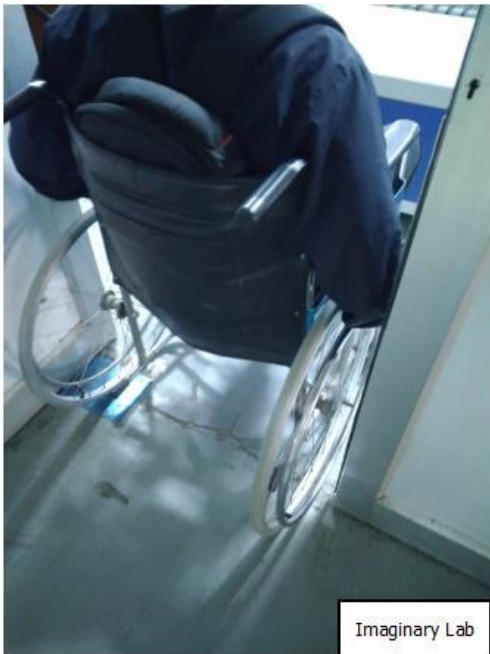
Imaginary Lab

Inside labs are accessible in Imaginary labs

These are a few more pictures clicked during the survey of imaginary labs. The labs inside the imaginary labs are accessible and the back gate has a narrow gap and a wheelchair can get over that gap easily.

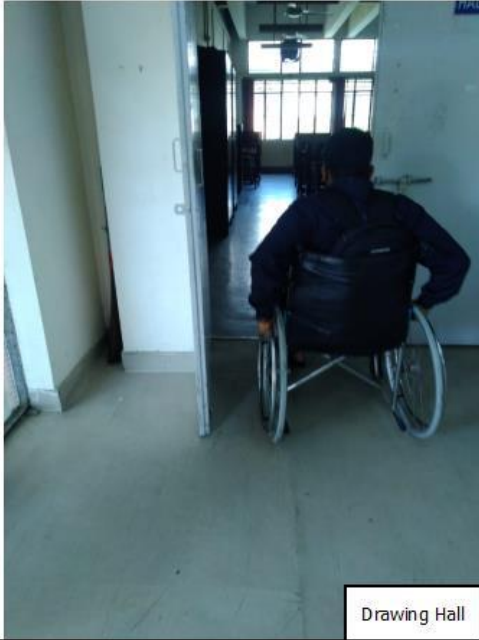
Drawing Hall

Drawing hall can be reached on wheelchair comfortably

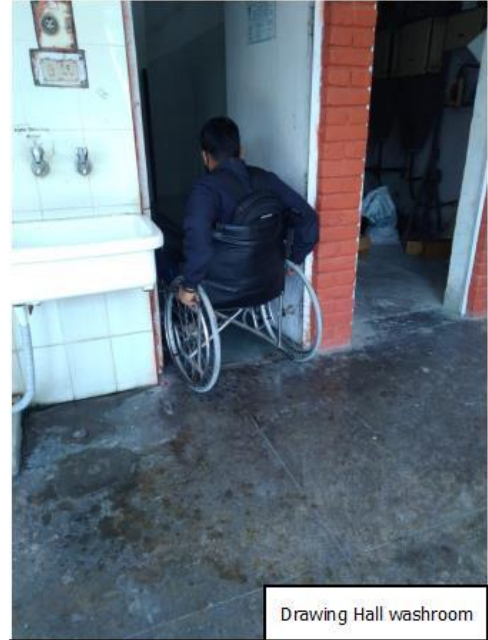
Drawing Hall washroom

These washrooms are accessible to handicapped person

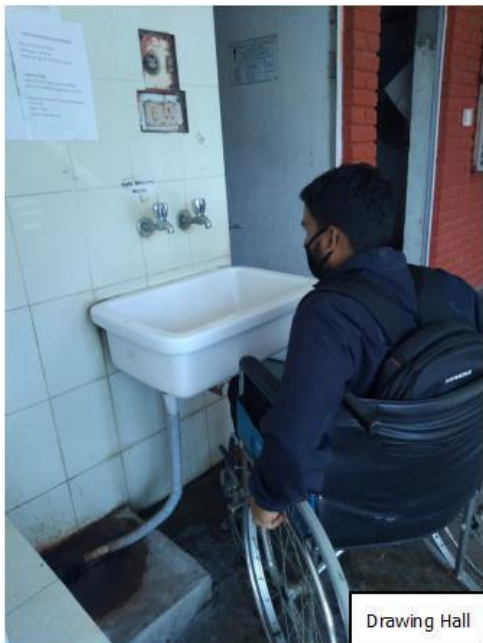
Drawing Hall

These water taps are accessible to handicapped person

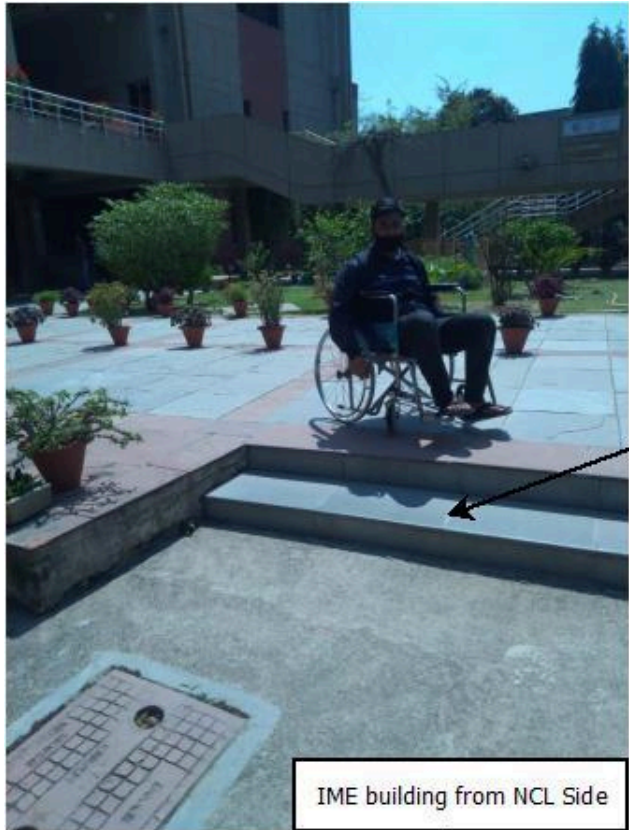
### Entrance near NCL:

IME main gate has ramp but to reach to ramp stairs makes inaccessible pathway

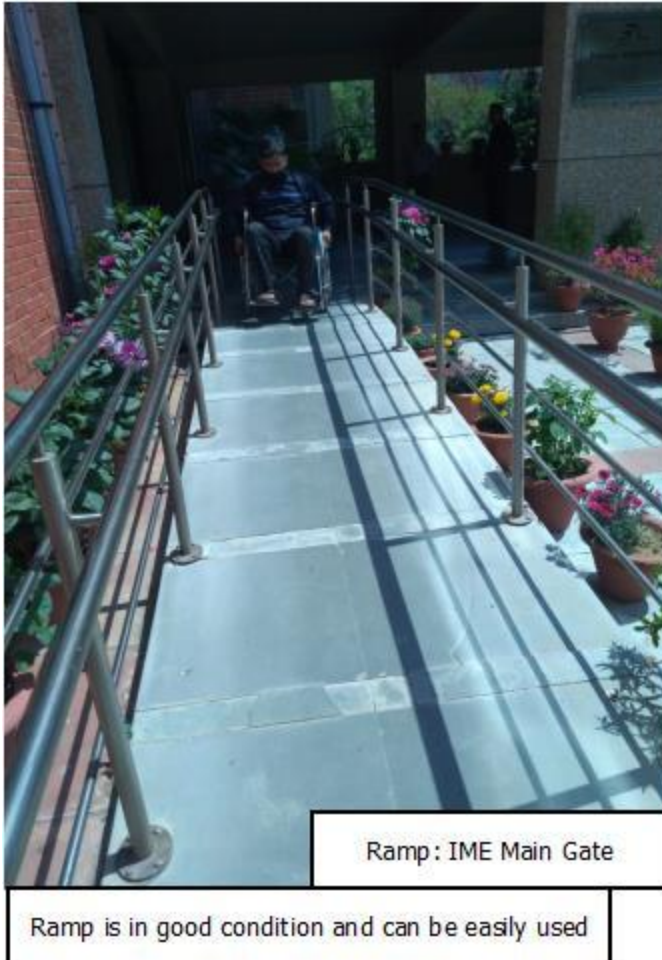
## Ramp: Main Gate

This ramp is in good condition and this ramp is only on the ground floor of this building and to get to this ramp one has to come from the Drawing hall side on a wheelchair as the NCL side has stairs before the ramp which is shown in the above photograph.

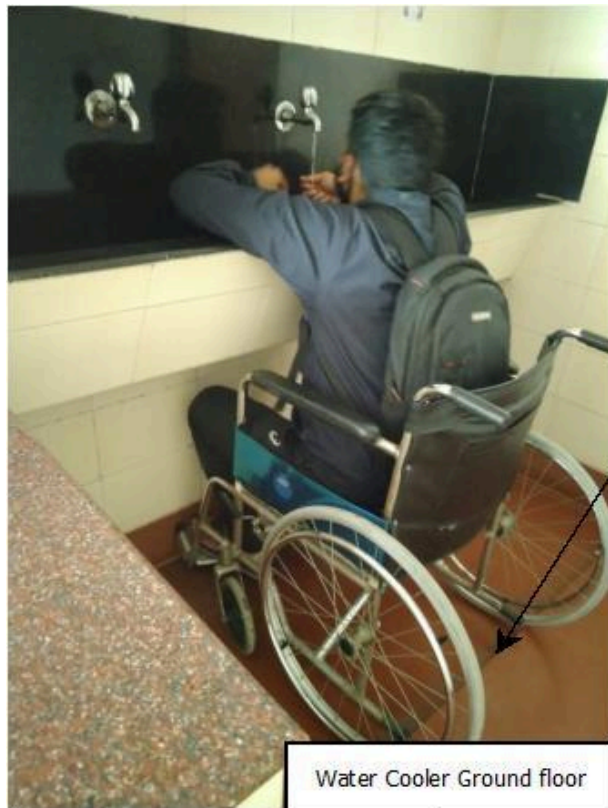
## Drinking water facility:

1. Tap is out of reach from mouth for drinking water
2. Due to a small step tyre gets stuck in it

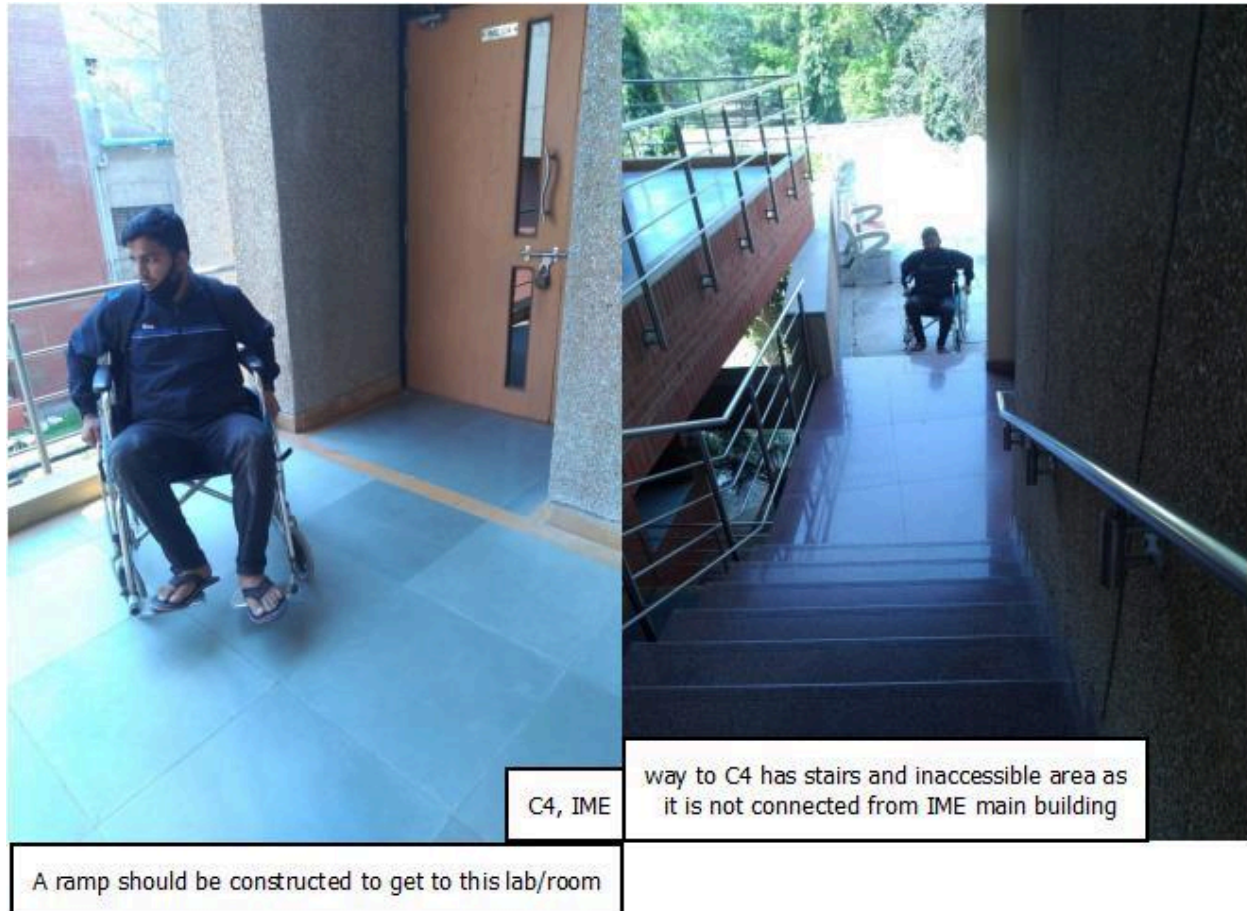
During the survey we tried to get to C4 which is in tower 2(other than the main building) and for that one way which we found is shown in the above photograph and it can be clearly observed that one has to take stairs to get to C4.

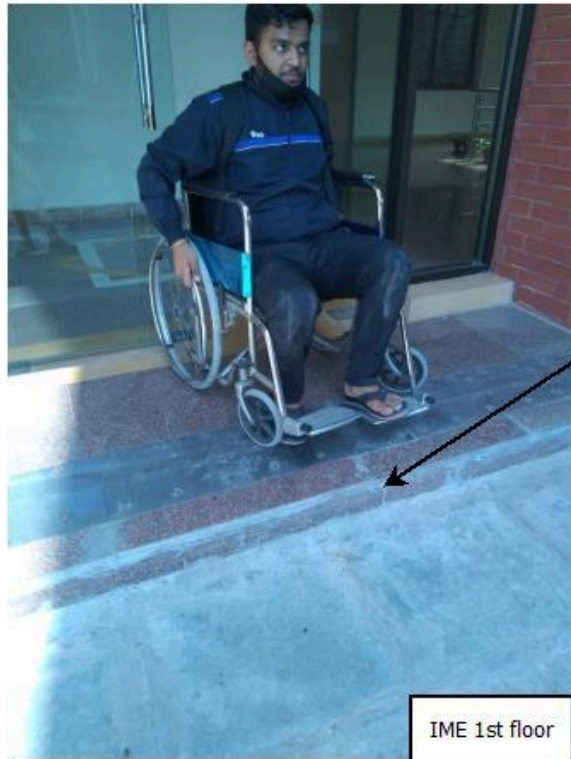
IME first floor has 2 similar gates and both have stairs in front of them due to which it is inaccessible for handicapped person

A permanent glass should be present  
Step should be made into a slope

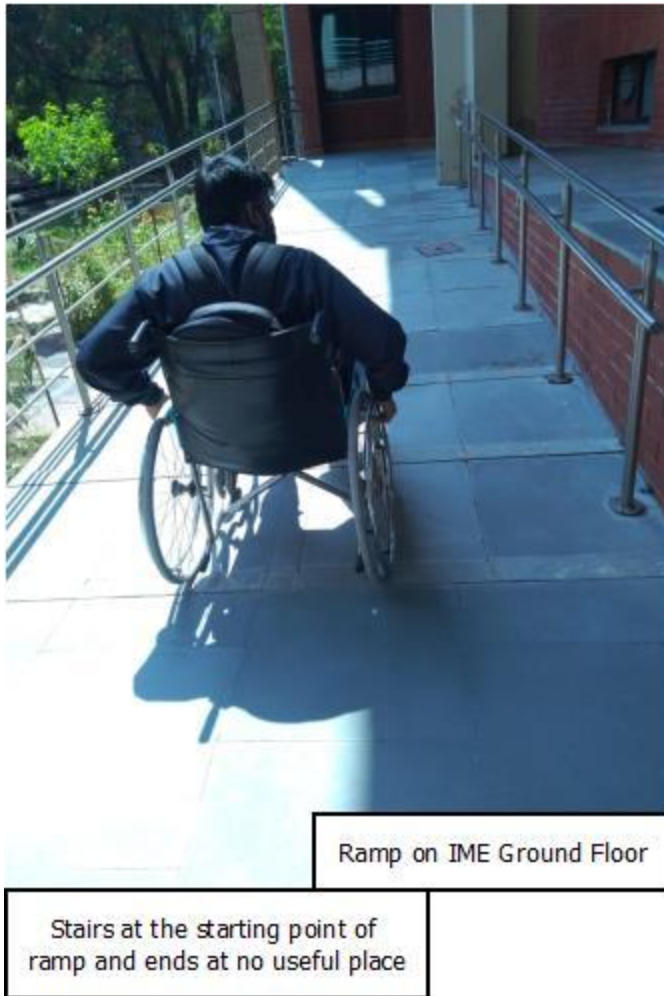
This ramp starts after a few steps from gate-2 on the ground floor of IME building and the gate-2 has stairs(basically the starting point of this ramp) and this ramp ends in an empty area where no rooms/labs are present.

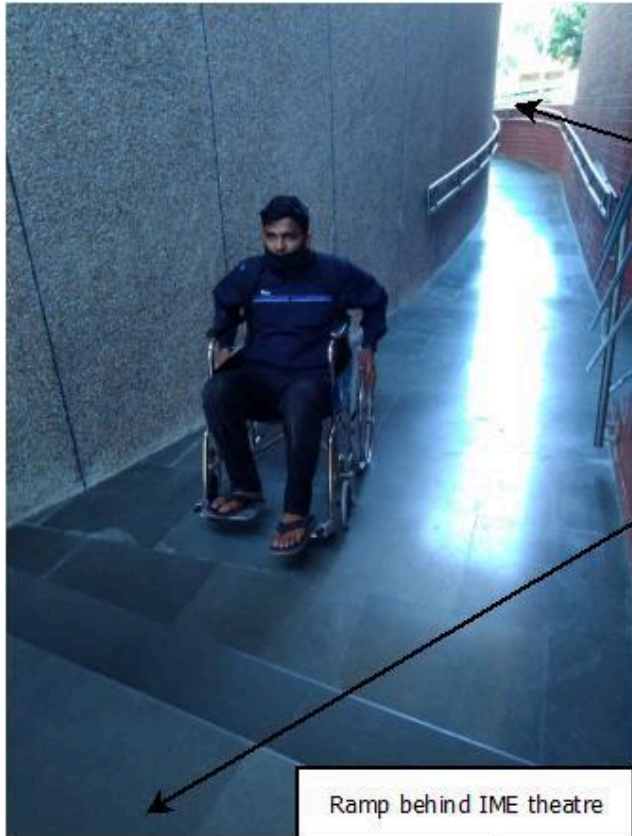
Two ramps are connected at the end followed by stairs from main building

Ramp is in good condition but is of no use

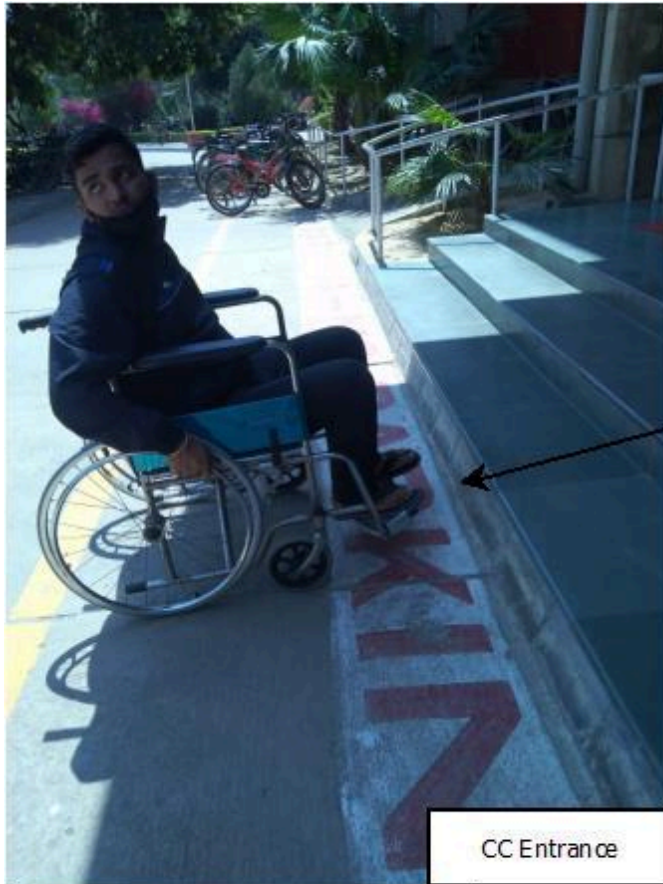
Main Entrance:

Main entrance of CC doesnt have a ramp for entrance and only way to get inside is stairs

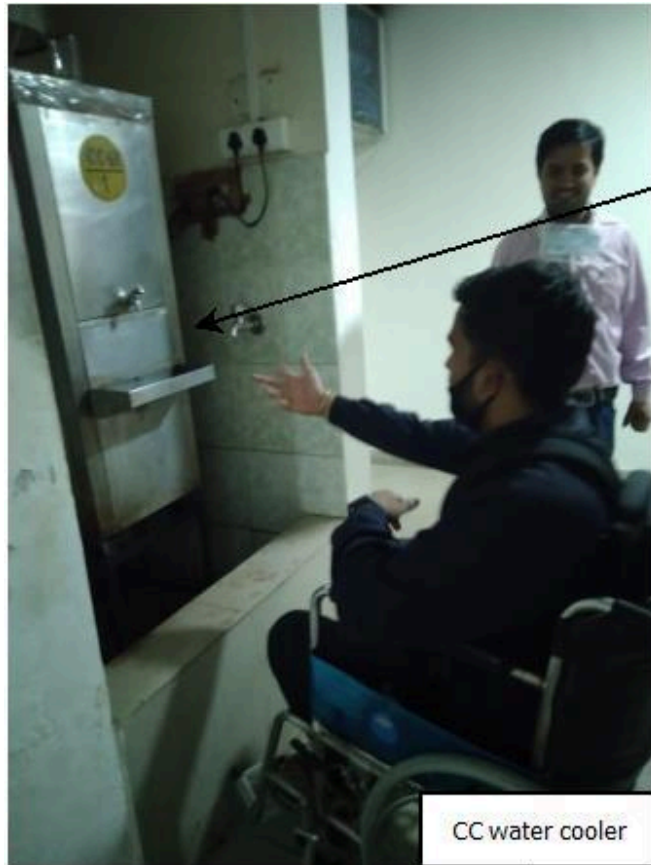
Water cooler is way out of reach even a glass or bottle can't be filled by person on wheelchair

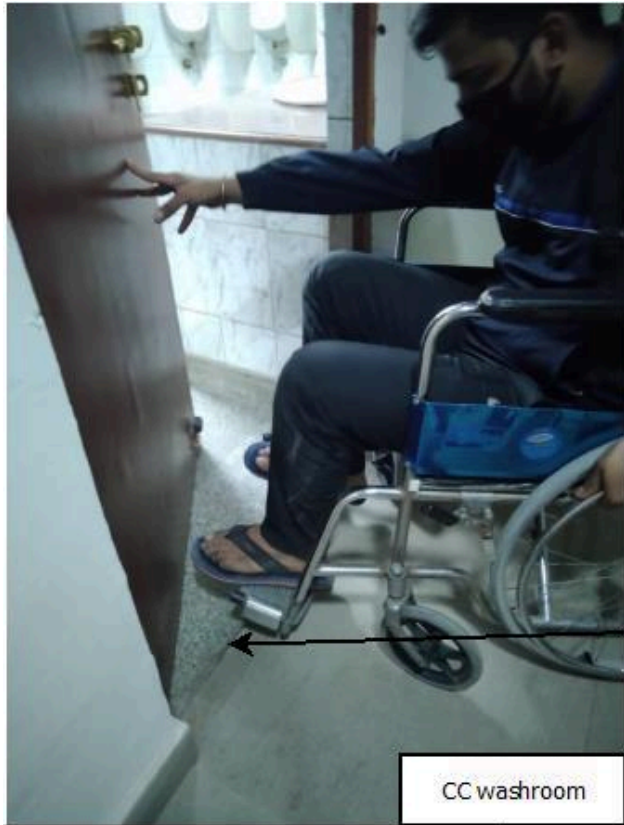
In this stepping tyre gets stuck and door is also not wide enough for wheelchair to get inside properly

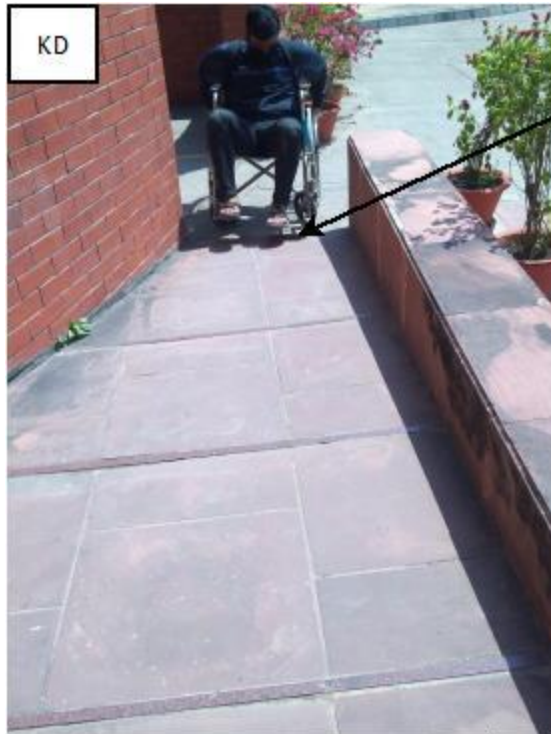
Step at the starting of ramp  
due to which tyre gets stuck

Step should be levelled to the ground

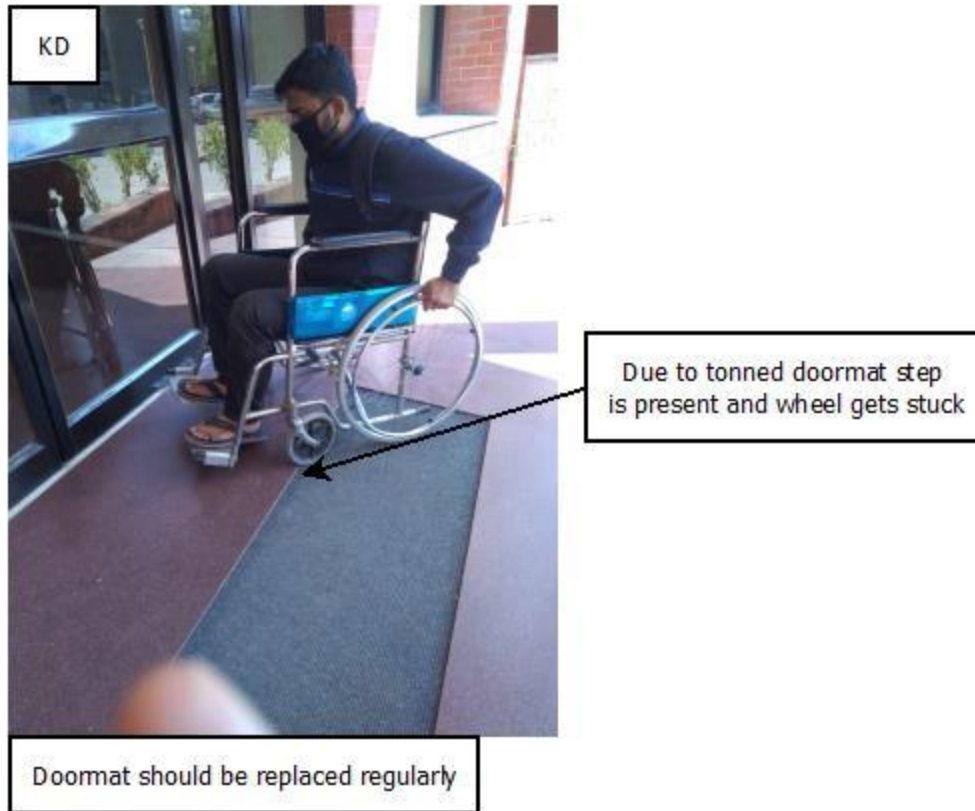
### Issue:

Doormat should be replaced from time to time and should be properly maintained.

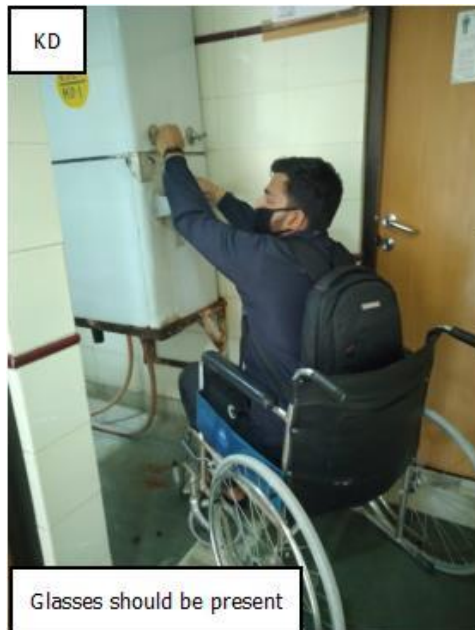
Water tap is out of reach from mouth and glasses are not present

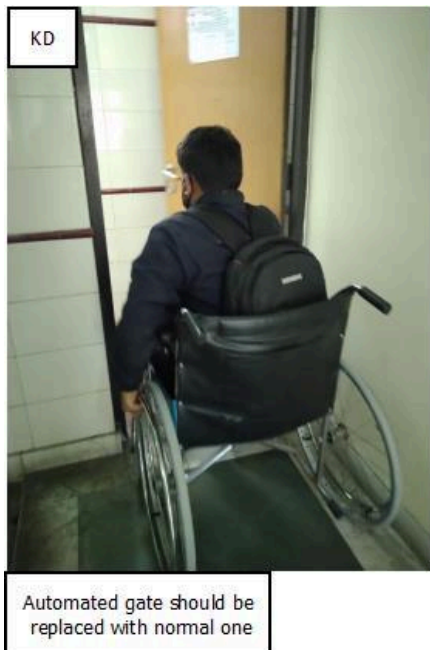
Door is narrow and automated so not possible to get inside on wheelchair

Door here is much narrow that even a mechanical chair couldn't get inside and the door is also automated which makes it impossible to enter inside on a wheelchair.

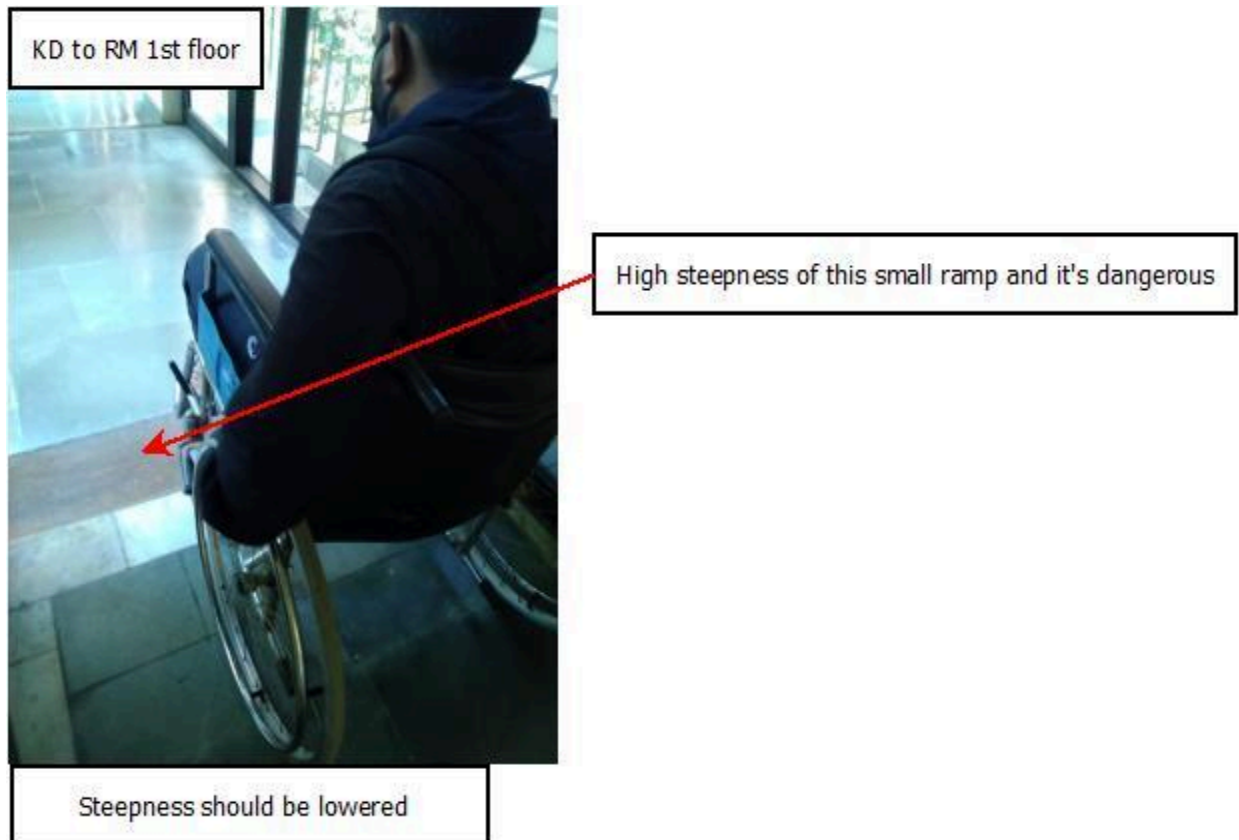
Issue:

This ramp should be replaced by a ramp with much lower slope than this and should be checked before installing so that handicapped person doesn't face difficulty and risk should not be there in passing over it.

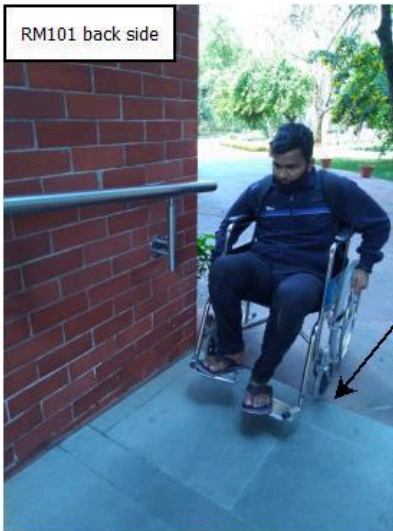
RM101 back side

A small step is present and due to this tyre gets stuck and wheelchair can't be moved further

Small step should be levelled with the ramp

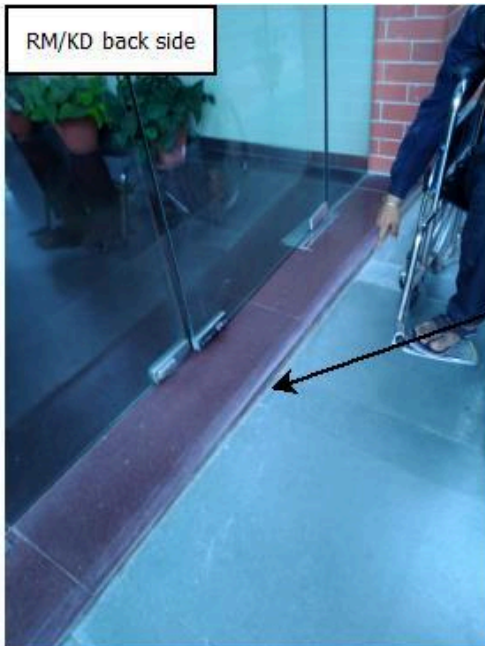
RM/KD back side

A small step is present and due to this tyre gets stuck and wheelchair can't be moved further

Solution: Steps should be levelled with the ground by making them into slope and proper maintenance should be priority.
