Accessibility on wheelchair @ IITK

Report submitted as community service towards CDAP

## **Lift Inaccessibility @ IITK**

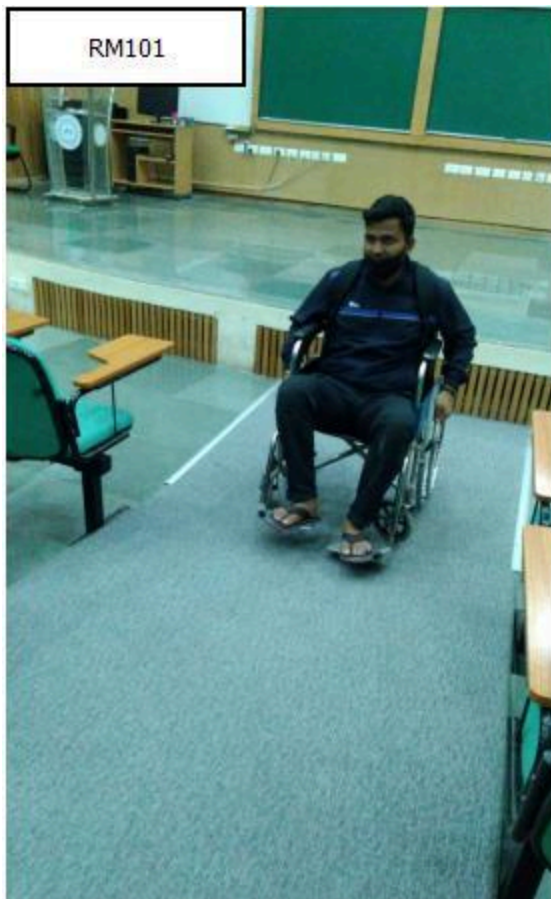
RM101:

Steepness is a little higher for mechanical wheelchair  
Stage is inaccessible due to absence of ramp

Ramp should be constructed to connect stage as well

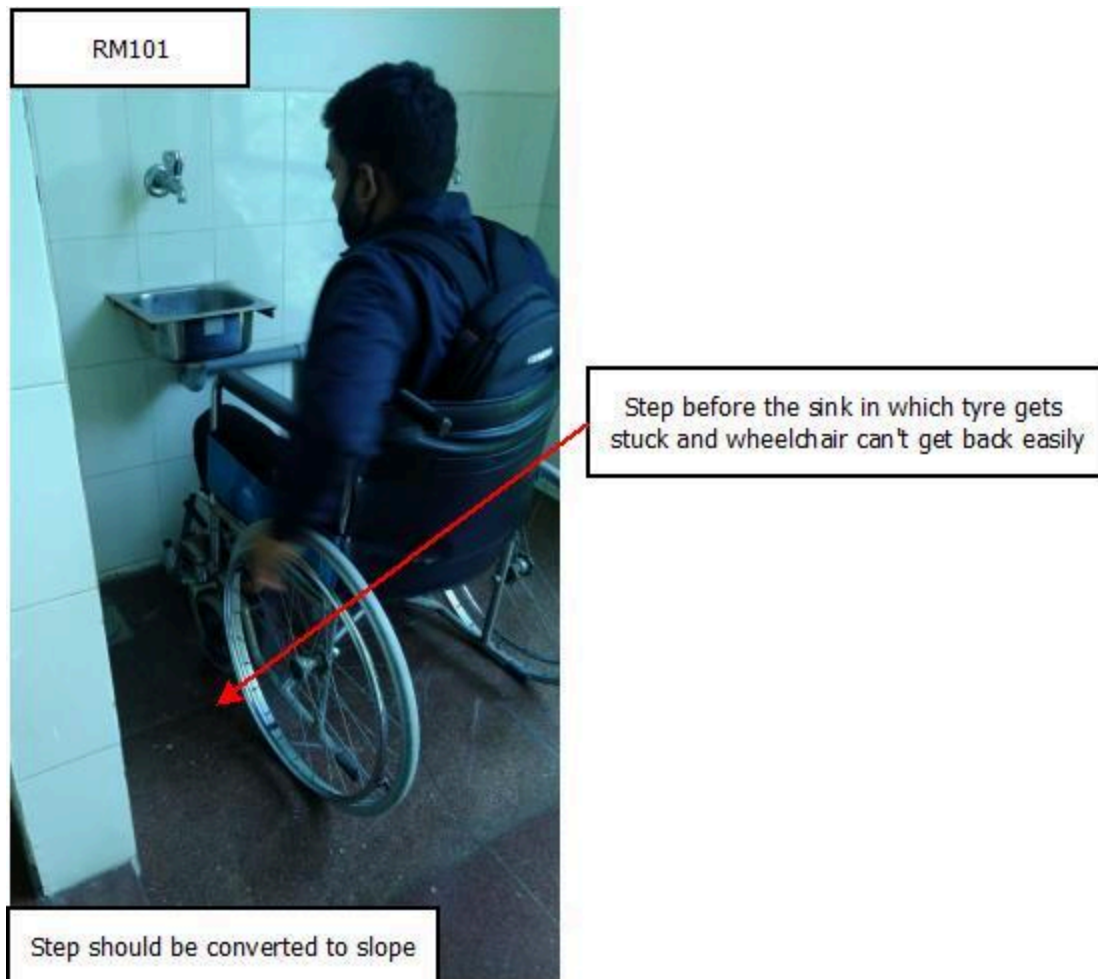
Drinking water facility in RM:

In RM building sink and tap are at perfect height and which is not an issue but to get to the tap it has a step before it in which the wheel gets stuck and the wheelchair cannot be moved further.

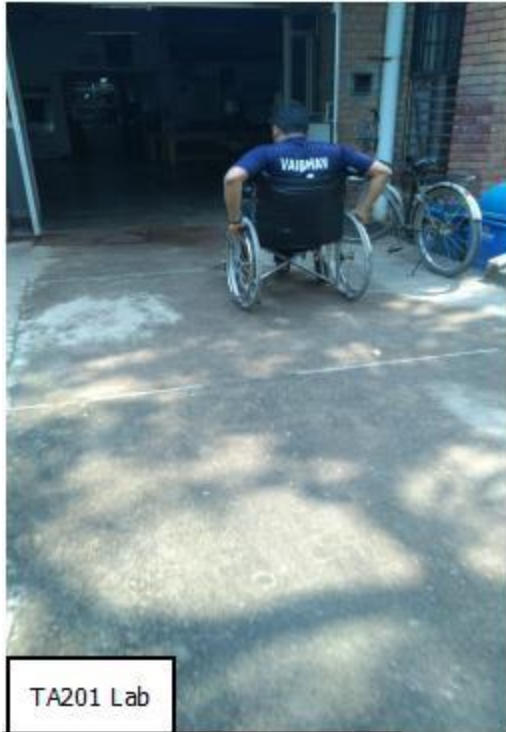
TA201 Lab

Entrance ramp is good to use

This ramp is in good condition and can be used by person on wheelchair(wrongly mentioned in photo as TA201)

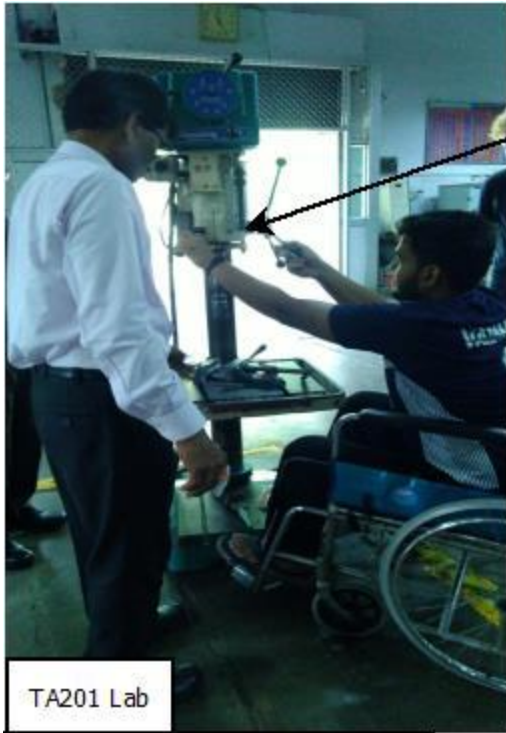
TA201 Lab

Limited reach is the issue

Modified wheelchair can be useful

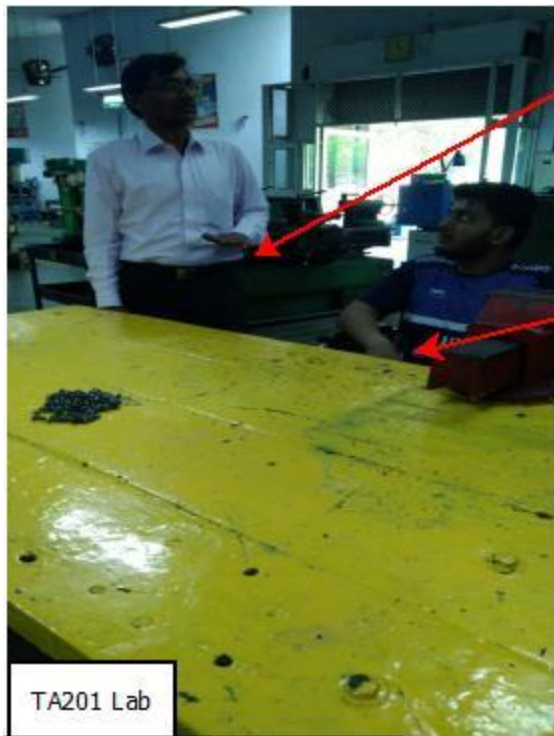
TA201 Lab

Standing height is the required height for comfortable working

Sitting height is much lower than required height

Modified wheelchair is required

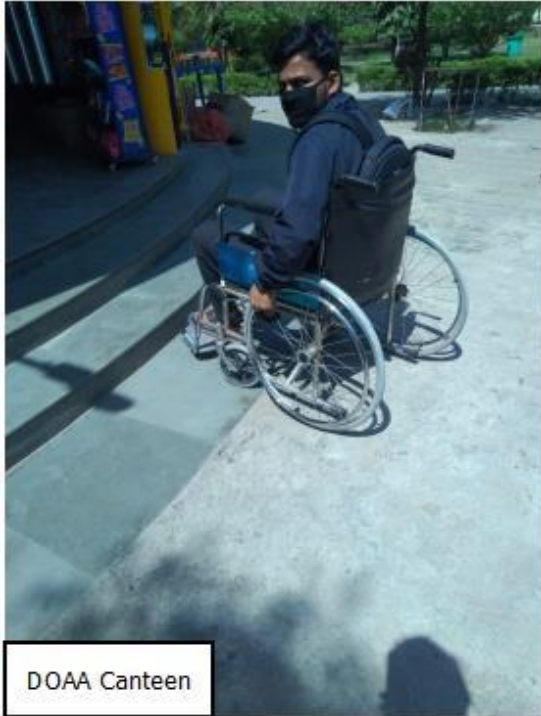
DOAA Canteen

Stairs makes it inaccessible to get to the Counter

In DOAA canteen one needs to take stairs to reach the token counter and this makes the canteen of no use for handicapped people.

A ramp should be made so that one can get to the token counter to buy some snacks.

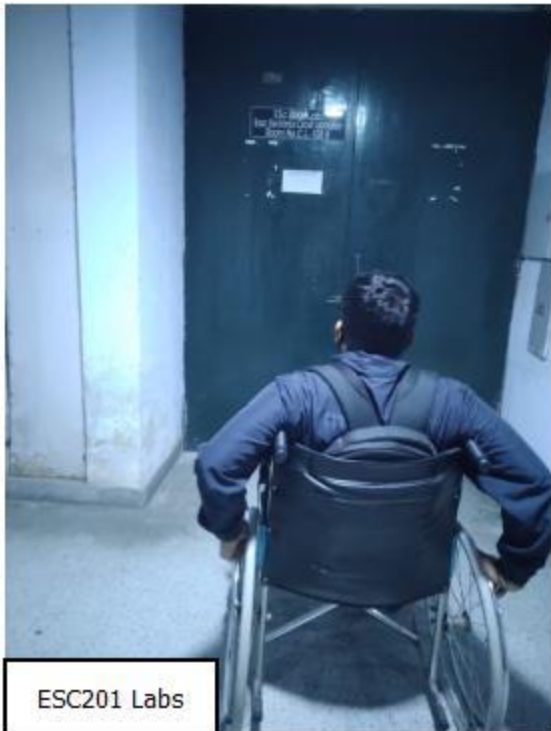
ESC201 Labs

Accessible lab inside Old core lab ground floor

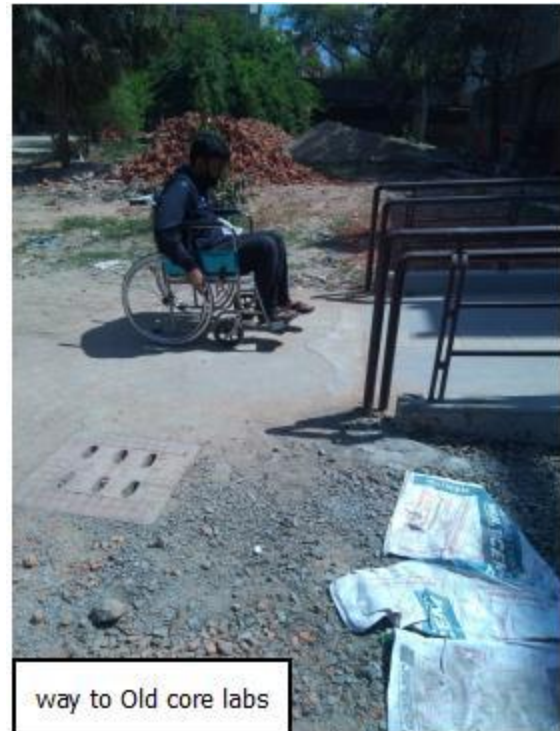
way to Old core labs

This Ramp is good to use

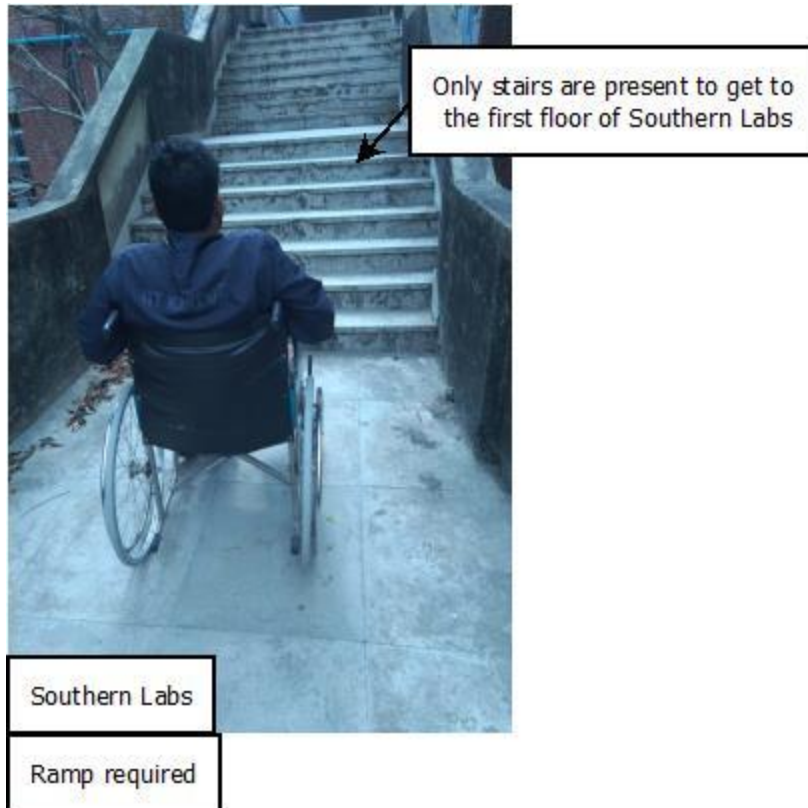
To get to the first floor of Southern labs the most suitable way is through the library skywalk for a handicapped person. But there's no ramp constructed to get to the first floor of this building.

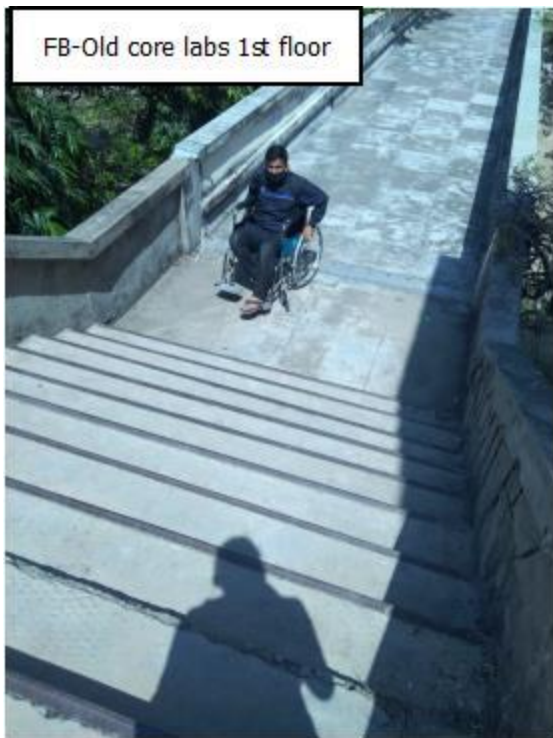
FB-Old core labs 1st floor

Stairs makes it inaccessible
