BUILDING PLANS / PUBLIC BUILDING

# Renewal of the St. Michael's Cathedral in Veszprém

The renovation of the Saint Michael Cathedral in Veszprém, Designed by Czita Architectural Office (Czita Építész Iroda)

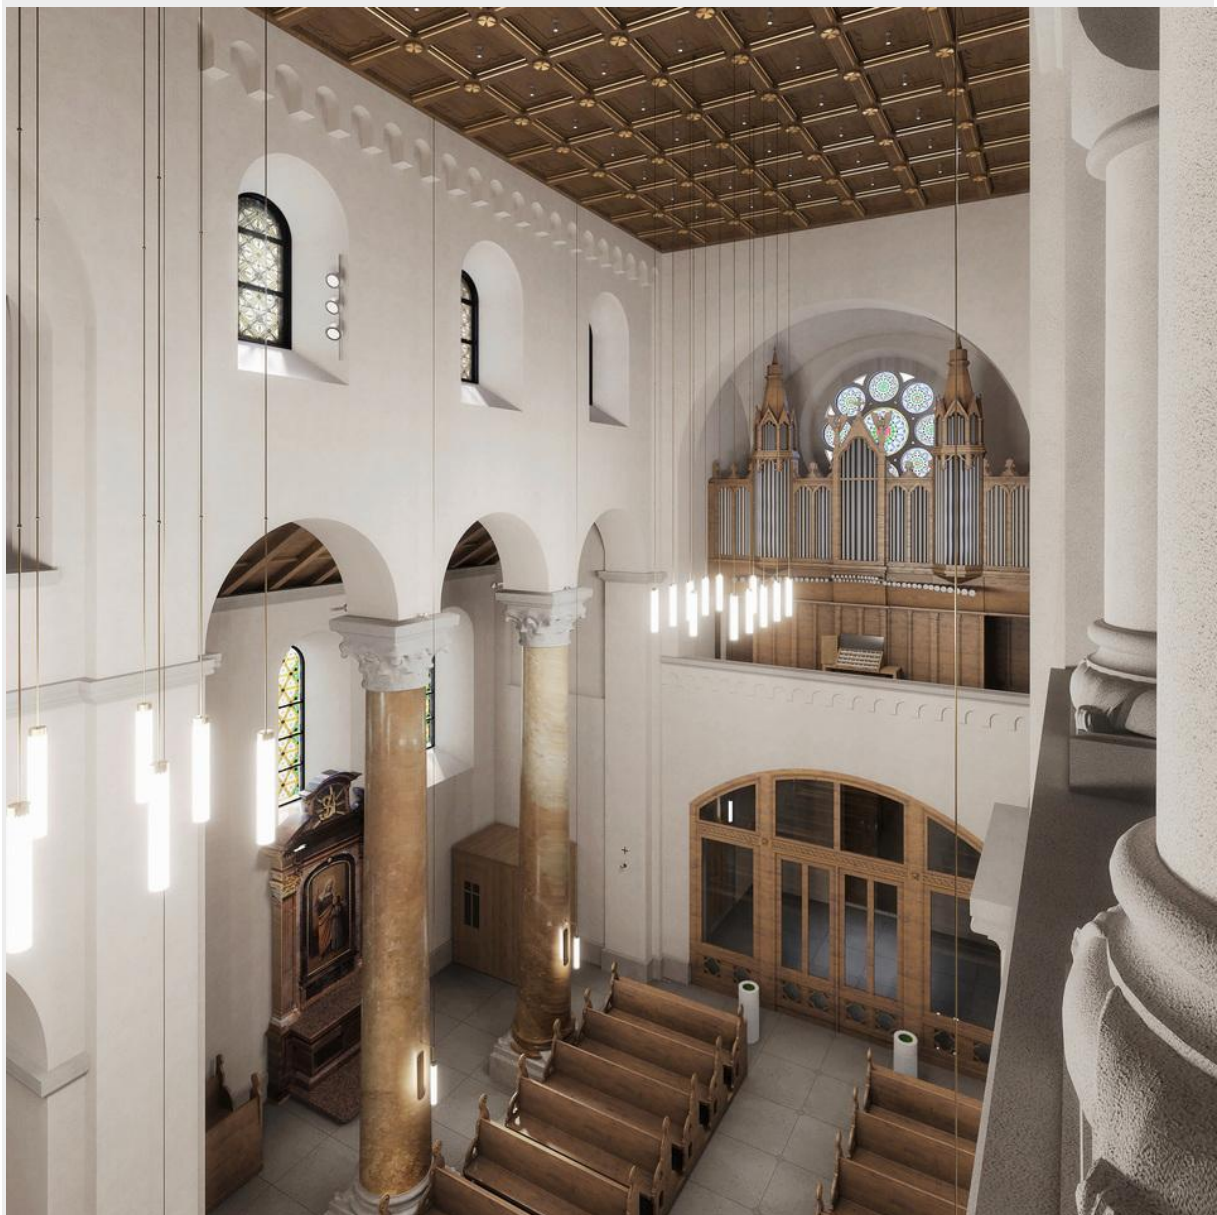
3/11

The renovation of the Saint Michael Cathedral in Veszprém, Designed by Czita Architectural Office (Czita Építész Iroda)

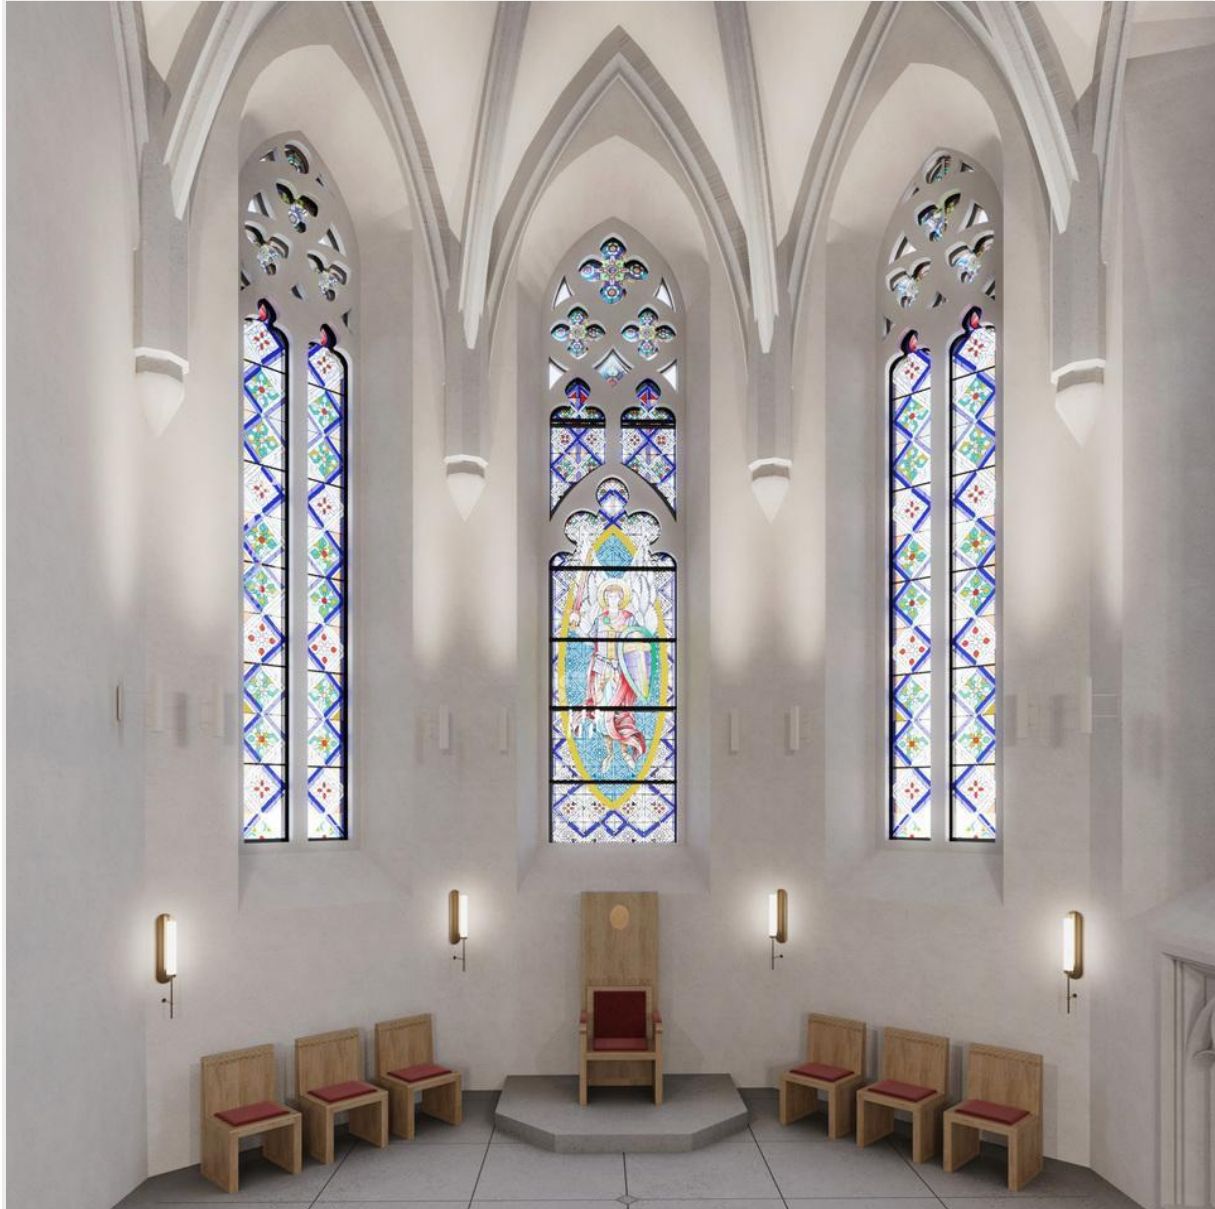
6/11

The renovation of the Saint Michael's Cathedral in Veszprém, Designed by Czita Architectural Office (Czita Építész Iroda)

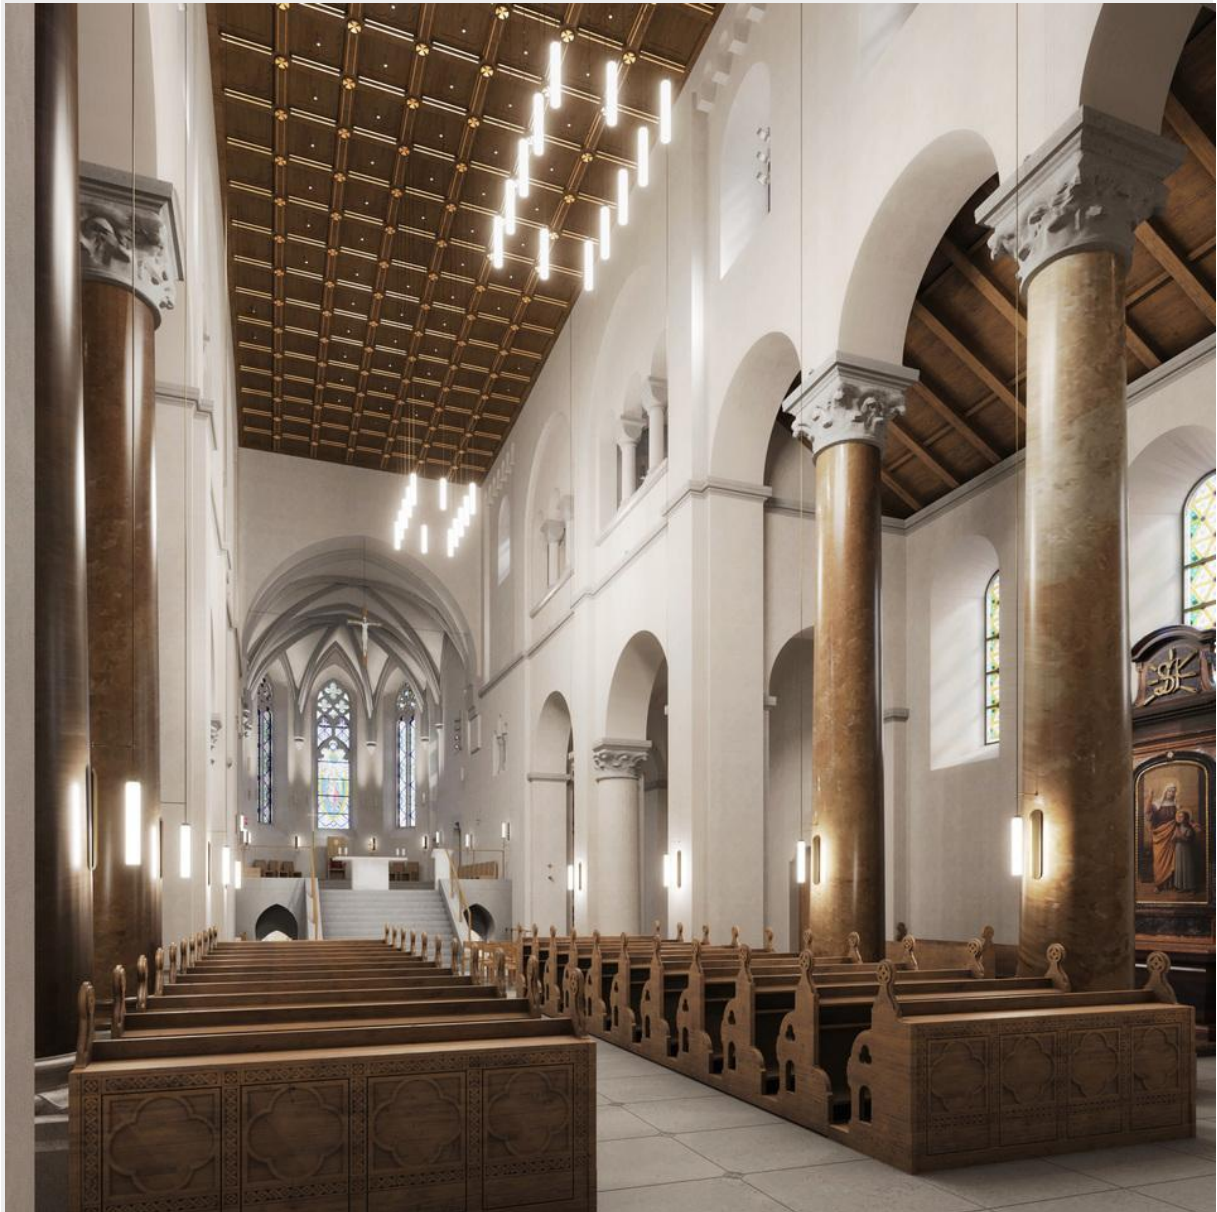
2/11

The renovation of the Saint Michael's Cathedral in Veszprém, Designed by Czita Architectural Office (Czita Építész Iroda)
