Title	ASGM Mercury pilot remediation in Lombok and West Sumbawa
Client	TAUW Foundation
Project leader	Guido van de Coterlet
Author(s)	Carlo Bensaïah and Boudewijn Fokke
Second reader	t.b.d.
Project number	1279669
Number of pages	54
Date	August 3, 2022
Signature	This document was released with the explicit approval of authorized project management

Reference R001-1279669CBN-V01

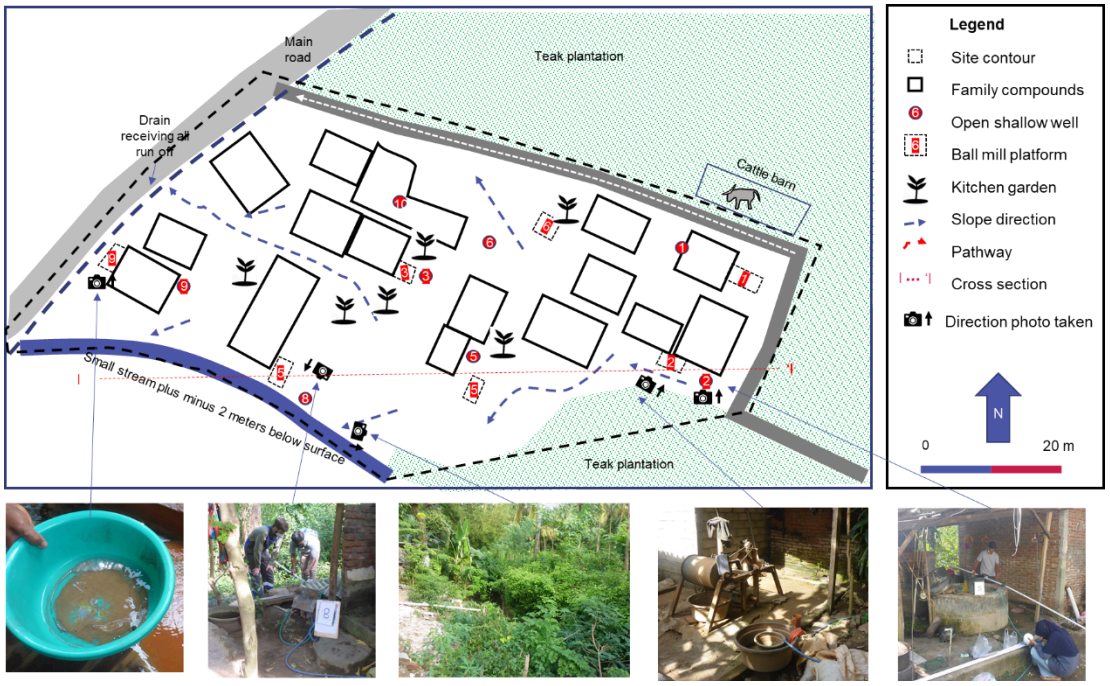
Figure 3.2: Kayu Putih with the multiple potential sources of mercury contamination and the potential pathways

During the fieldwork, observations were made that might indicate the presence of soil and groundwater contamination. The presence of bricks, waste such as plastic bags, batteries and food remains was observed to be present at the surface and topsoil. For details, reference is made to the bore logs in Appendix 1a. At the time rod-mill location 9 was sampled the mill was emptied and the mercury from the mercury gold amalgam was separated using a cloth (see Figure 3.2).

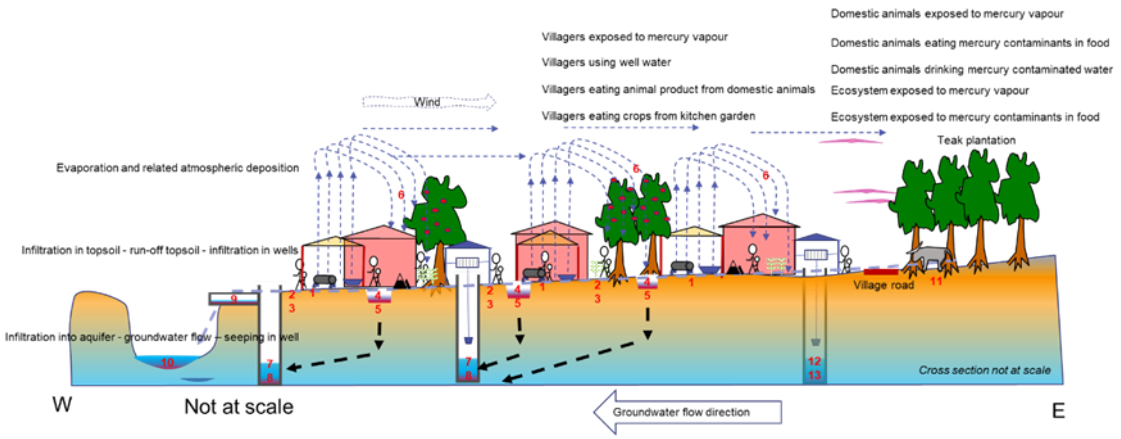
Figure 3.3: The cross-section A – A' of Kayu Putih with the multiple potential sources of mercury contamination, the potential pathways and the potential receptors

Figure 3.2 provides the site layout and Figure 3.3 is a representative cross-section of Kayu Putih with the multiple potential sources of mercury contamination, the potential pathways and the potential receptors.

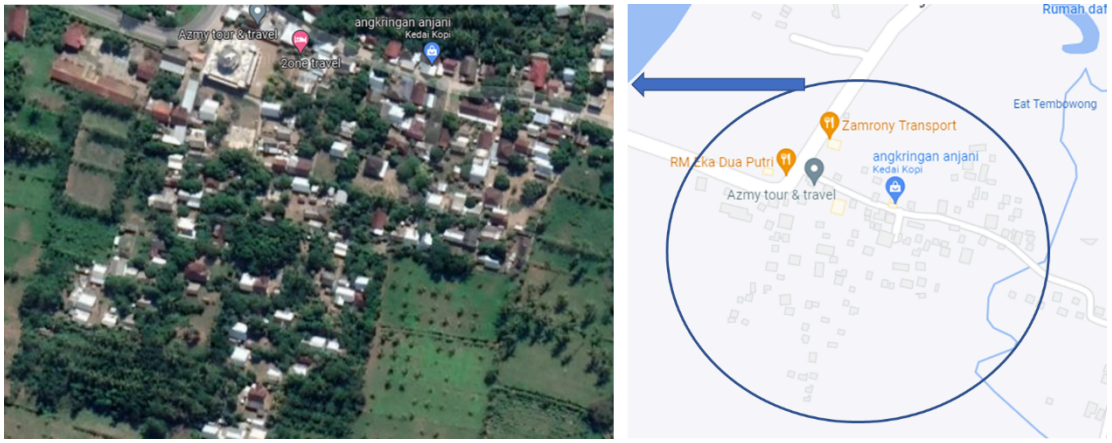
Figure 3.4: The study area of the village Temboulon

A family that was involved in ASGM activities was visited. One of the children of this family was born deaf and dumb. A medical specialist concluded after a medical examination that this was likely caused by mercury exposure of the parents.

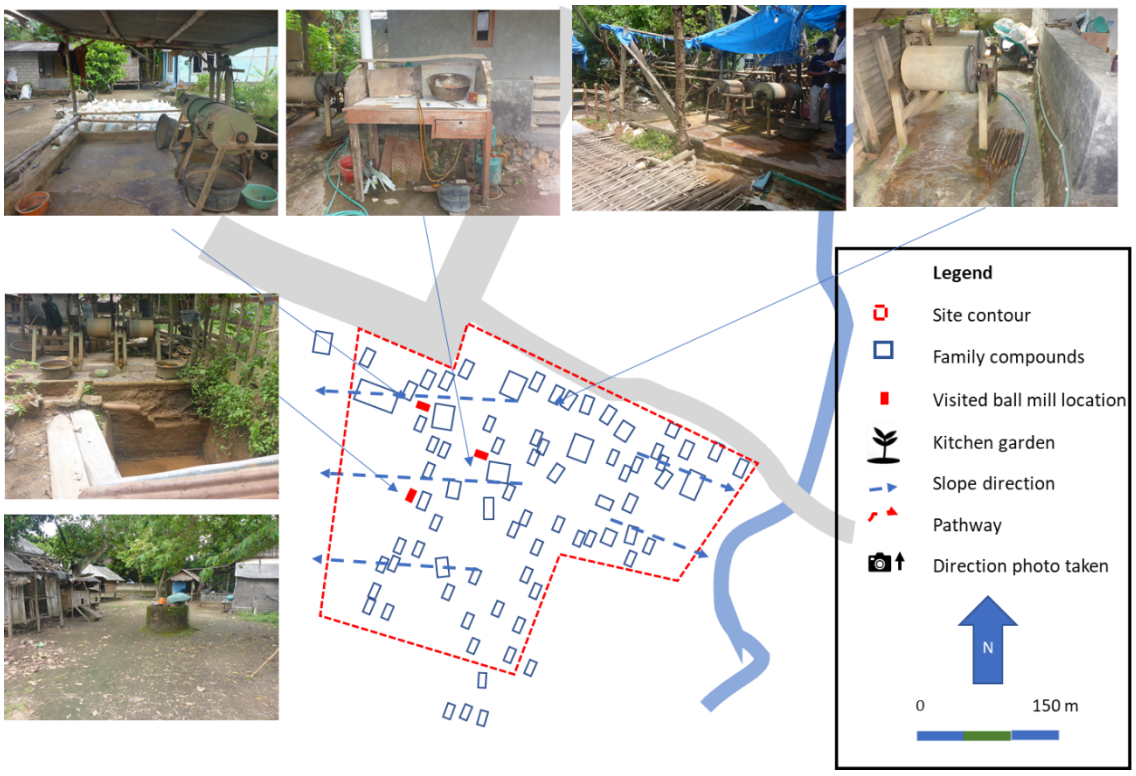
Figure 3.5: Site lay-out study area of the village Temboulon and photographs illustrating the on-site situation

- All the rod-mill locations that used and or are using mercury
- The place where mercury is burned (see Figure 3.5)

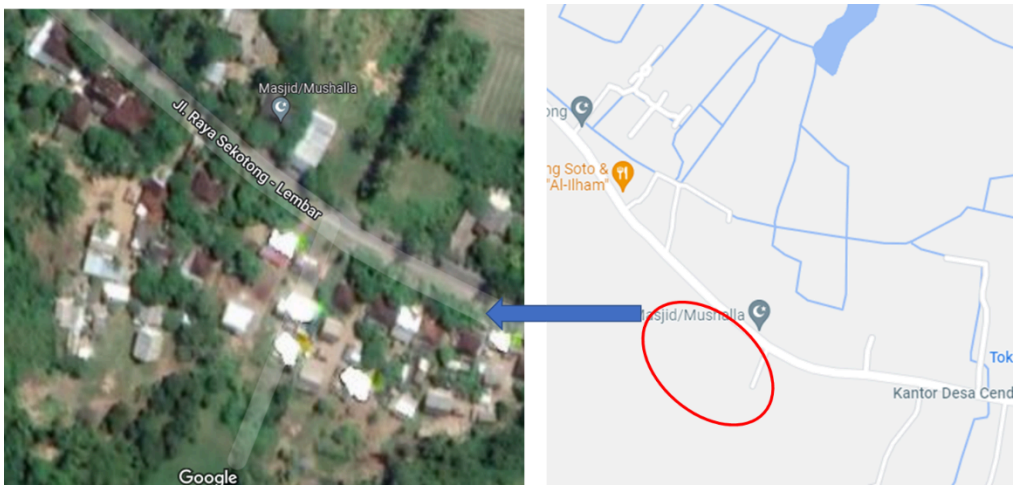
Figure 3.6: The location of the study area in Cadi Manik

The study area in Cadi Manik has around 25 family compounds and about 70 people are living in this community. Nearly all villagers are involved in ASGM. Also, on this site the potential sources, pathways and receptors of mercury are as described for Kayu Putih (see Section 3.1.1) and can be summarized as follows:

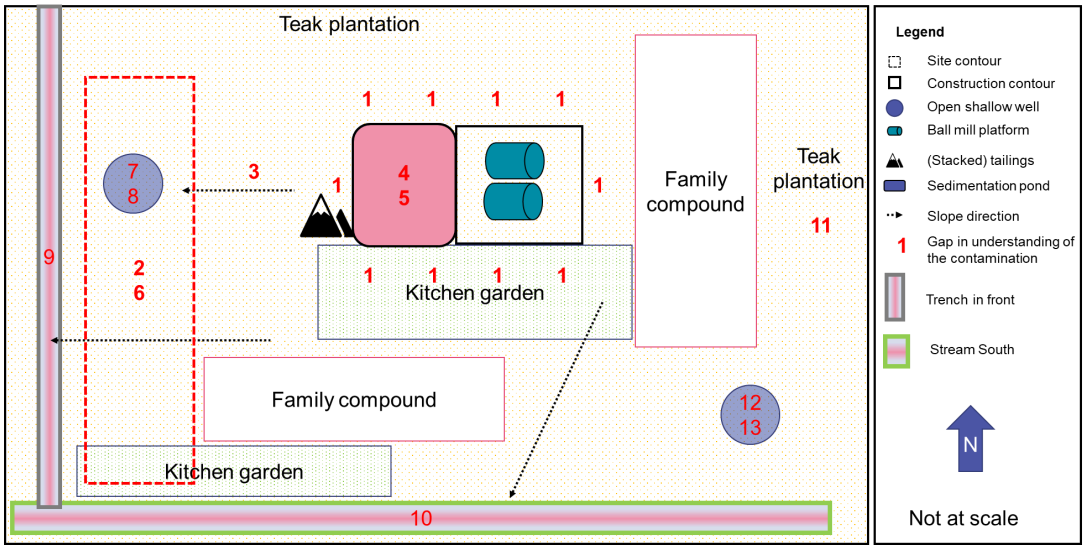
Figure 3.7: The general layout of a rod-mill location in Kayu Putih with the knowledge gaps

In total ten, more or less identical (former) rod-mill locations were in Kayu Putih at the time of the detailed site investigation. For an overall overview and cross section reference is made to Figure 3.3 in Section 3.1.1. The general layout of rod-mill location including the knowledge gaps is presented in Figure 3.7 and a schematic cross section is provided in Figure 3.8. To structure the gap analysis and the detailed site investigation each gap is consequently numbered. These gaps are listed in Table 3.2. Based on the gaps a sampling and analyses plan is made and presented in Section 3.2.3.

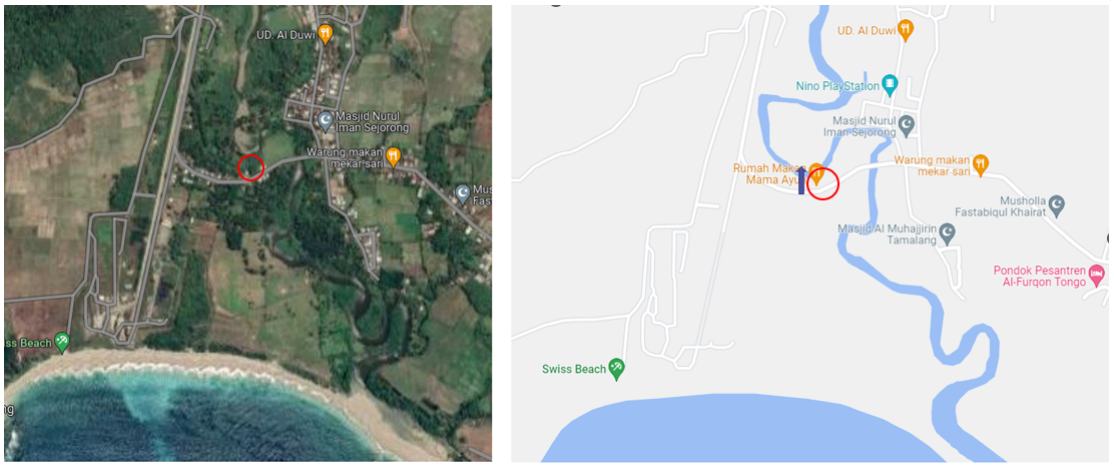
Figure 4.1: Location of 01-04-2022 site 3 in Tongo, West Sumbawa

The former ASGM rod-mill platformer was not maintained and household waste is dumped at the site. Groundwater is extracted 50 m towards the east of the site.

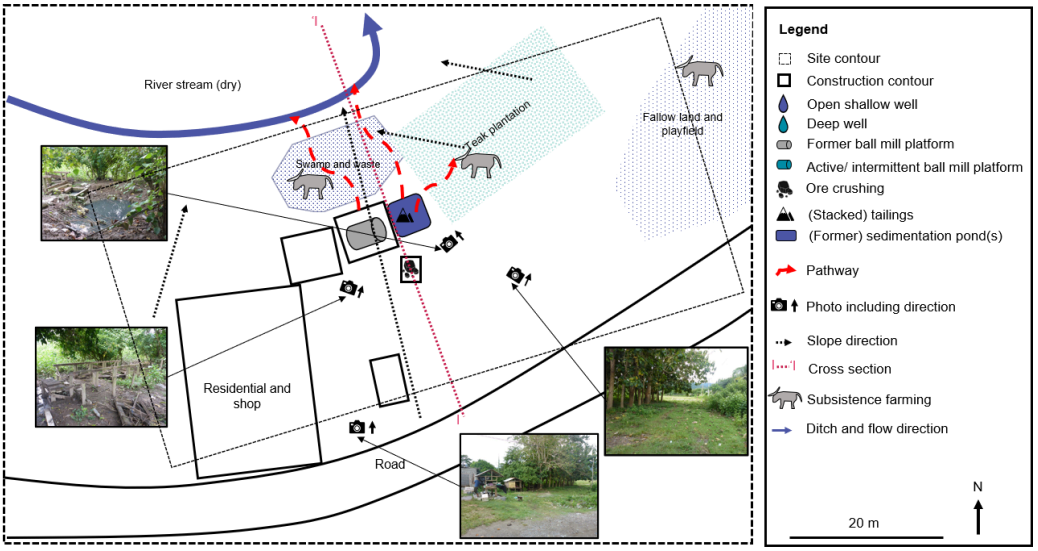
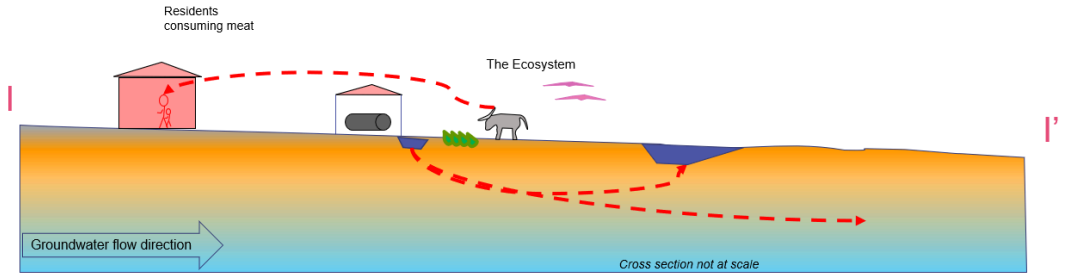
Figure 4.2: The ICSM of 1-04-22 Site 3 in the village Tongo on West Sumbawa

Potential sources
The potential sources of the mercury contamination are:
- The contaminated topsoil around the former rod-mill location
- The sludge in the former sedimentation pond

Potential pathways
The potential source receptor pathways are:
- Direct contact with the contaminated topsoil
- Leaching of rainwater in the soil
- The groundwater, flowing to the northern direction
- Direct contact with the contaminated groundwater
- The spreading potentially contaminated topsoil by run off towards the river north of the site
- Spreading by wind of airborne contaminated fine soil particles
- Direct contact by consuming contaminated crops and animal product

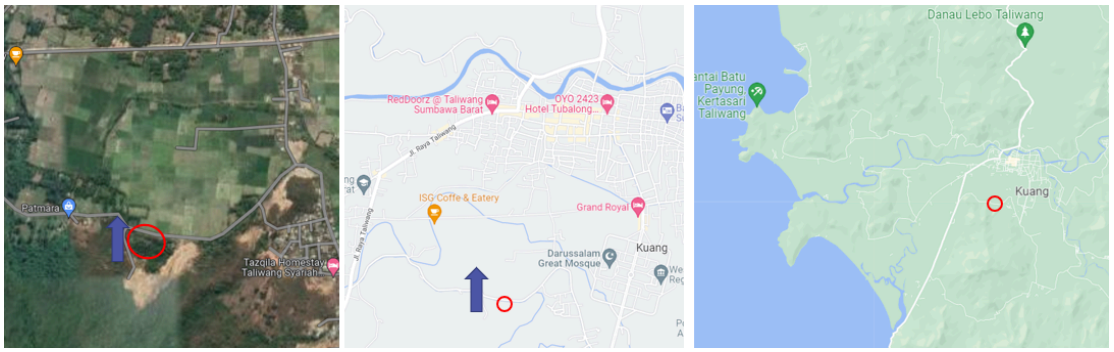
Figure 4.3: Location of 02-04-22 site 1 – Southwest of the city centre of Kuang

slopes to the north, runoff is therefore directed towards the north. Groundwater flow direction is interpreted towards the north. The unnamed road is situated on a dike to the north of the site, separated by paddy fields. The soil at the site is young (entisols and inceptisols), formed on alluvial deposits and is used for residential purposes. One house with a well, small swamp/pool, kitchen garden and cattle are present. Approximately 100 m to the east a drinking pool for cattle is situated on-site.

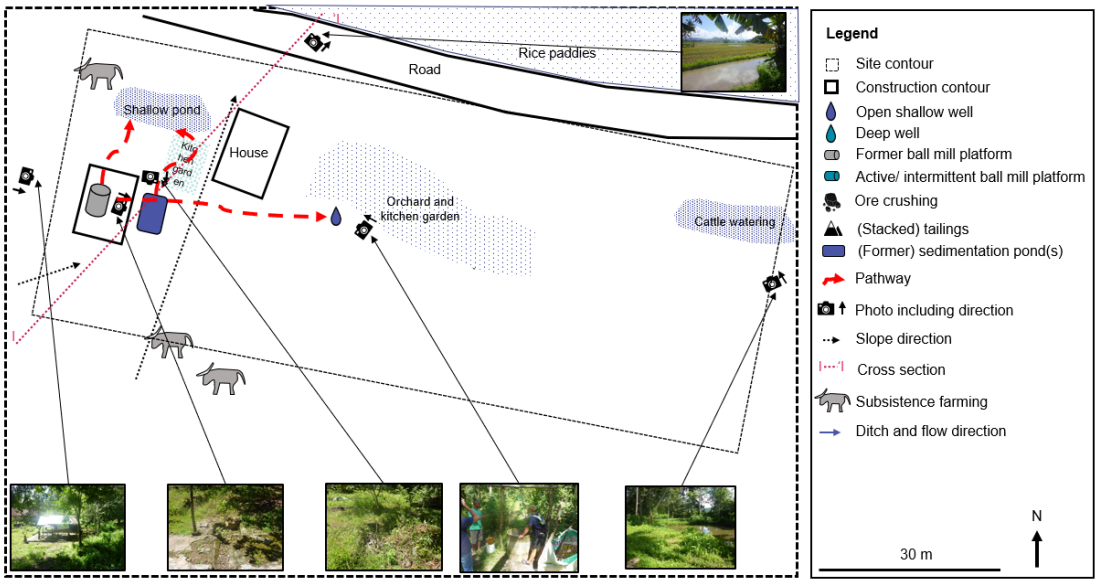
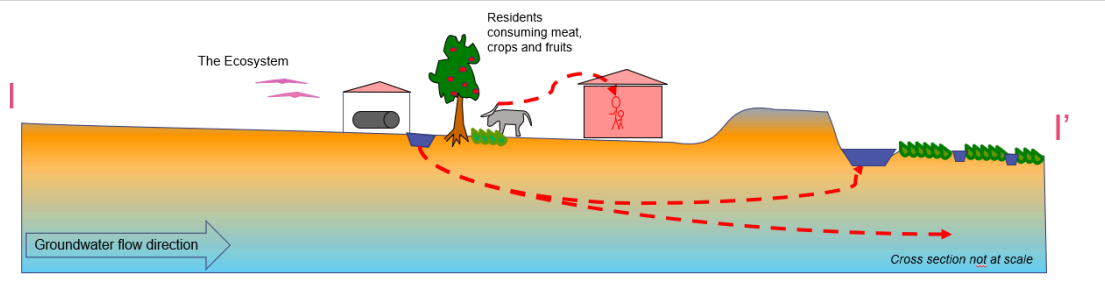
Figure 4.4: The ICSM of site 2-04-22 Site 1 southwest of the city centre of Kuang in West Sumbawa

Potential sources
The potential sources of the mercury contamination are:
- The contaminated topsoil around the former rod-mill location
- The sludge in the former sedimentation pond

Potential pathways
The potential source receptor pathways are:
- Direct contact with the contaminated topsoil
- Leaching of rainwater in the soil
- The groundwater, flowing to the northern direction
- Direct contact with the contaminated groundwater
- The spreading potentially contaminated topsoil by run off towards the river north of the site
- Spreading by wind of airborne contaminated fine soil particles
- Direct contact by consuming contaminated crops and animal product

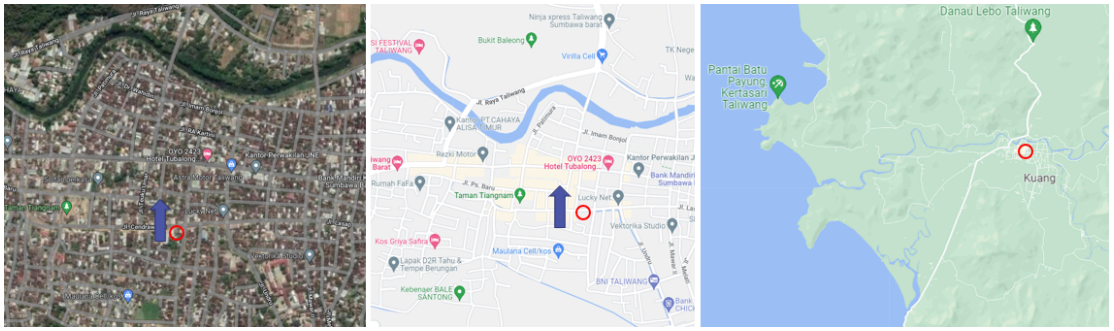
Figure 4.5: Site 02-04-2022 site 3 in Kuang, West Sumbawa

The site is located in the centre of Kuang of the Taliwang regency in West Sumbawa and approximately 7.5 km east of the Indonesia Ocean (Figure 4.4). The site is situated south to the road Jl. Cendrawasih and approximately 500 m south of a large meandering river. The terrain slopes slightly to the south, runoff is therefore directed towards the south, but groundwater flow direction is interpreted towards the north. The soil at the site is young (entisols and inceptisols), formed on alluvial deposits and is used for residential purposes, such as a house, shop, restaurant and kitchen garden. One well is situated on-site and multiple wells were identified at north, east, south and west of the site within a distance of 50 m. No animals were observed to be present o-site.
