Updated 5th April, 2017

Some MH370 Right Flaperon Separation Mechanics

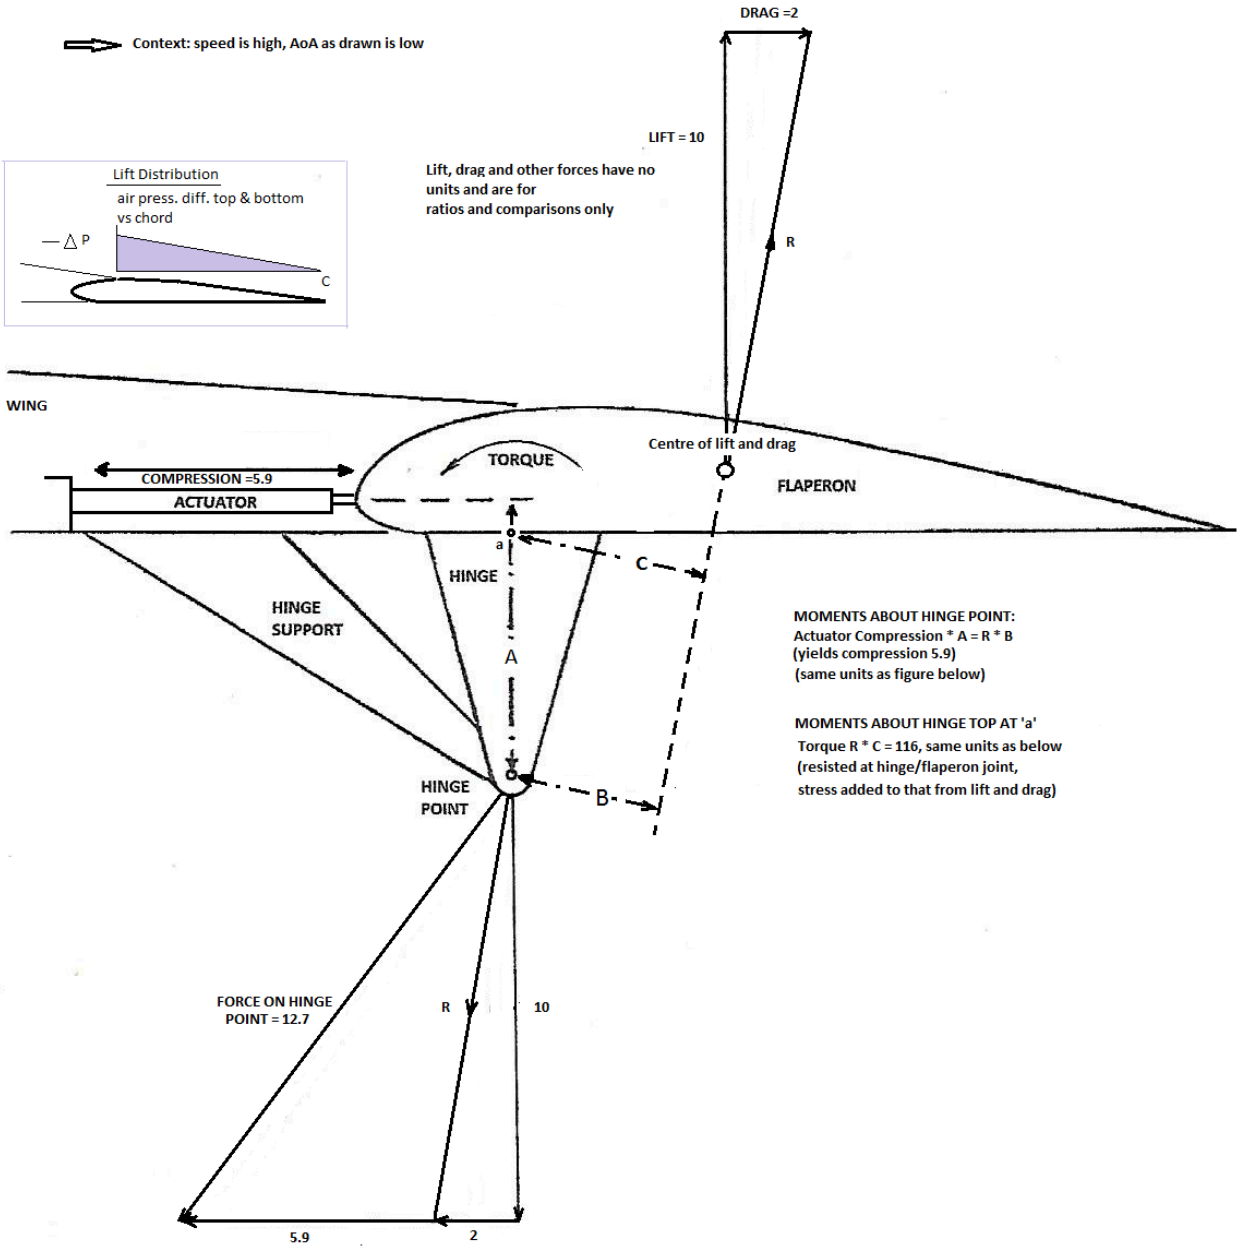
Below is a diagram of the normal loading experienced by a flaperon.

The drawing is intended to be representative of the actual flaperon, inboard end, its principal dimensions having been deduced from various depictions and photographs. The position of the centre of lift supposes (see insert) the lift to be highest where the flaperon is exposed to upper wing airflow towards its front. It is taken to be zero at its trailing edge and linear between the two. That leads to the centre of flaperon lift being almost 0.3 of its exposed length from the lift front.

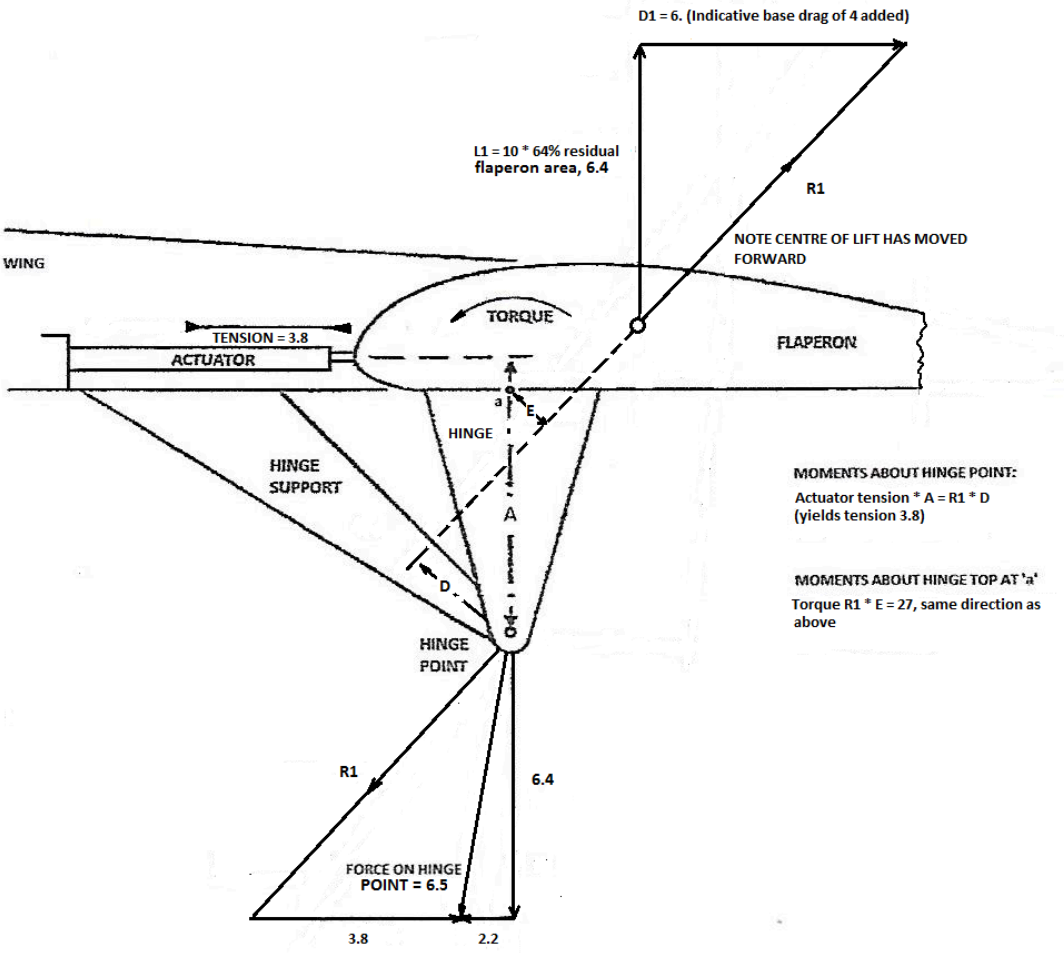
The second diagram below is of flaperon loading after loss of a representative portion of trailing edge.

The centre of lift has moved forward, remaining at almost 0.3 of the residual exposed length. The lift is reduced proportionately to its smaller area, other parameters being as before. Drag has been multiplied by an indicative three to allow for base drag at the break. The earlier lift drag ratio of an indicative 5 to 1 (high speed, low AoA) has been reduced accordingly.

Please notice that while the force at the actuator has decreased also, it is now in tension.
