Anatomy of a Power Inflator Failure

by Philip Bonds

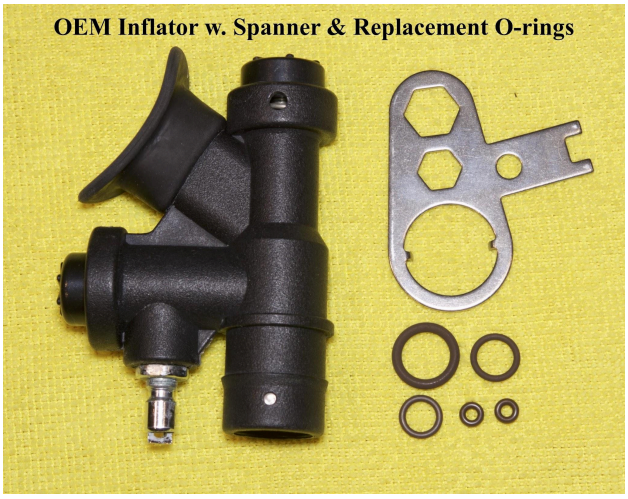
Here is my failed power inflator. It is a commonly used type of inflator on many different brands of buoyancy compensators and wings, and it is sometimes recommended as a replacement power inflator when OEM inflators need to be replaced. I cannot even guess how many years I used this inflator before it failed due to lack of maintenance. Some of you might recognize the model. It is simple and very reliable. Like most equipment, it is very reliable as long as it is not neglected.

While the inflation valve in my power inflator failed, the air dump valve continued to function very well. As a matter of fact, the manufacturer of this particular power inflator has never received a report of a dump valve failure on this model. My inflator valve was leaking air into my wing (BCD) at a fairly constant and rapid rate. The leak was filling my wing about every five to eight minutes. I was dealing with the leak by dumping air. Needless to say, this resulted in me burning through my air much more quickly than normal. An accurate assessment of the problem did not occur until we noticed my wing filling to the maximum on its own in one of the dive tenders after a dive.

Valve core disassembled. The inner parts control the air flow into the BCD or wing. Corrosion and bad o-rings are present.

All of the internal working parts of my failed power inflator could have been cleaned-up and new O-rings could have been installed. And, I could have done it myself rather than paying an equipment technician at a dive shop to do it for me. But, would it surprise you to learn that the company that makes my wing does not recommend servicing its power inflators? The company recommends replacement rather than service.

Recommendation of replacement is really no surprise since replacement may actually be more economical than service work. The new replacement power inflator on the right only costs $17.00 and it is exactly the same inflator as the failed inflator on the left. A service kit for my power inflator with all of the necessary O-rings and a spanner multi-tool can be purchased for $8.00. Of course, if one chooses service work over replacement, an equipment technician is going to charge for the service kit and the time it takes to do the service work. The bill for a service job is probably going to be more than the cost of a replacement.
