# CENTER FOR ECOLOGY & NATURAL RESOURCE SUSTAINABILITY

## **SITE 14**

### **Herrick Fen**

*Report Written By: Stephanie Deibel  
Date of Site Visit: 26 March 2013  
Date Finalized: 30 April 2013*

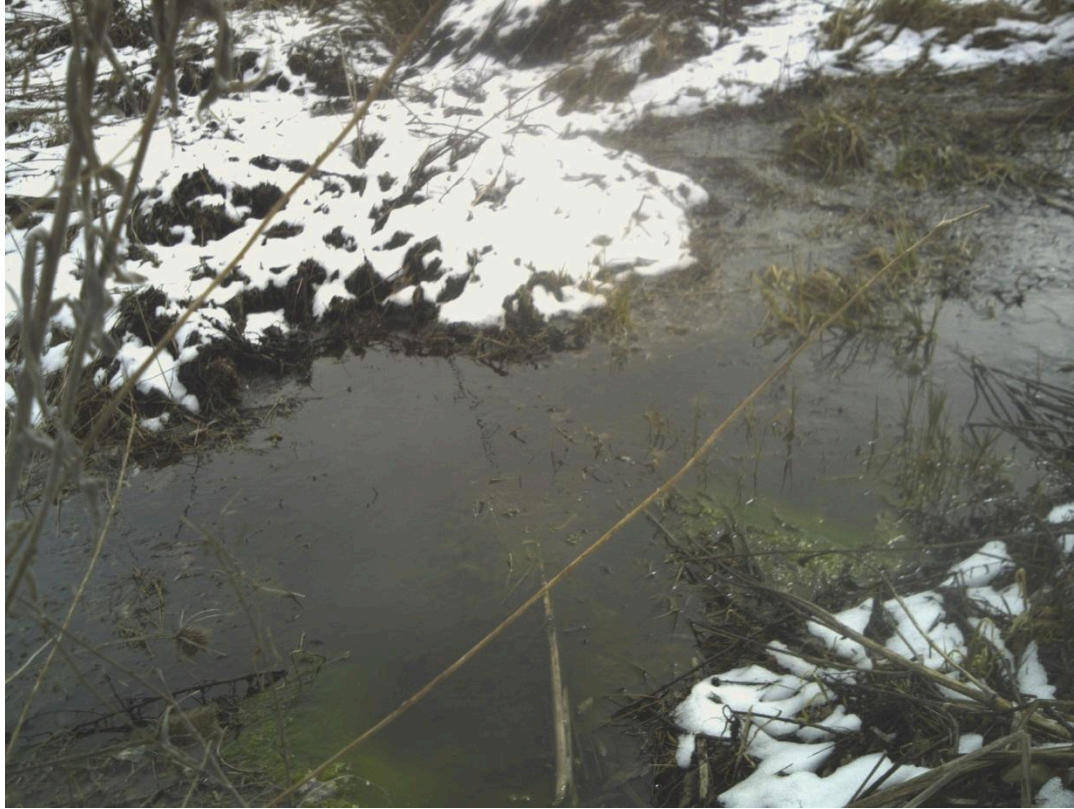
**S14-24:** *Shotgun Shell*

- Corner – Photo Point S14-21 – is not clearly marked. Open field habitat is to the north and shrub habitat is south of this point. A stream is located in the south direction.
- Corner – Photo Point S14-22 – can be found by a switch in habitat type. The area owned by Kent is open field, which is adjacent to shrub growth
- Algae – Photo Point S14-23 – bright green in color has a bubbly texture.
- Shotgun Shell – Photo Point S14-24 – was found at this location at time of visit.

- Having found a shotgun shell on KSU property, there may be some trespassing of hunters.
- Tire marks can be seen throughout the fen, which may have been created by someone who is not allowed on the property. Further investigation needs to be done to determine if the Nature Conservancy created these marks.
