## 16 Bayview Road

We were not given permission to scan the entire yard. We scanned the main line although we knew where it was from the valve system discovery. 14 Bayview Road Gas was tracked and it crosses into 16 Bayview Road and out to the road. It is 3' 9" below grade. Should not be an issue for a new service if/when needed.

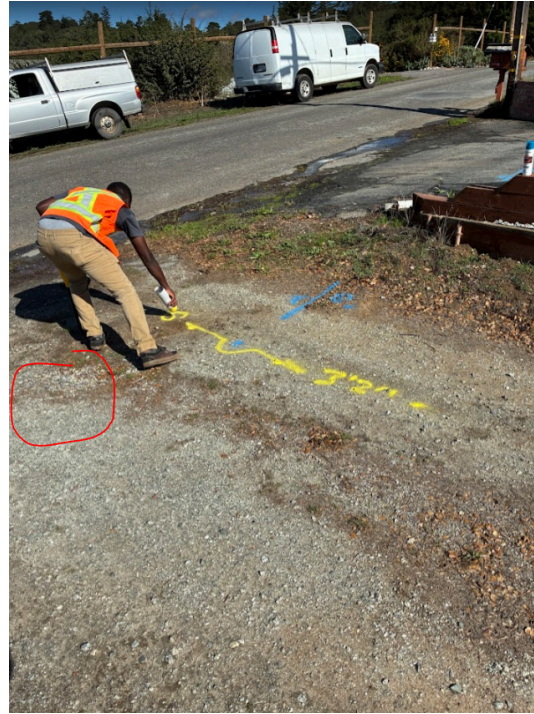
7'+ under the secondary driveway on the right side. Side. so deep the signal was dropped.
