Park Avenue Bicycle Audit

May 18th, 2025

Libbytown Neighborhood Association
Parkside Neighborhood Association
Portland Bicycle and Pedestrian Advisory Committee

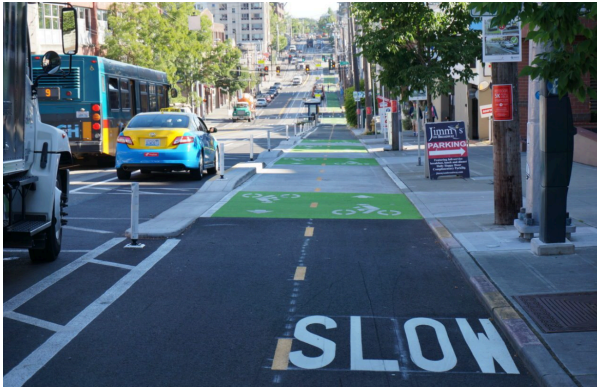
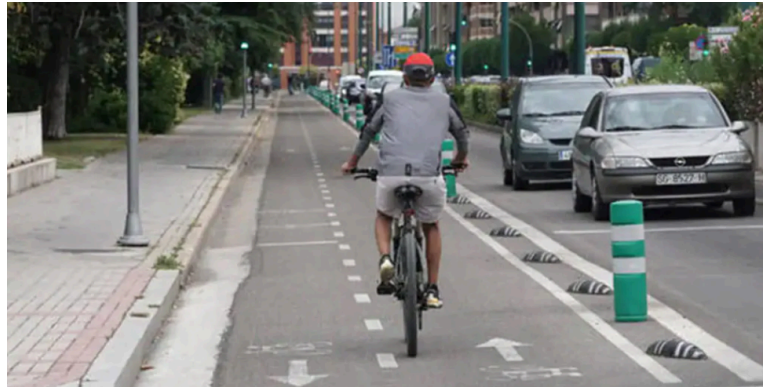
There are various types of bike lanes utilized around the world. One of those is a two-way bikeway that isolates and protects bicycles from vehicle movements (except at intersections). In terms of space usage within the right of way, this method provides some significant advantages over bike lanes on either side of the street.

Park Avenue in Portland offers an ideal opportunity to provide a comprehensive yet compact version of this concept.

We recommend that Portland plans for and develops a two-way bike lane from Preble Street to the planned traffic circle at Congress Street². Bike lane infrastructure should allow for travel between various parts of the city. One of the failures of the existing Park Avenue bike lanes is that they only run for a short stretch from High Street to St. John Street. The bike lanes should get significantly more use if they fed into more neighborhoods of Portland. An argument could be made that a two-way bike lane should continue on Congress Street all the way to the Westbrook line. The design's sudden end at Forest Avenue as Park Avenue becomes Portland Street contributes to the failure of this dangerous intersection.

Due to the two way operation, these lanes would need to continue to be parking separated. We are suggesting that it be installed on the north side of the street as it has far fewer impediments along the entire recommended route. This report leaves the road design to the actual designers of the infrastructure.
