# ***Draft MLK Corridor Rail Crossing Safety Review Technical Memorandum***

**October 2021**

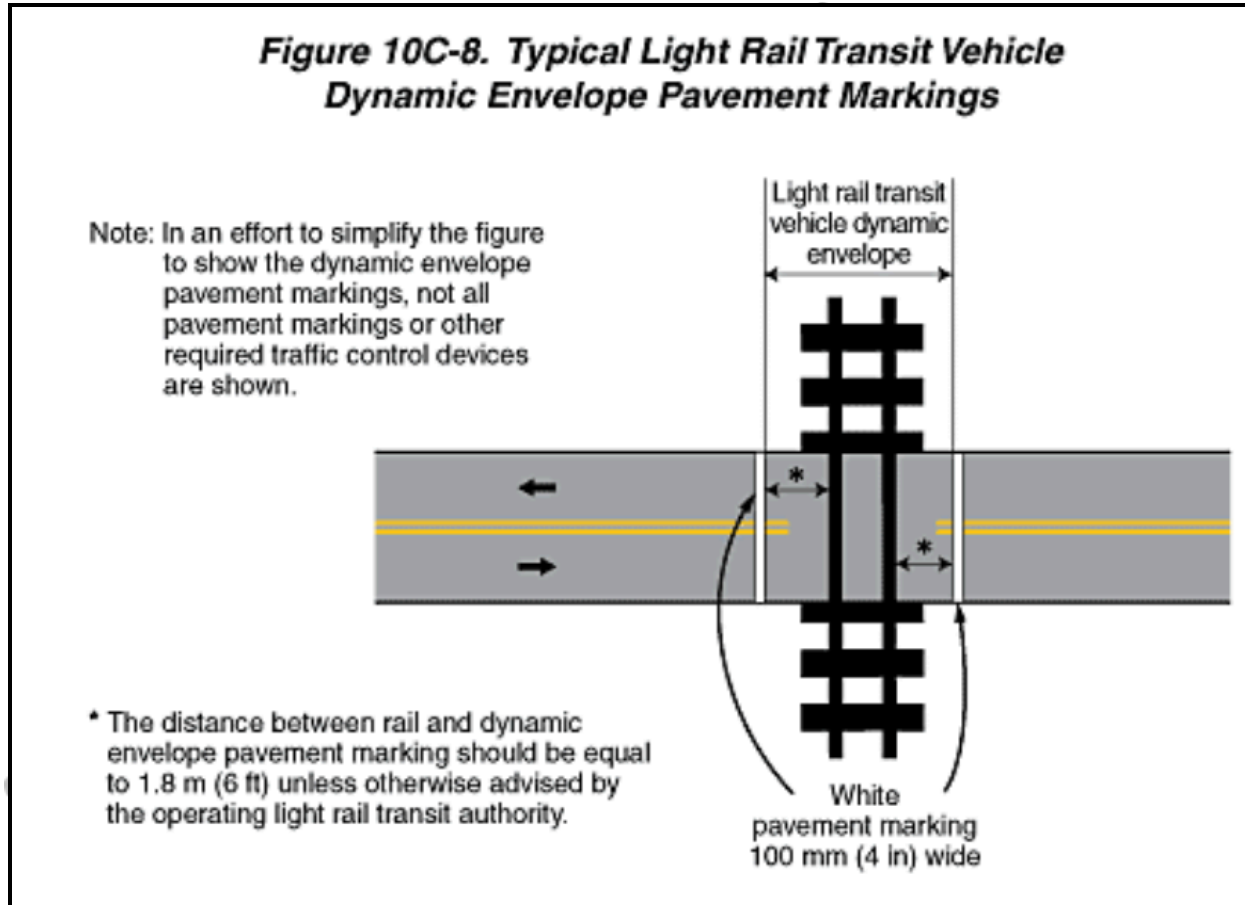
**Figure 4: Dynamic Envelope Pavement Markings**

The light rail/street crossings along MLK appear to originally have been constructed with a colored pavement material to distinguish the dynamic envelope from the surrounding street. However, over time, these markings have faded considerably, and the contrast is no longer as apparent. ST should consider having the dynamic envelope pavement markings reapplied at intersections along the MLK corridor.

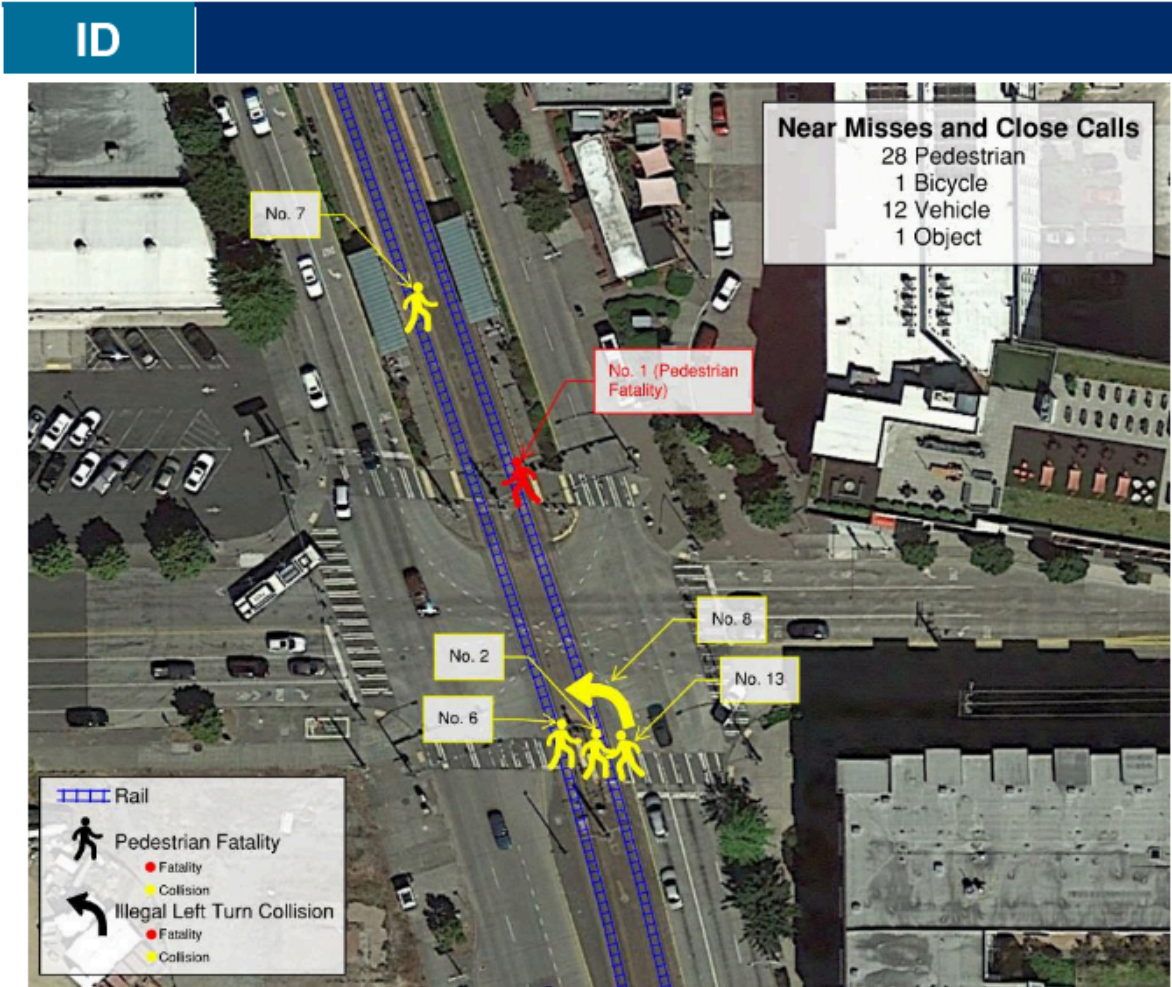
Crossing Safety Review

| Intersection Details | Potential Mitigation |
|---|---|
| <div>Traffic Conditions:</div> <ul style="list-style-type: none"><li>Designated NB/SB left turn lanes</li><li>LED Preemptive Training Warning sign on signal head in both directions</li><li>Crossing arms not present</li></ul> <div>Pedestrian Conditions:</div> <ul style="list-style-type: none"><li>Pedestrian signal present symbolizing TRAIN</li></ul> | <ul style="list-style-type: none"><li>Implementation of ped swinging gates</li><li>Increased pedestrian signage and pavement markings</li><li>Crossing arm installation</li><li>Installation of Z-crossing in northern crossing</li></ul> |

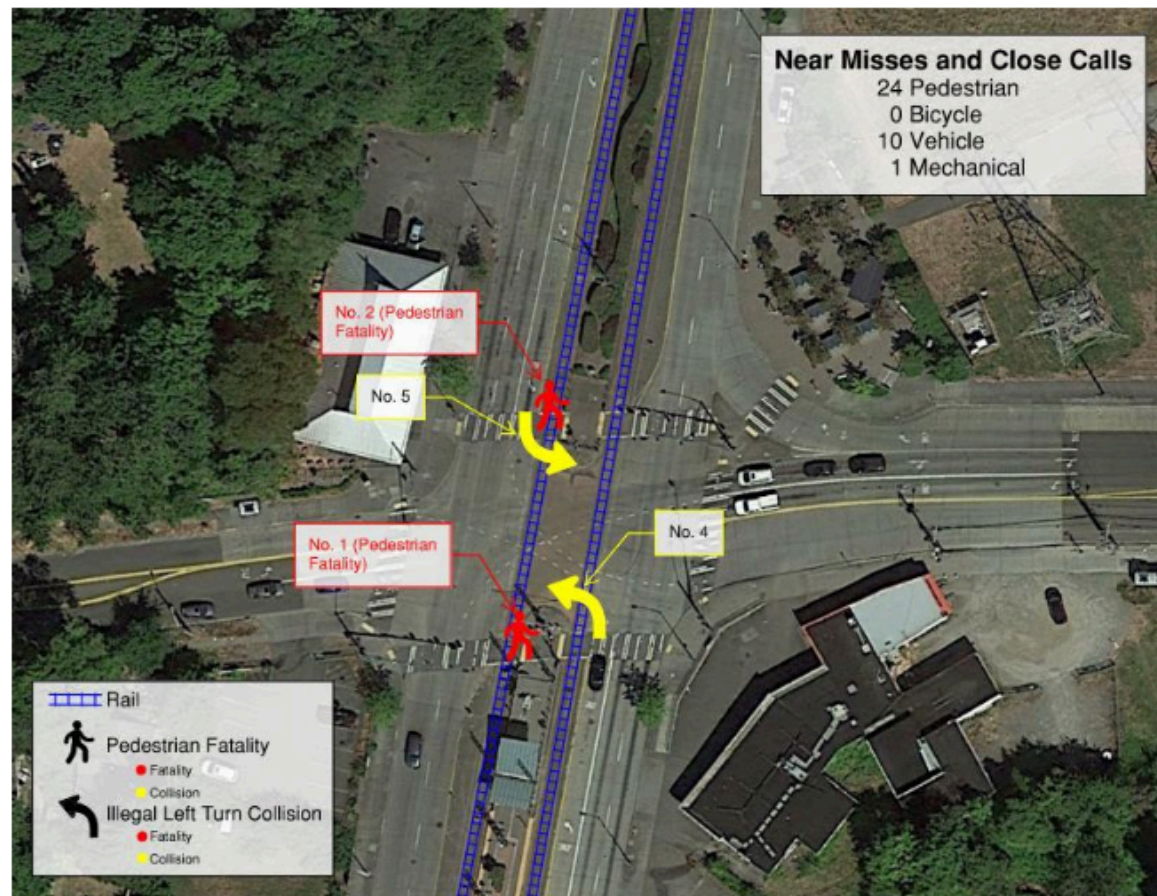
## Crossing Safety Review

- Implementation of ped swinging gates
- Increased pedestrian signage and pavement markings
- Crossing arm installation
- Installation of Z-crossing
- Dynamic Train Envelop Pavement Markings
- Rail safety ambassadors
  - In pavement lighting

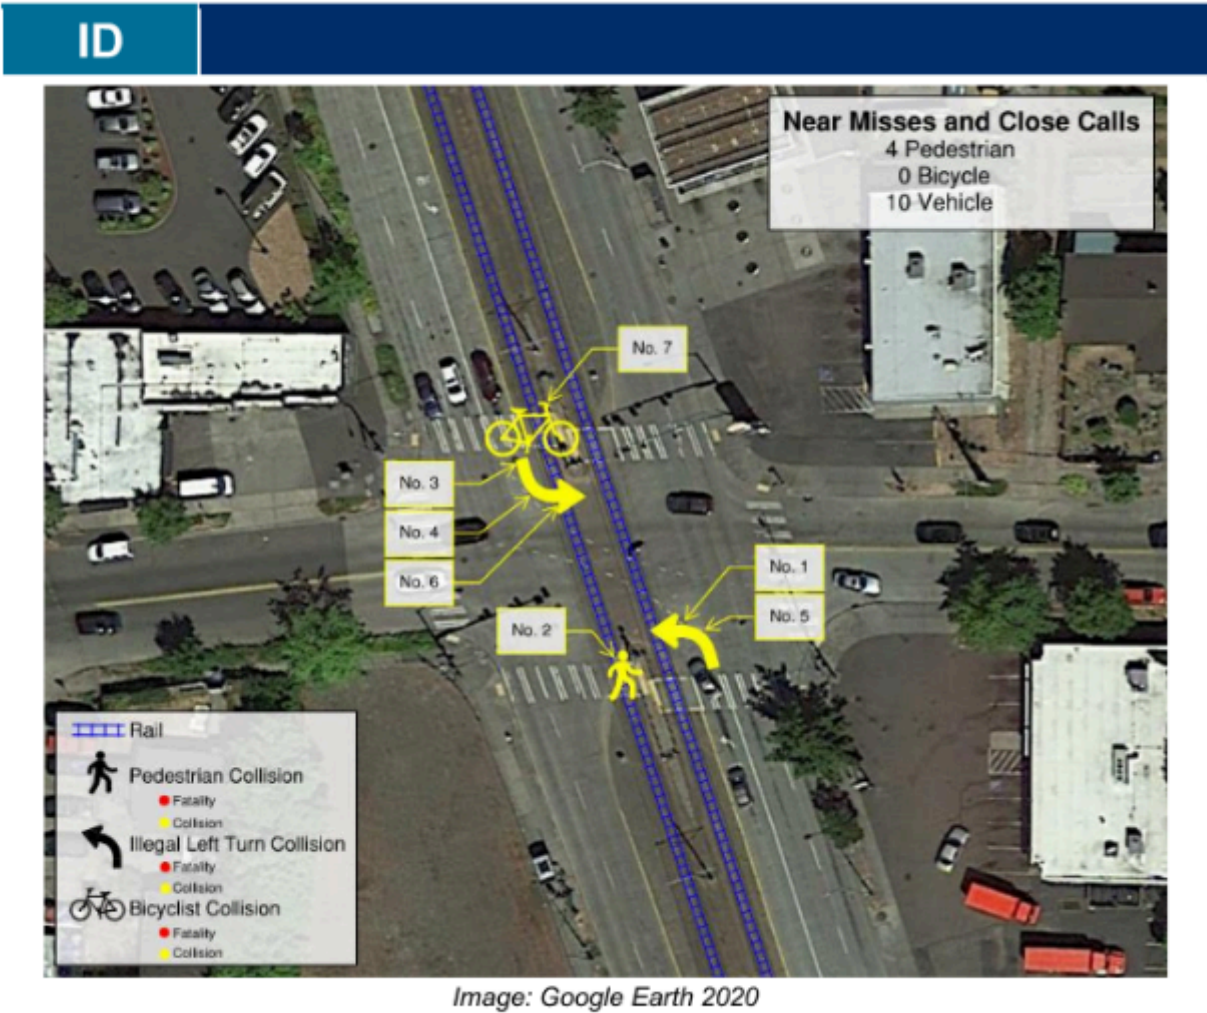
Crossing Safety Review

| Intersection Details | Potential Mitigation |
|---|---|
| <p>Traffic Conditions:</p> <ul style="list-style-type: none"><li>Designated NB/SB left turn lanes</li><li>LED Preemptive Training Warning sign on signal head in both directions</li><li>Crossing arms not present</li></ul> <p>Pedestrian Conditions:</p> <ul style="list-style-type: none"><li>Pedestrian signal present symbolizing TRAIN APPROACHING in the center island facing both directions (both crossings)</li></ul> | <ul style="list-style-type: none"><li>Implementation of ped swinging gates</li><li>Increased pedestrian signage and pavement markings</li><li>Bigger pedestrian holding area</li><li>Crossing arm installation</li><li>In pavement lighting</li></ul> |

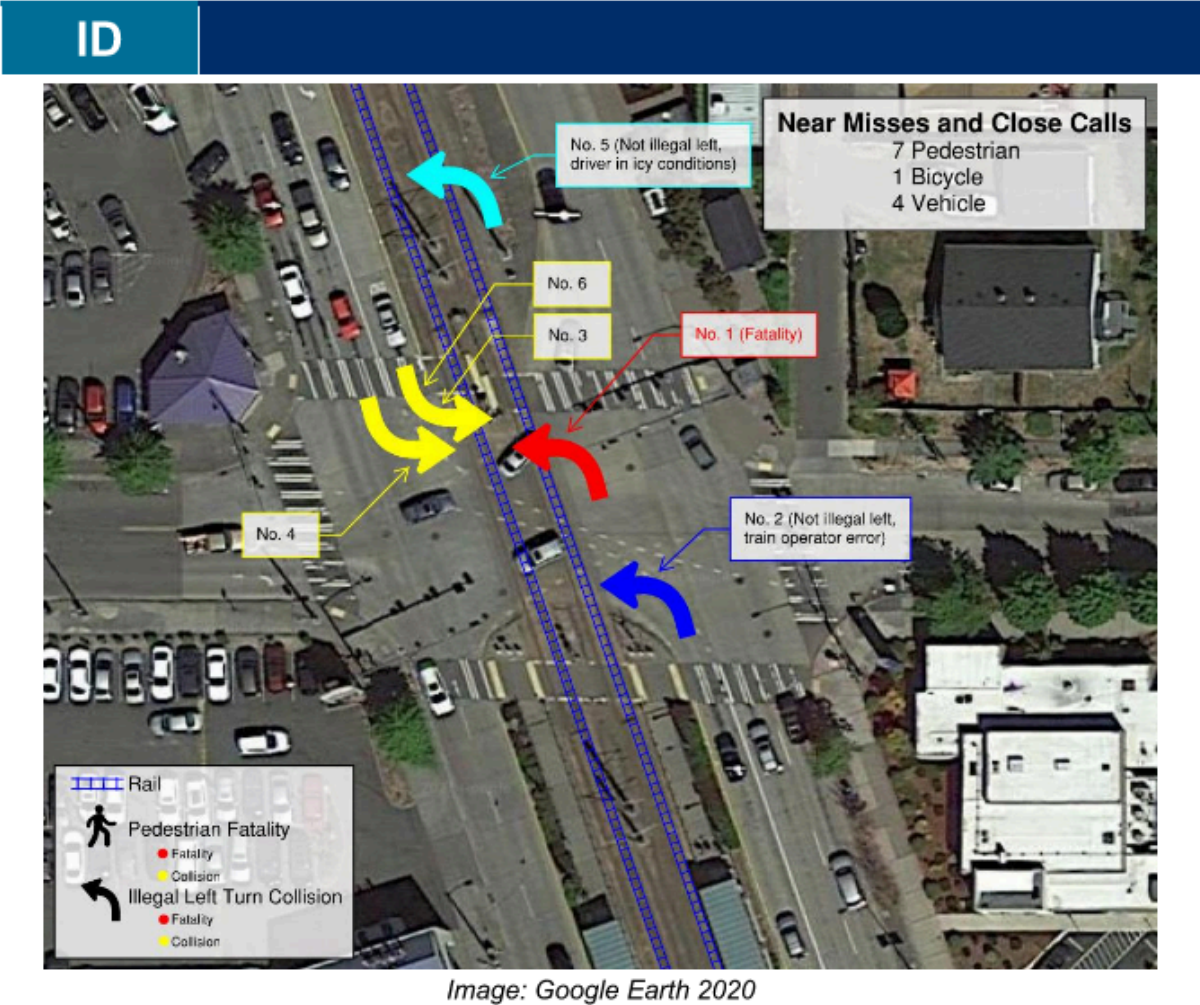
Crossing Safety Review

| Intersection Details | Potential Mitigation |
|---|---|
| <p>Traffic Conditions:</p> <ul style="list-style-type: none"><li>Designated NB/SB left turn lanes</li><li>LED Preemptive Training Warning sign on signal head in both directions</li><li>Crossing arms not present</li></ul> <p>Pedestrian Conditions:</p> <ul style="list-style-type: none"><li>Pedestrian signal present symbolizing TRAIN</li></ul> | <ul style="list-style-type: none"><li>Pavement warnings (retroreflective or rumble transverse rumble strips?)</li><li>Crossing arm installation</li><li>Bigger pedestrian holding area northern crossing</li><li>Z-crossing southern crossing</li></ul> |

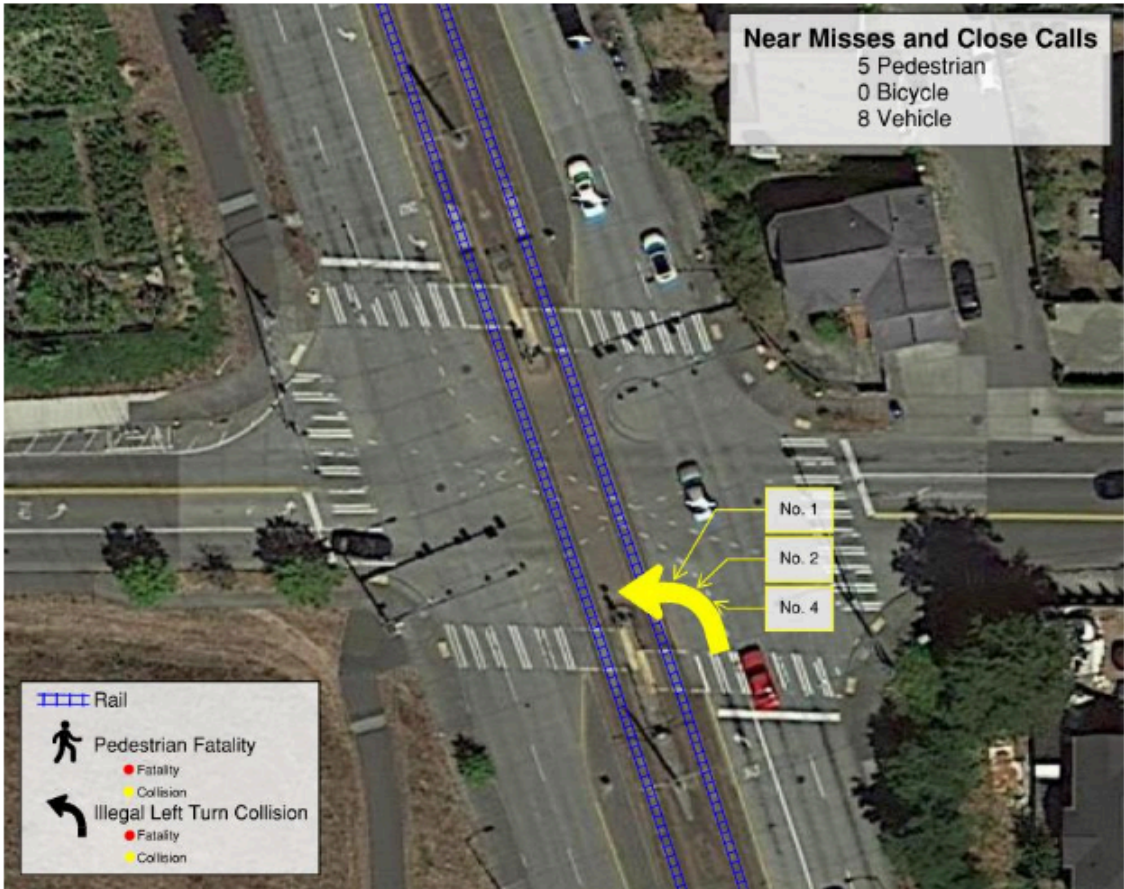
Crossing Safety Review

| Intersection Details | Potential Mitigation |
|---|---|
| <p>Traffic Conditions:</p> <ul style="list-style-type: none"> <li>Designated NB/SB left turn lanes</li> <li>LED Preemptive Training Warning sign on signal head in both directions</li> <li>Crossing arms not present</li> </ul> <p>Pedestrian Conditions:</p> <ul style="list-style-type: none"> <li>Pedestrian signal present symbolizing TRAIN APPROACHING in the center island facing both</li> </ul> | <ul style="list-style-type: none"> <li>Pavement warnings (retroreflective or rumble transverse rumble strips?)</li> <li>Crossing arm installation</li> <li>Bigger pedestrian holding area</li> <li>Implementation of ped swinging gates</li> <li>Increased pedestrian signage and pavement markings</li> </ul> |

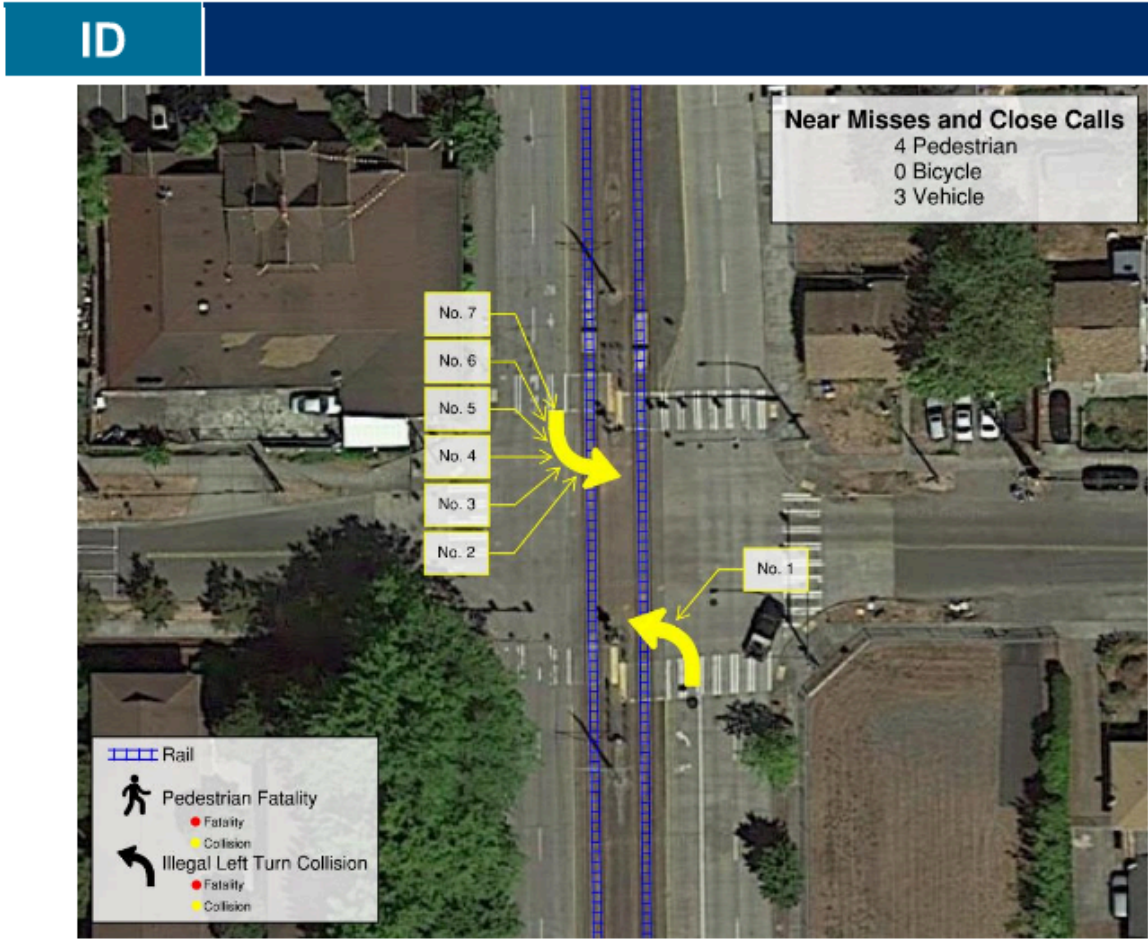
Crossing Safety Review

| Intersection Details | Potential Mitigation |
|---|---|
| <p>Traffic Conditions:</p> <ul style="list-style-type: none"><li>Designated NB left turn lane</li><li>LED Preemptive Training Warning sign on signal head in NB direction</li><li>Crossing arms not present</li></ul> <p>Pedestrian Conditions:</p> <ul style="list-style-type: none"><li>Pedestrian signal present symbolizing TRAIN APPROACHING in the center island facing both directions (both crossings)</li><li>7 crossing present (both crossings)</li></ul> | <ul style="list-style-type: none"><li>KCM Safety recommends speed reductions through grade crossings along the MLK corridor (outlined in KCM Safety Hazard Analysis of MLK Corridor)</li><li>Pavement warnings (retroreflective or rumble transverse rumble strips?)</li><li>Crossing arm installation</li><li>Bigger pedestrian holding area</li><li>Implementation of ped swinging gates</li><li>Increased pedestrian signals and pavement</li></ul> |
