**Report for Reconnaissance Archaeological Survey of the 17-19 Pinckney Street Well,
Boston (Beacon Hill), Massachusetts**

Joseph Bagley

2019

City of Boston Archaeology Program
201 Rivermoor St.
Boston, MA 02132

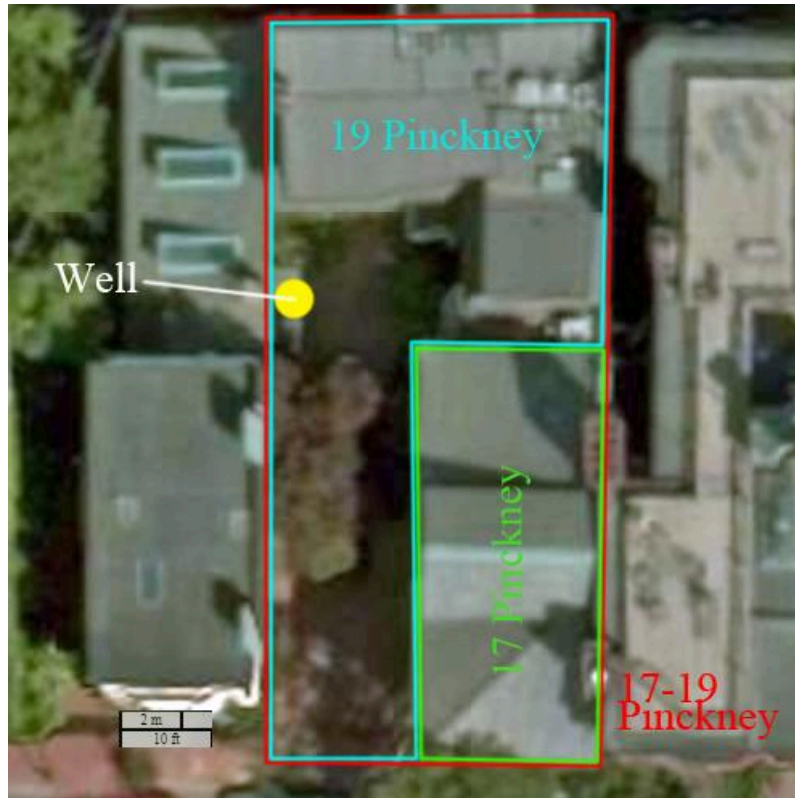
The well was located adjacent to the western edge of the property, likely abutting the actual property line of 19 and 21 Pinckney Street. It was located between 2 and 3 meters south of the western/northern addition to 17 Pinckney Street, a white wooden structure today numbered 19 Pinckney Street. Today, the courtyard to the west of 17 Pinckney and south of 19 Pinckney Street is owned by 19 Pinckney Street owners but the two properties would have been historically the same owner during the period of the presumed use of the well (Figure 19).

Figure 19- Property map showing ownership of 17-19 Pinckney Street at time of survey. 17 Pinckney street property indicated in green outline, 19 in blue, and 17-19 in red. Well (yellow) shown to scale (4 feet wide) on property of 19 Pinckney St.
