### Home Inspector 4

#### Crawl Space - Structural Defects, Insulation Defects and other fraudulent Omissions

## **Crawl Space Structural and Insulation Defects - \$4,358 for structural and \$2,000 for insulation**

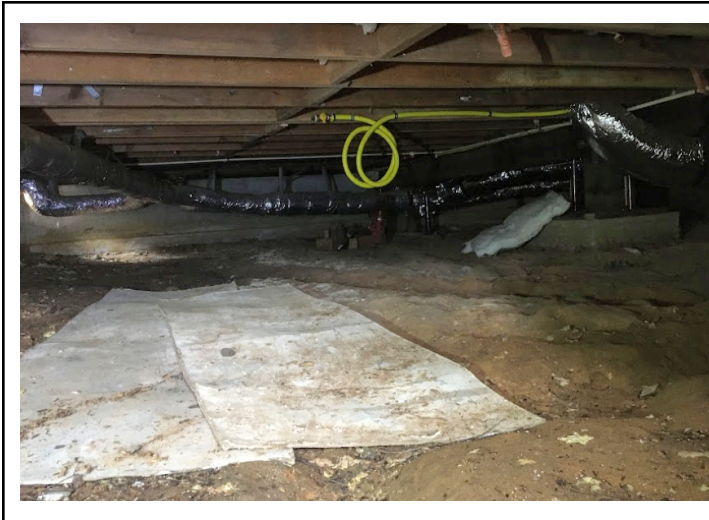
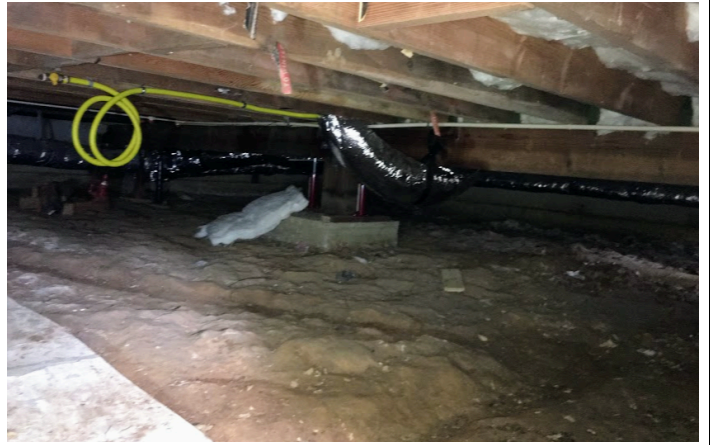
### Center Post Dryrot and Structural Defect Details

The post had clear signs of dry rot visible from 15' away

- 1) The flood line that corresponded with the line on the walls
- 2) After close of escrow, the home was jacked up by 3/4" to correct the fall from dry rot
- 3) After close of escrow jacks were installed to support the home in the event of further main post deterioration

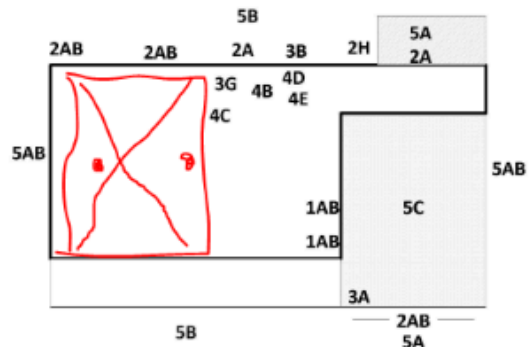
### A Proper Sketch for example

The red X is uninspected crawl.

The two dots represent locations of dry rotted support columns
