FRACTURE ANALYSIS OF A 1994-1997 HONDA EXHAUST MANIFOLD

Authors: Caleb Leavitt, Mariko Belle Liwag, Vivian Mac, Wyatt Taylor

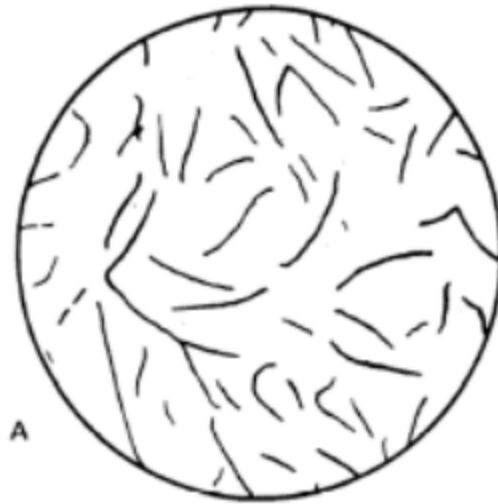
These manifolds are usually casted as seen by the microstructures seen in Figures 4 and 5. These result in the typical cast iron microstructure with graphite flakes which form during solidification in an austenite matrix (Figure 9). Silicon is alloyed to promote graphite formation to yield low ductility, moderate strength, and high thermal conductivity. The wear and abrasion resistance of gray cast irons usually depend on the microstructures.

Figure 9: The preferred graphite flake structures for gray cast iron.
