# GRAND CANAL TWO-WAY CYCLE TRACK REVIEW

# RATHMINES ROAD (PORTOBELLO) TO GRAND CANAL STREET LOWER

1st July 2013

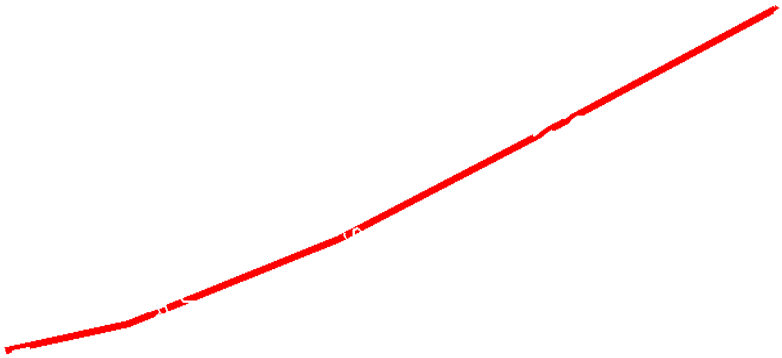
**Fig 2 - Section of route inspected and key bridge junctions**

The section of the route inspected and the Bridge junctions monitored are shown in Fig 2 below, i.e. all junctions between Portobello Bridge and Lower Grand Canal Street Bridge.

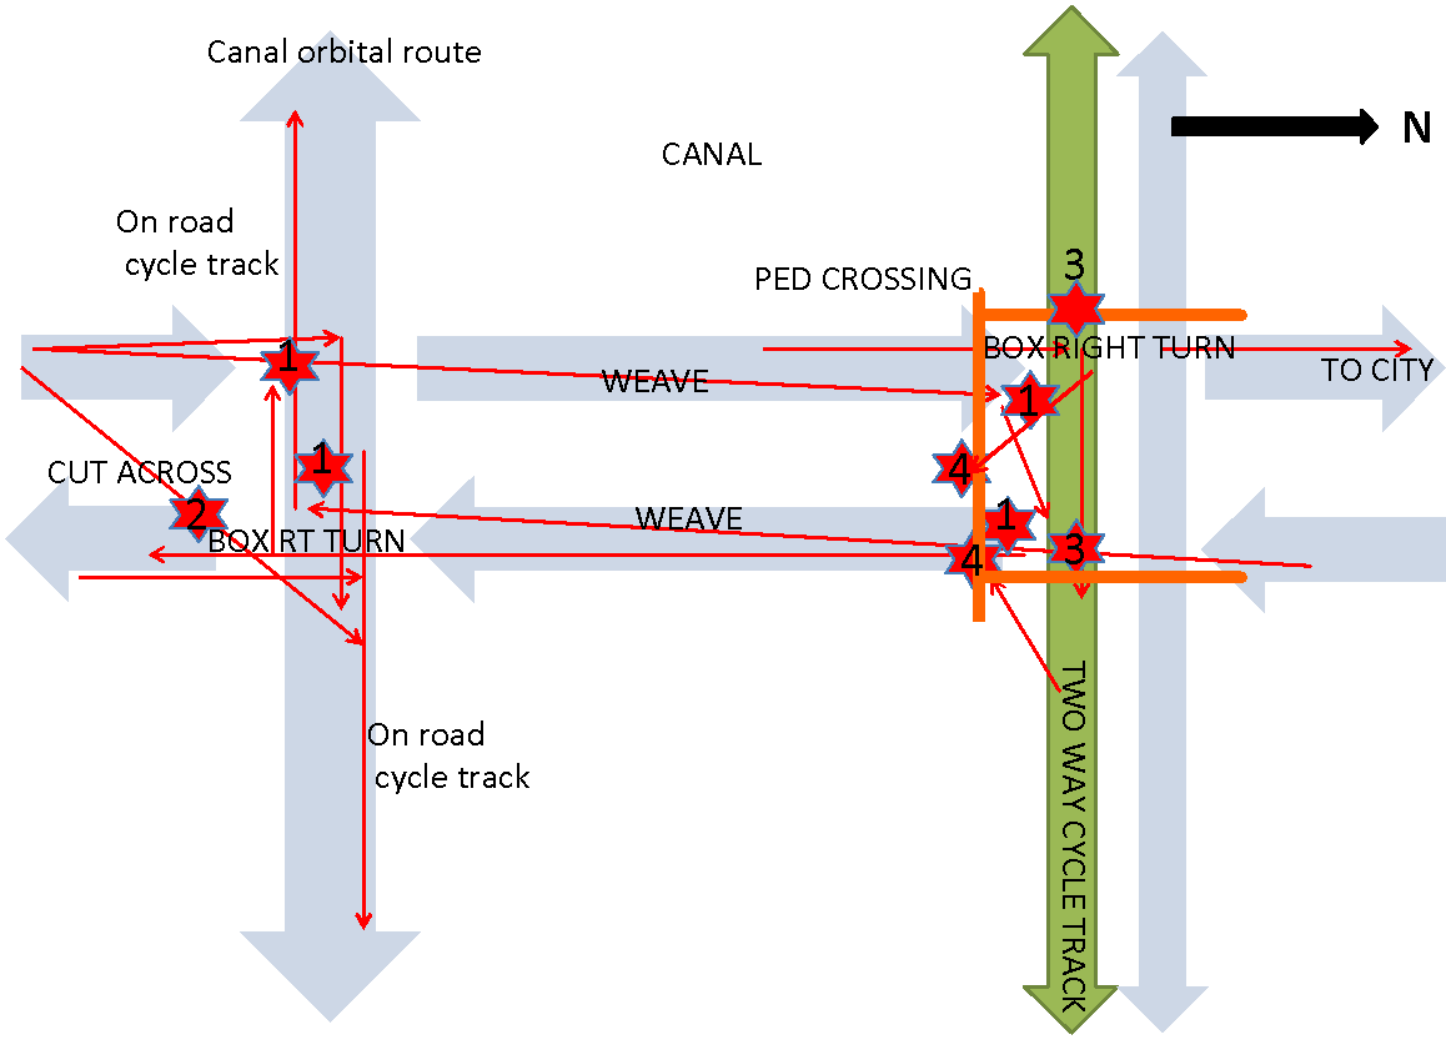
**Fig 8 – Conflict Diagram**

Figure 8 below identifies the potential conflicts observed. One is as a result of a cycle weaving maneuver to turn right into the cycle track, the other is a direct cut across the traffic lanes by a cyclist to access the cycle track from the footpath and the third is a pedestrian /cycle conflict at the signalized pedestrian/cycle crossings with pedestrian movements across the road and cyclists turning left and right to/from the cycle track.

If one looks at the likelihood of occurrence of a conflict and its severity we can surmise that the highest risk and most severe conflict is probably cyclists on the main radial roads cutting across or weaving across traffic lanes and holding (in the middle of the bridge) to turn right into the two way cycle track, when there is very limited space on the bridge for the exposed cyclist to hold and wait for a gap in the opposing traffic. The other conflict identified i.e. cyclists turning through the pedestrian crossing would not be considered to be high risks as speeds are low and visibility between the cyclist and pedestrian is good.

*Essentially there is a problem of space on the Canal Bridges to segregate all movements. Some movements must therefore mix and conflict. All the movements are under the control of signals and one cannot design for illegal movements, which are also occurring, ie breaking of the red cycle and pedestrian lights.*

| **Conflict Type (ref diagram 5.0)** | **Frequency (observed – to be validated)** | **Potential Outcome (e.g. v. serious, serious, minor..)** | **Risk** | **Design Solution / Mitigation** |
|---|---|---|---|---|
| **Veh/Cycle Conflict**<br><br>TYPE 1 :TURNING RIGHT FROM MAIN ROAD TO TWO WAY CYCLE TRACK<br>Cyclist weaving from extreme left to two-way facility on far right (fig 6)<br>or<br>taking stationary position mid bridge between two opposing traffic streams (fig 5) | **Very frequent** | **Serious** | **High** | **Encourage "left to go right: by creating Box Turn space** |

| **Veh/Cycle Conflict**<br><br>Type 2 – ESSENTIALLY SAME AS 1 ABOVE BUT USUALLY BY RISK AVERSE CYCLIST<br>cyclists cutting across into opposing traffic prior to bridge to access on road cycle track | **Infrequent** | **Serious** | **High** | **Encourage "left to go right" by creating Box Turn space** |
| **Cycle/Cycle Conflict**<br><br>Type 3: CYCLISTS BLOCKING ENTRANCE TO CYCLE TRACK- Cyclists stacking in both lanes of cycle facility, precluding cyclists from entering .. | **Frequent** | **Minor – due to low speeds** | **Low** | **Cyclists are not stacking correctly behind holding lines for signals or on the correct side. Holding lines should be moved forward and more stacking space created.** |
| **Ped/Cycle Conflict**<br>Type 4: PEDESTRIANS CROSSING BRIDGE ON "GREEN MAN" – Cyclists turn through crossing pedestrians (fig 9) | **Very frequent** | **Minor due to low speeds** | **Low** | **Not much can be done but the flashing amber lights help. Recommend changing to Toucan crossings for consistency** |
