## Journal 08

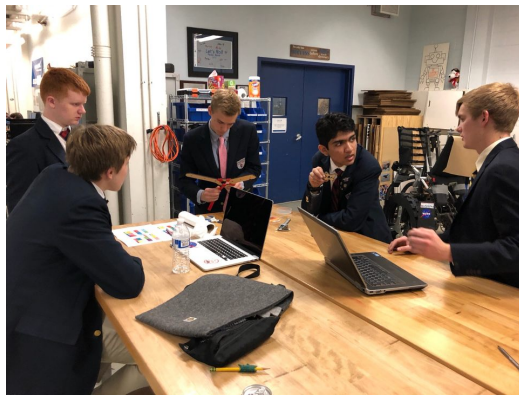
- Experimented w/ tolerances on chainring adapter, brake mount, and flanges
  - Narrowed all tolerances

- Published steel-steel tolerance = 0.005", actual determined to be 0.002-0.003
- Attached freewheel bearings to freewheel adapters
- Mounted two wheels w/ new flanges to freewheels and to axle
- Freewheels work properly - drive in one direction, slip in the other
- All left-thread freewheels go on left side of wheels, all right-thread on right side

The tolerances on the parts were modified because, after cutting them on the laser cutter, we found them to fit too loosely onto the axles. A tighter fit is desired to reduce play and shifting during use. The published steel → steel tolerance seems to high, but that may be due to inaccuracies in manufacture of the shafts. The freewheel bearings were attached to adapters, and

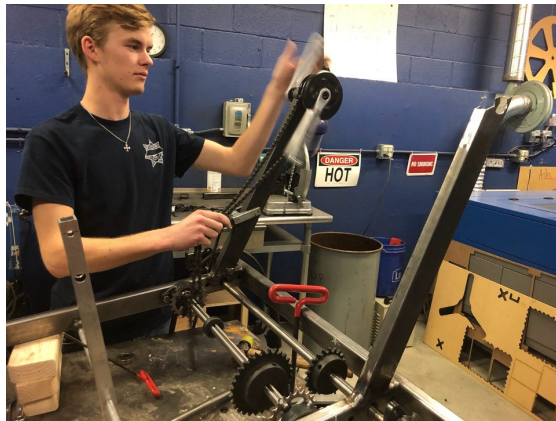
- Checked chainring adapters for fit - it seems steel tolerances can be less than 0.002" or that the fabrication was not accurate to 0.001"
- Ground surface of seat brackets to remove them
  - Eventually, Micah used a mallet and a cutting blade to remove the seat brackets
  - Seat fits onto seat brackets
- Used dremel to slightly modify lever for steering to fit properly
- Fit as many freewheel bearings as possible into flanges and bolted together, but there is a shortage of nuts for the bolts
- Hammerschmidt assembly
  - Welding of ISCG-05 tabs to bottom bracket shell produced bubbling on inner threads
  - Solved by using a dremel to get rid of threads in the bubble location
  - With force, bottom bracket threaded onto shell, but spacers were required
  - Entire assembly put together after replacing 24T chainring w/ 22T
  - Entire assembly works - idles backwards, drives forwards

- **Problem: Right side hammerschmidt chain will output to the outside of the frame. Need to add small, 5"x5/8" axle to pedal bar on right w/ two chainrings to transfer chain from right side of pedal bar to left to prevent chain from going to outside of frame rather than inside**
- Attached common axle w/ roller sprocket 30T and two chainrings 22T

This was, as expected, a highly productive day. All components are properly fitted, but the tolerances are looser than expected, and a caliper measurement showed that they are truly looser than they are in the drawing. After slight modifications, both the steering control lever and the seat brackets are fully functional. However, there seems to be a lack of the nuts used to hold on the freewheel bearings. Why that is I do not know, but we may need to order extras. The hammerschmidt mounting initially seemed to be difficult, and was further complicated by the bubble on the threads of the bottom bracket shell, but after that one issue, the rest proceeded smoothly and without incident. However, in order for both to be fully functional, it will be necessary to add a second axle to the pedal bar on the right side of the rover to transfer the chain to the opposite side of the pedal bar. The common axle is fully functional. The steering system is, as well, fully functional with the exception of the wheelboxes. The rest of the system works well and without resistance, and confers a mechanical advantage by the point of the steering control lever.
