# iCube Ultra Firmware Upgrade Guide

**Tutorial Overview:** This tutorial addresses the issue of cable spring-back during iCubeUltra operation, which causes positional offsets during engraving. By upgrading the firmware according to this guide, the system locks the motors for 5 seconds after detecting motor movement, effectively mitigating the offset caused by cable spring-back.

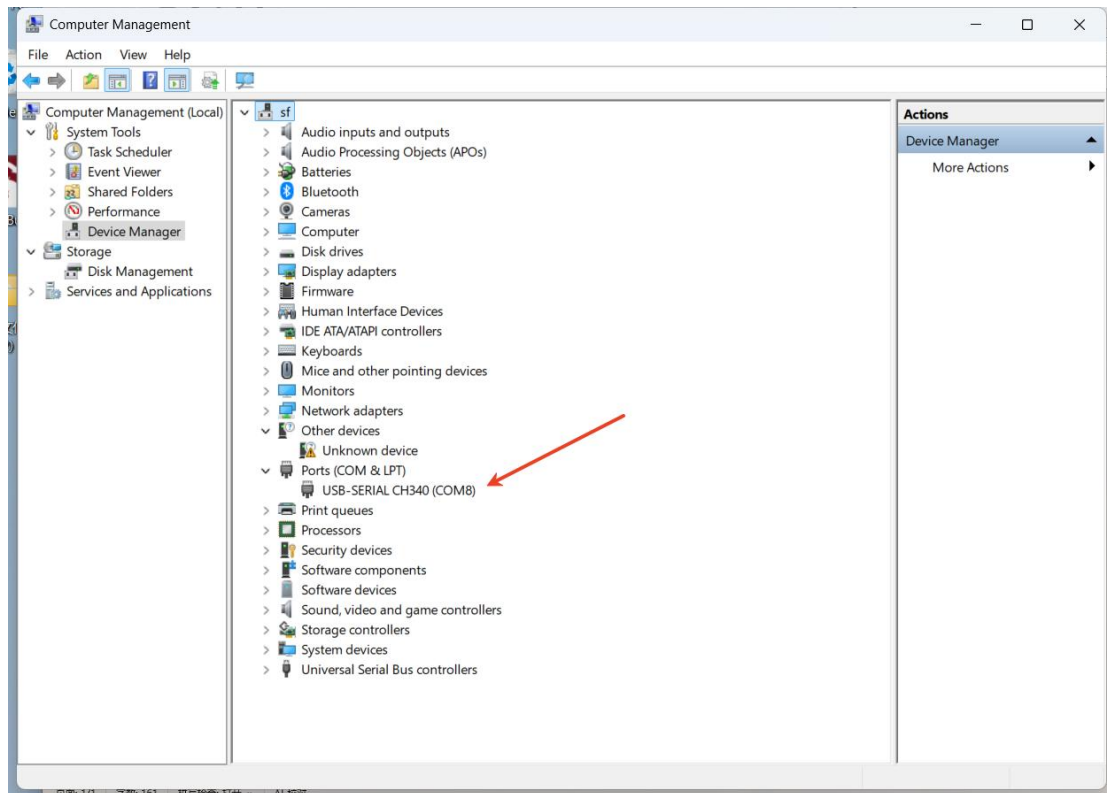
1. Power on the iCube Ultra and connect it to the computer; check the COM port assigned to the CH340 via Computer Management.

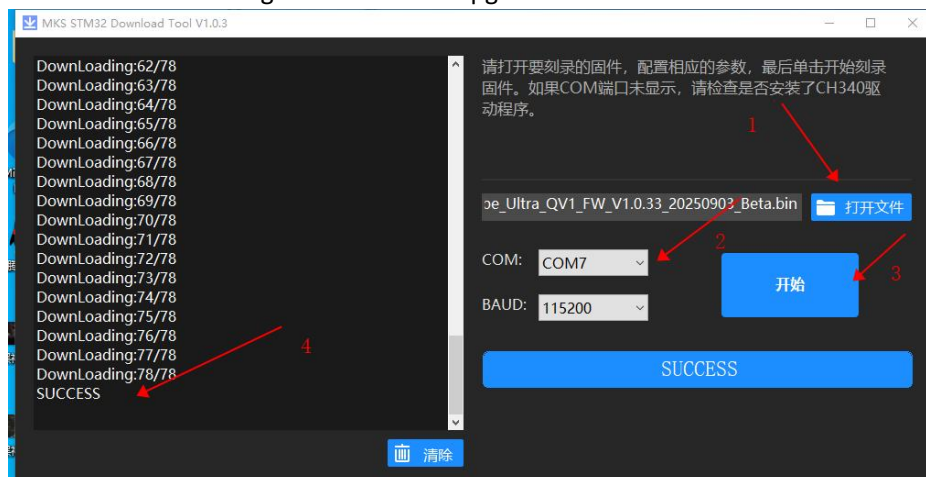
3. Select the firmware to be flashed and the COM port corresponding to the iCube Ultra, then click "Start" to begin the firmware upgrade.
