Without a working crank position sensor, the ignition system can't tell whether your SAAB's engine parts are rotating or the relative position, and won't fire the spark or run the fuel pump. You end up dead in the water with an engine that turns over but doesn't start. This specific sensor (#7484546) is used on both SAAB's 9000 and non-turbo 900 models from 1989 until Trionic 5.5 was introduced in 1994. The complete sensor assembly is not available from SAAB, but I've tracked down the OEM sensor so you can replace the sensor yourself and reuse your old wiring and housing.

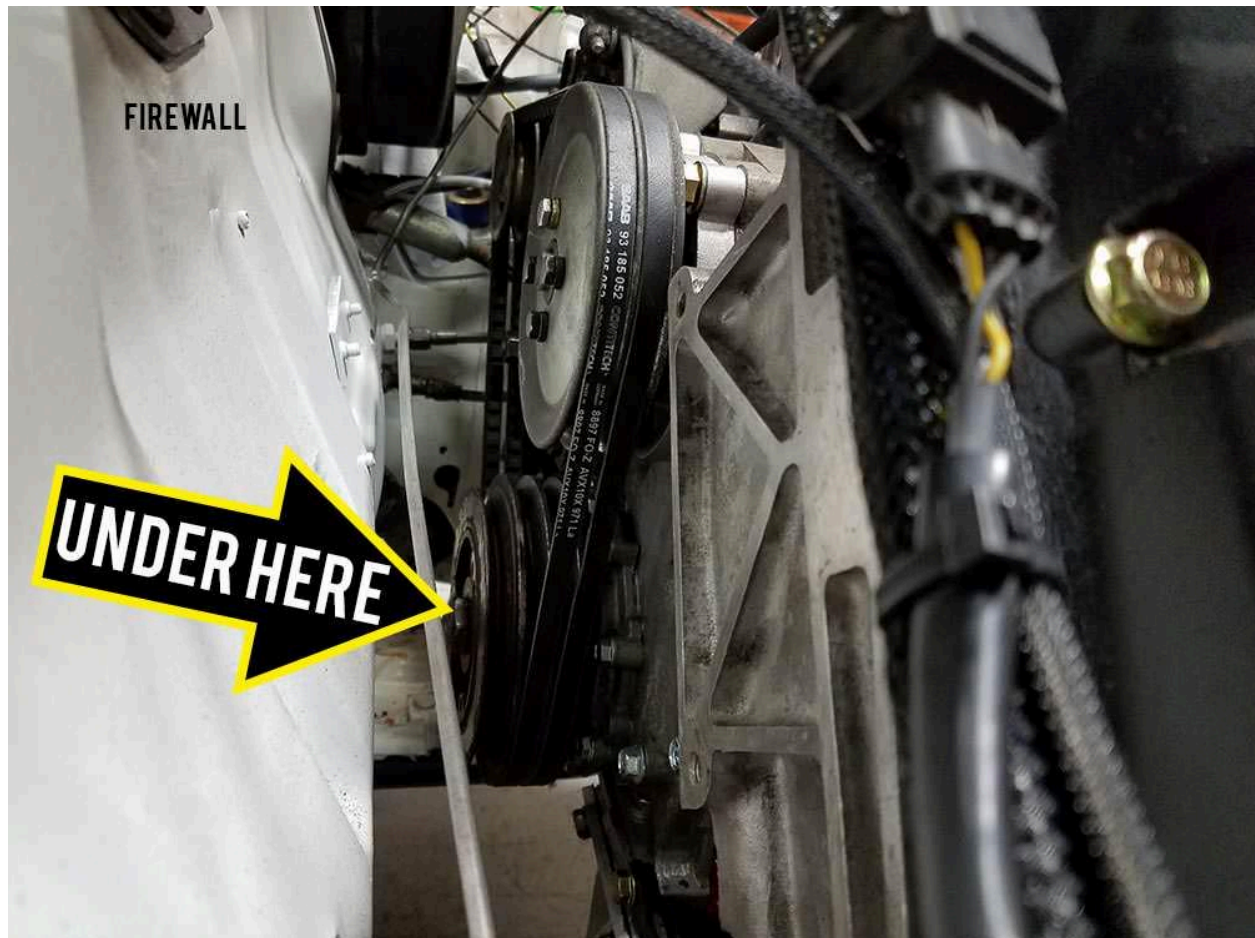
Now I just happen to have a classic 900 oil pump housing which holds the sensor up against the crank pulley, but in your cars you'll need to remove your crank pulley to get access to these parts. Depending on if this is for a 900 or 9000, this process is a little different to get the pulley off, but once you remove it, you'll be staring at this on your engine.

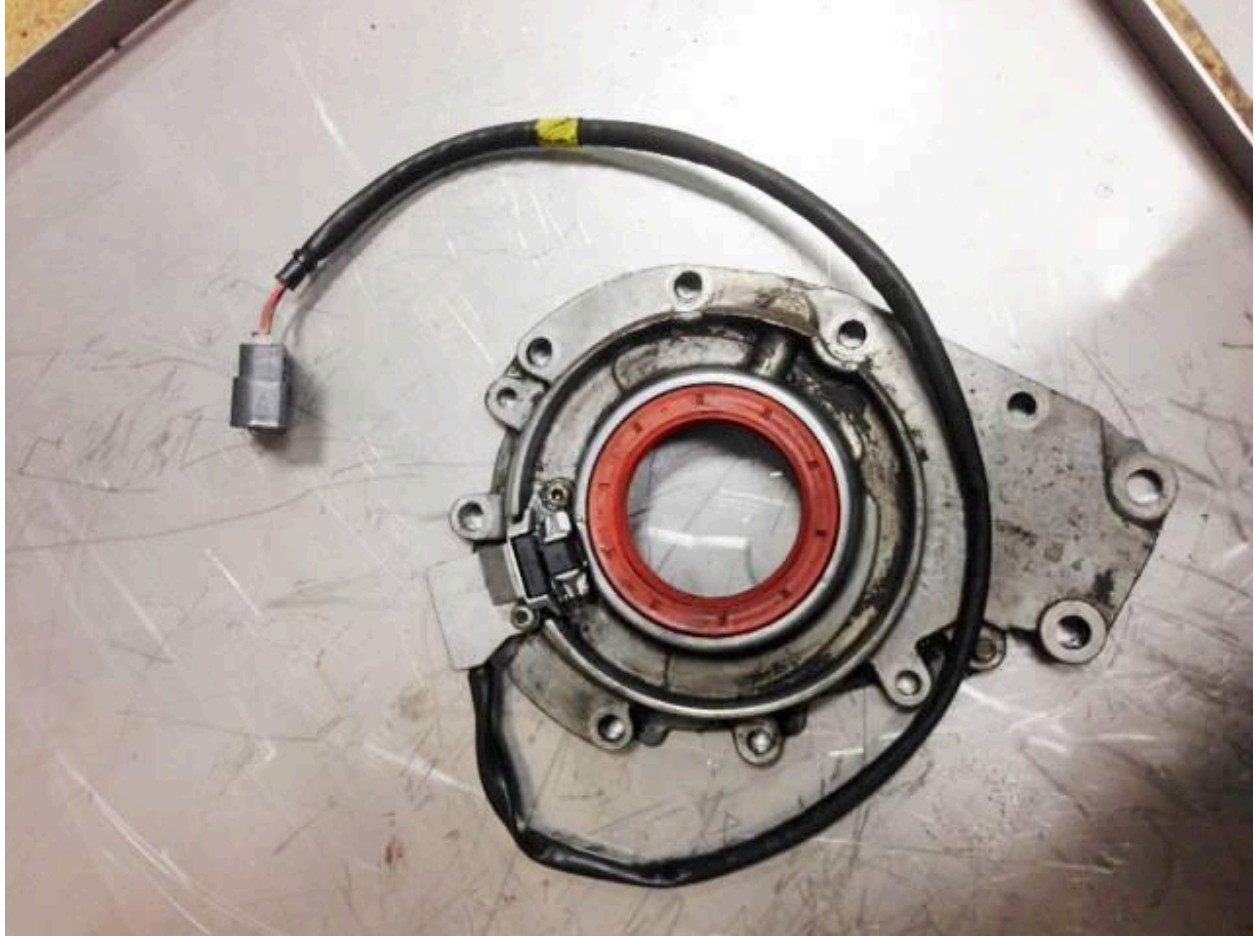
To remove the sensor, unscrew the two T20 torx screws holding it to the oil pump housing. Once these are removed you can unplug the sensor and remove it from the vehicle.

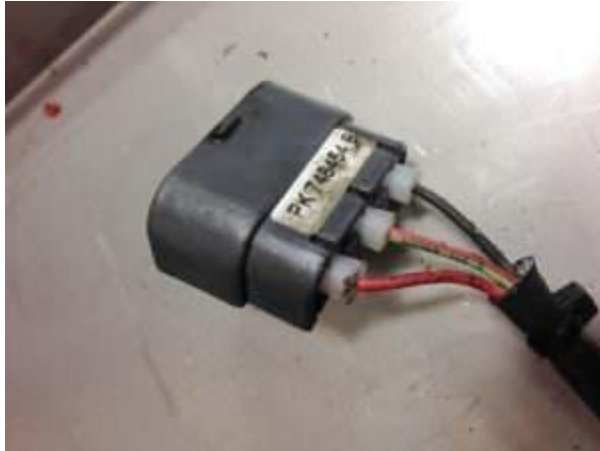
Once you have the sensor on the bench you'll notice that it has a nice silicone-infused fiberglass wrap around it. This serves as a heat shield and insulator and you'll want to keep as much of it as possible. After you cleaned all the years of engine gunk off the housing and wiring take a quick look over the rest of the parts just to make sure that nothing else caused the sensor failure besides old age. If the harmonic balancer has separated , it can take out the sensor and engine oil pump housing in a short time. A leaky crankshaft (front main) seal can contaminate the sensor with dirt and build up as well so it's best to make sure all these parts in your SAAB's engine are in good condition before completing the repair.

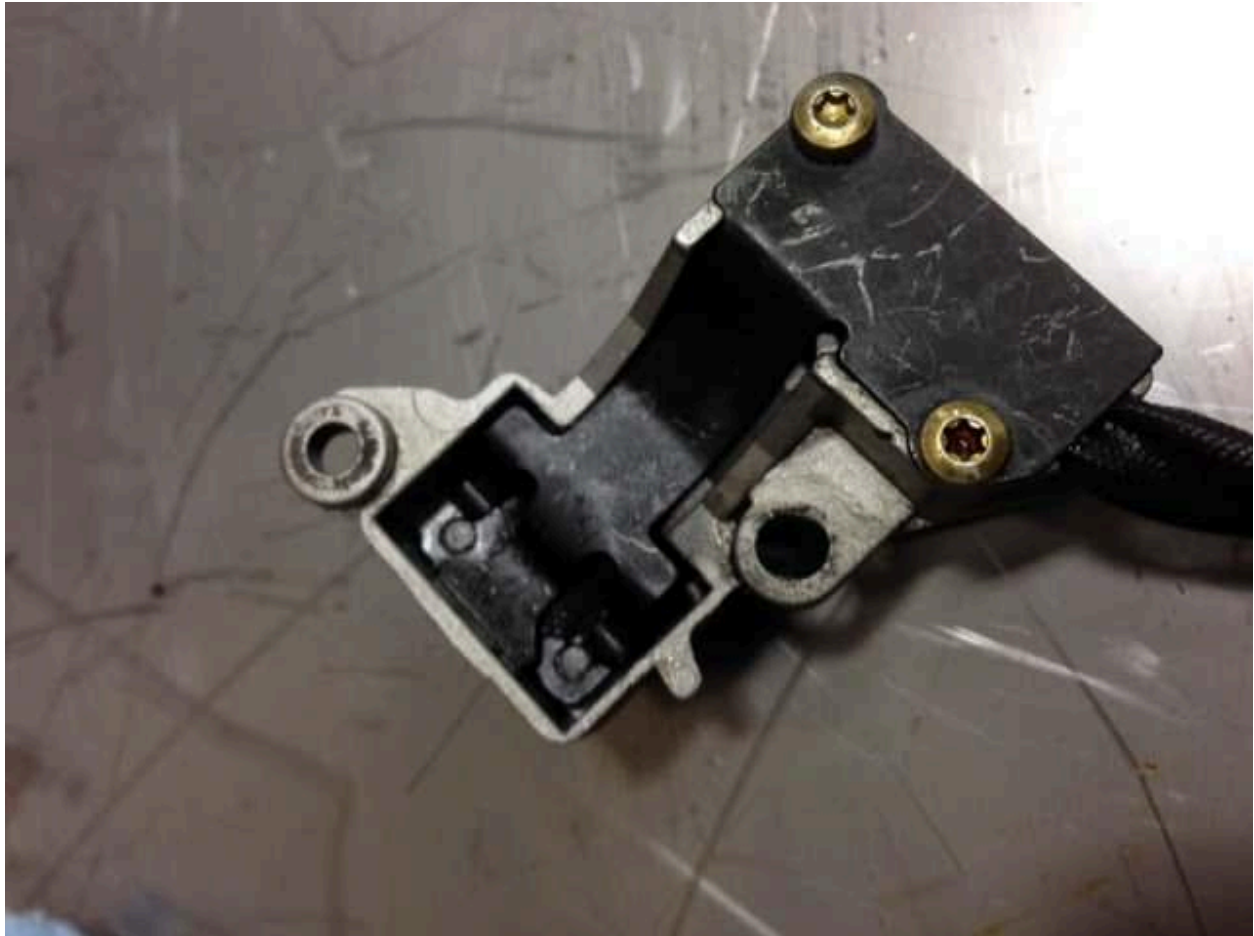
Now back to our sensor, if we flip the Saab 900 Crankshaft Position Sensor assembly over, you'll see two smaller T10 torx screws holding the sensor retaining plate. Remove these and the old sensor can be removed easily from the housing. Before we put the new one in , we'll splice the wires together and seal the harness as best as possible in order to keep heat and contaminants away from the wiring.

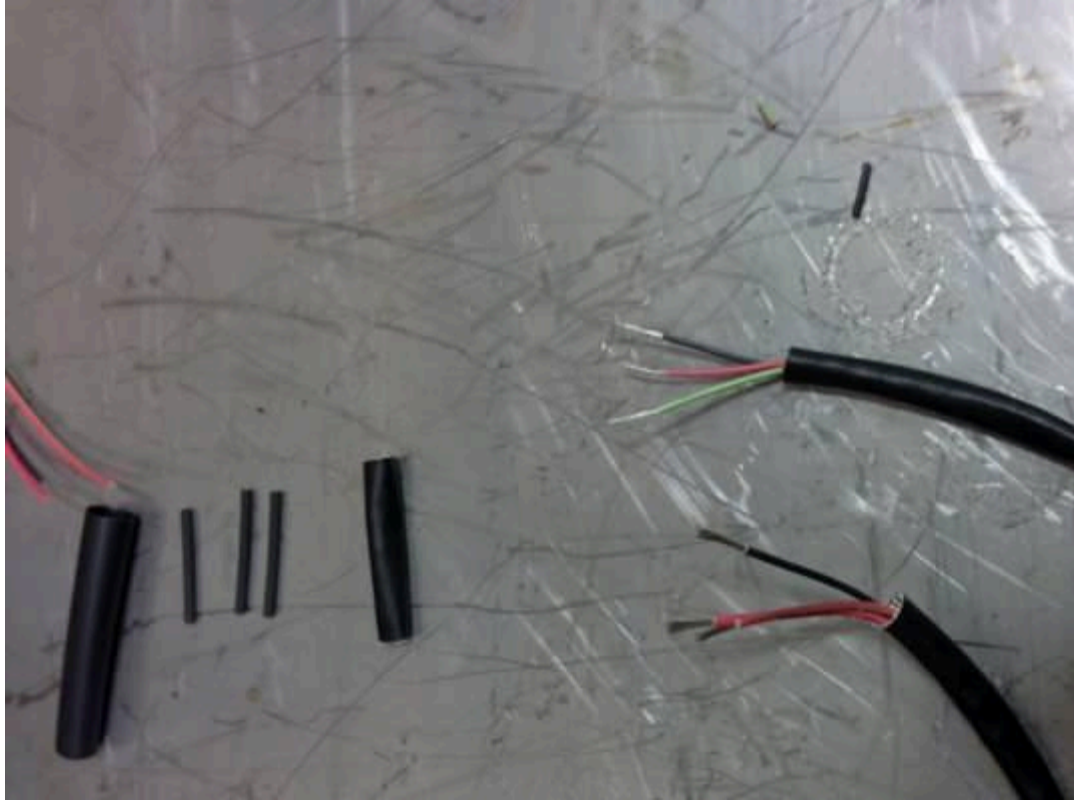
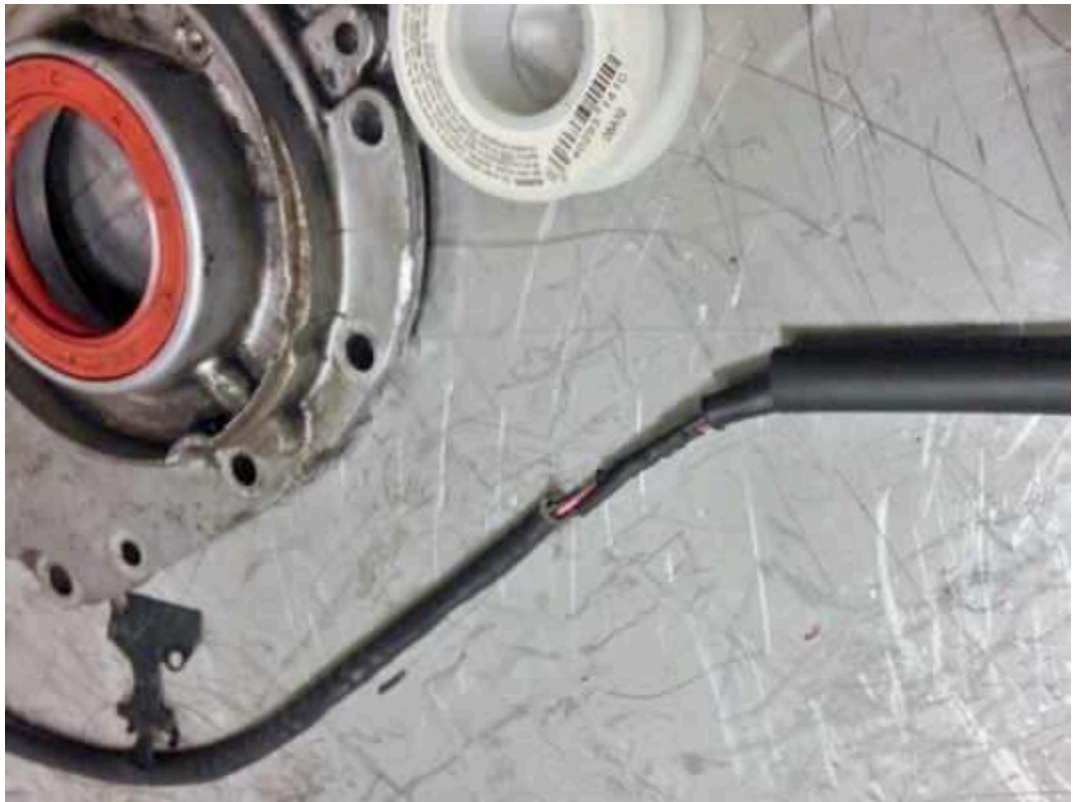
Pay no attention to the markings on the old sensor

However, if you were diligent enough to read these positions *on the old one* and matched the wiring to that, you'd end up with a very frustrating afternoon of not actually fixing your car and possibly having to buy a new sensor, since you just fried it. It seems that somewhere along the way the manufacturer corrected the symbols to go with the corresponding wire colors. **So with the new sensor as long as you match color to color** (*red to red, black to black and red/green to green if that wasn't obvious*), then all will be right with the world and the little markings on your new one actually make sense.

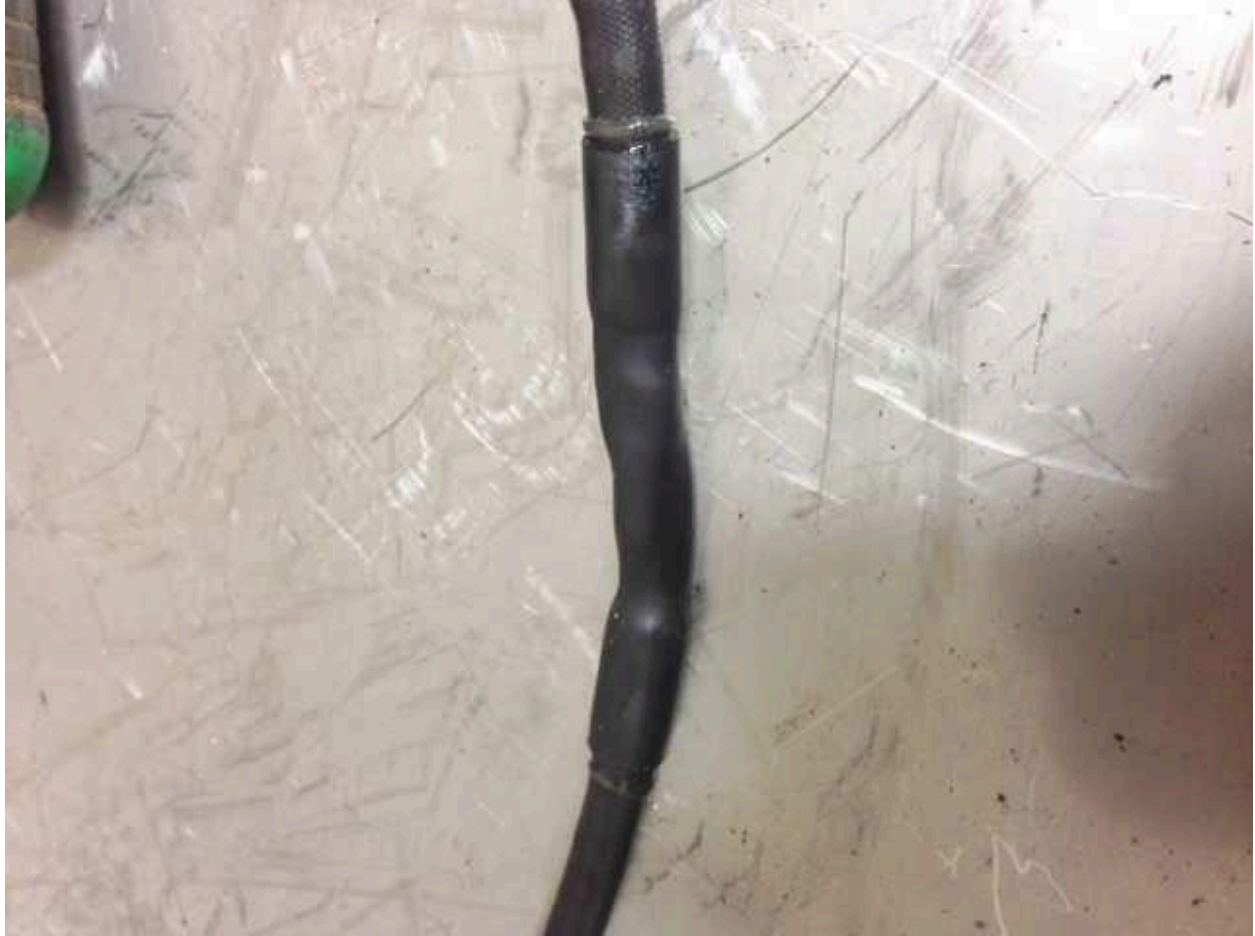
So after the wires have been spliced together, heat shrunk and the sheathing patched you can insert the sensor back into the housing, reinsert the retaining clip and screws and you should be ready to put your Saab 900 Crankshaft Position Sensor back in the car for that satisfying crank, crank, vroom-vroom noise you so desperately want to hear.

My process is to clip the factory the length of the new pig tail and then trim the sheathing out two inches so that you have room to make your splice. This time around I chose to use solder and heat shrink around each individual wire and then around the sheathing to make a weather tight patch. High-quality , properly sized butt connectors with the heat-shrink glue can also be used with great results. It just depends on what tools you have and what you are comfortable with.
