TAUW by Zekeringstraat 43g P.O. Box 20748 1001 NS Amsterdam T +31 20 60 63 22 2 E info.amsterdam@tauw.com ASGM Mercury pilot remediation in Lombok and West Sumbawa TAUW Foundation

R001-1279669CBN-V01

1 Introduction

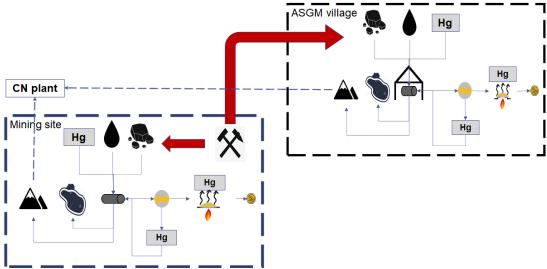
Figure 2.7 Schematic representation of ASGM processes

Our understanding of the ASGM process is illustrated in Figure 2.6. The cyanidation of the tailing in the Cyanide (CN) plants is represented by "CN plant" in the figure. This process is not detailed as this is out of the scope of this project but the figure illustrates the various source of the potential mercury contamination.

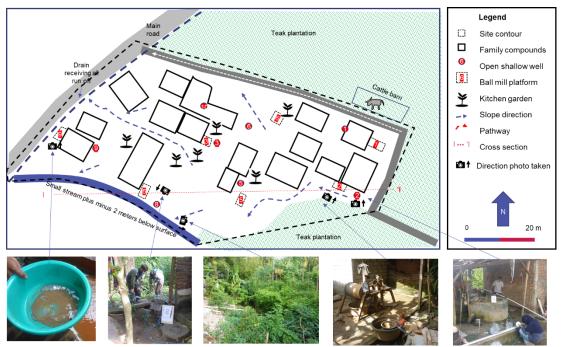
Figure 3.2: Kayu Putih with the multiple potential sources of mercury contamination and the potential pathways

Figure 3.2 provides the site layout and Figure 3.3 is a representative cross-section of Kayu Putih with the multiple potential sources of mercury contamination, the potential pathways and the potential receptors.

During the fieldwork, observations were made that might indicate the presence of soil and groundwater contamination. The presence of bricks, waste such as plastic bags, batteries and food remains was observed to be present at the surface and topsoil. For details, reference is made to the bore logs in Appendix 1a. At the time rod-mill location 9 was sampled the mill was emptied and the mercury from the mercury gold amalgam was separated using a cloth (see Figure 3.2).

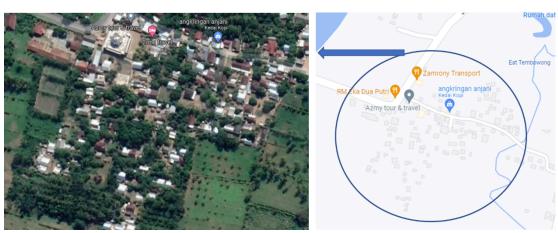
Figure 3.4: The study area of the village Temboulon

The potential sources, pathways and receptors of mercury for the study area of Temboulon are as described for the Kayu Putih site (see Section 3.1.1) and are summarized below.

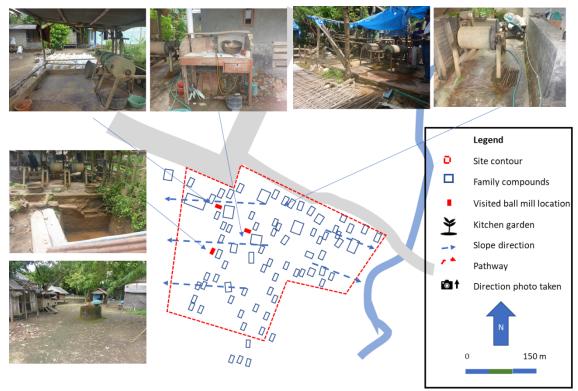
Figure 3.5: Site lay-out study area of the village Temboulon and photographs illustrating the on-site situation

- All the rod-mill locations that used and or are using mercury
- The place where mercury is burned (see Figure 3.5)

The Figure 3.5 is a map of the layout of the Temboulon study area. The cross-section of Kayu Putih, provided Figure 3.3, is also representative for the multiple potential sources of mercury contamination, the potential pathways and the potential receptors of the Temboulon study area.

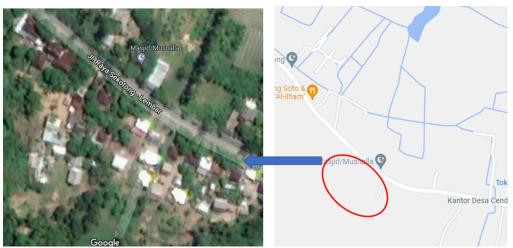
Figure 3.6: The location of the study area in Cadi Manik

Site number 3, Cadi Manik, in Seketong was visited on the 6th of April. This site is surrounded by a forested hill in the south, west and east. To the north the main road (Jalan Raya Sekotong, Lembar) is situated and opposite this road are lower laying paddy fields. The site itself is on the foot slope of the surrounding mountain/hill. The soils of the southern part of Cadi Manik are young (Entisols and Inceptisols) and are formed on colluvial parent material. The slope direction of the site is south to north oriented towards the paddy fields. The groundwater flow direction is expected towards the north (see Figure 3.6). It was told that the groundwater level drop could be more than 3 meters and shallow wells run dry during dry season. A 15 meter deep-well is installed to provide water during the dry season in the village.

The study area in Cadi Manik has around 25 family compounds and about 70 people are living in this community. Nearly all villagers are involved in ASGM. Also, on this site the potential sources, pathways and receptors of mercury are as described for Kayu Putih (see Section 3.1.1) and can be summarized as follows:

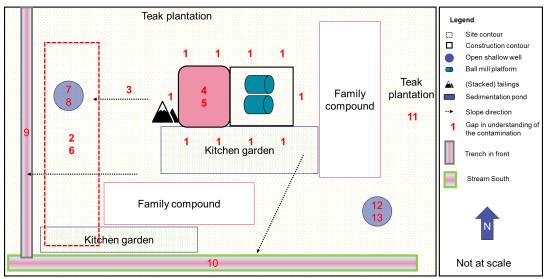
Figure 3.7: The general layout of a rod-mill location in Kayu Putih with the knowledge gaps

In total ten, more or less identical (former) rod-mill locations were in Kayu Putih at the time of the detailed site investigation. For an overall overview and cross section reference is made to Figure 3.3 in Section 3.1.1. The general layout of rod-mill location including the knowledge gaps is presented in Figure 3.7 and a schematic cross section is provided in Figure 3.8. To structure the gap analysis and the detailed site investigation each gap is consequently numbered. These gaps are listed in Table 3.2. Based on the gaps a sampling and analyses plan is made and presented in Section 3.2.3.

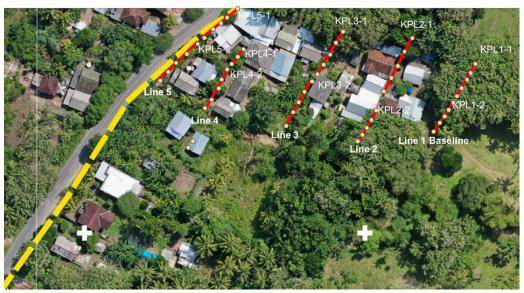
Figure 3.9: The baseline, the three line and the trench with the sample locations to verify of runoff has spread the mercury in the topsoil in the village

To investigate if ASGM activities have impacted the soil and groundwater, the topsoil $(0.0-0.10~\mathrm{m}$ bgl) around each rod-mill location and the down-gradient subsoil down, are sampled. Besides this, the water and the sludge in the wells near (down-gradient) each rod-mill location are sampled to verify if the mercury contamination has infiltrated into the aquifer and reached the well and/or rainwater runoff seeped in to the shallow wells around the wellheads. For the verification if runoff has spread the mercury contamination down-gradient in the topsoil, five lines parallel to the site contours and the sediments in the stream south, and the trench west of the site are sampled (see Figure 3.9). Line 1 is placed as a baseline to compare analytical results of downstream/down slope line samples. Based on interpretation and evaluation of the recorded soil observations soil, groundwater and sediment samples are selected for analyses.

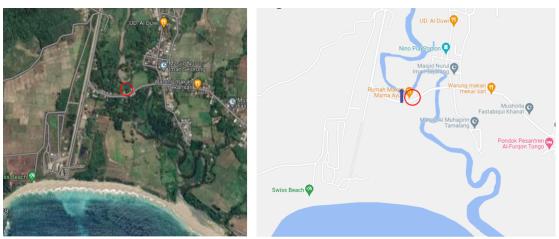
Figure 4.1: Location of 01-04-2022 site 3 in Tongo, West Sumbawa

The former ASGM rod-mill platformer was not maintained and household waste is dumped at the site. Groundwater is extracted 50 m towards the east of the site.

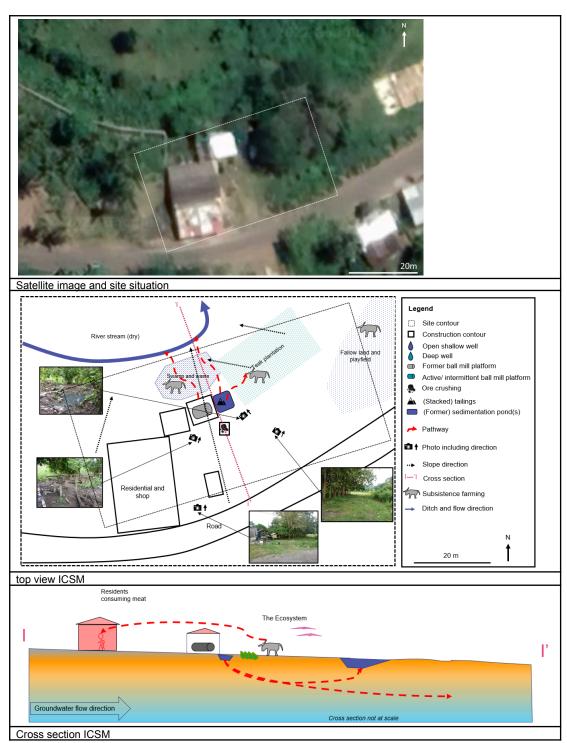
Figure 4.2: The ICSM of 1-04-22 Site 3 in the village Tongo on West Sumbawa

The potential sources, pathways and receptors of mercury for the study area are listed below and depicted in Figure 4.2.

- The people living on the potential contaminated site, using the groundwater, eating agriculture products from the kitchen garden on potential contaminated soil and eating the potential contaminated animal products of the animals roaming on-site
- The ecosystem, soil live and the (small) animals foraging on-site
- The ecosystem, in the river and sediment layer receiving the contaminated groundwater and contaminated runoff

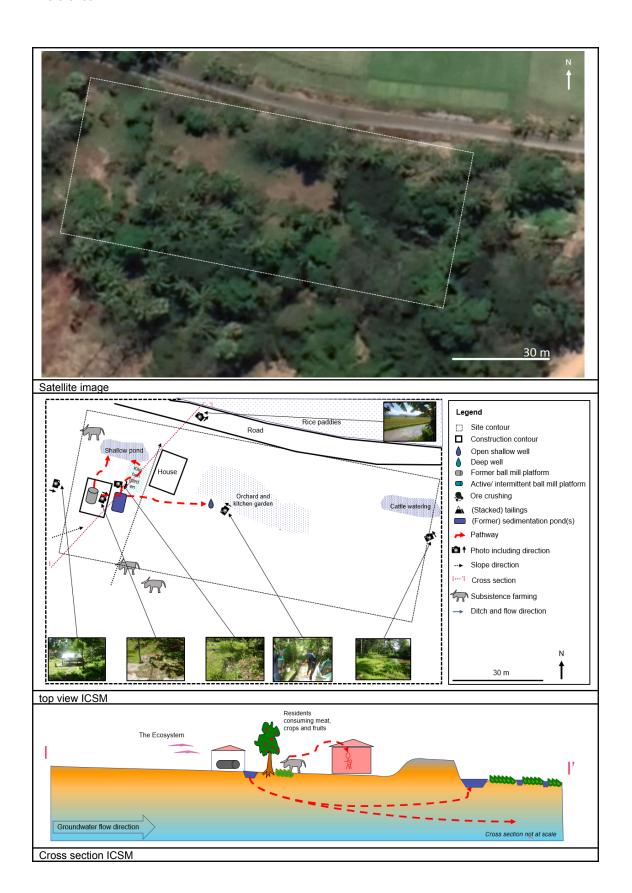
Figure 4.4: The ICSM of site 2-04-22 Site 1 southwest of the city centre of Kuang in West Sumbawa

- The people living on the potential contaminated site, using the groundwater, eating agriculture products from the kitchen garden on potential contaminated soil and eating the potential contaminated animal product of the animals roaming on site
- The ecosystem, soil live and the (small) animals foraging on site
- The ecosystem, in the river and sediment layer receiving the contaminated groundwater and contaminated runoff

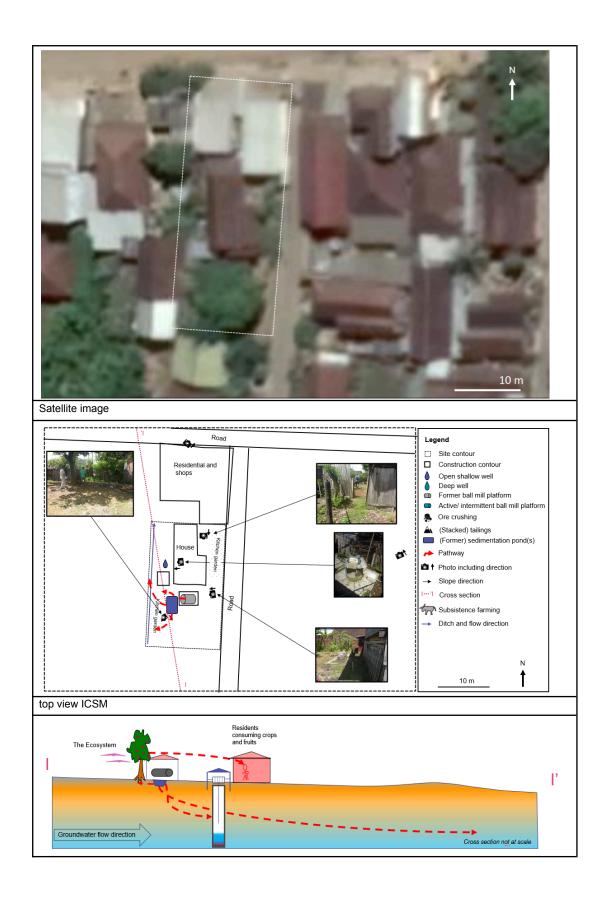
Cross section ICSM

- The people living on the potential contaminated site, using the groundwater and eating agriculture products from the kitchen garden on potential contaminated soil
- The ecosystem and soil life on site
- The ecosystem, in the river and sediment layer receiving the contaminated groundwater and contaminated runoff

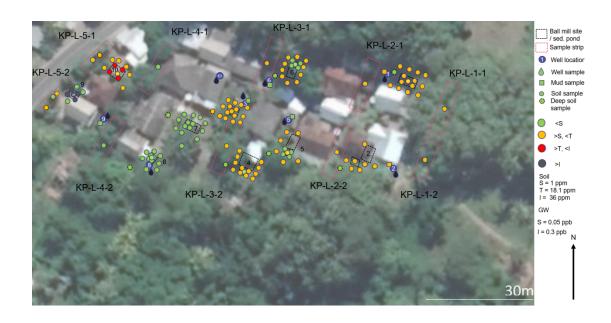
Appendix 1.c Site location map with boreholes and wells

The fieldwork was performed by staff from NEXUS3 Foundation, Mataram University, and TAUW on the 7th and 8th of April 2022. It was performed by manually using a hand-auger for boreholes till an approximate depth of 1 meter below ground level (bgl). Sediments from the ponds and the sludge in the shallow groundwater wells were manually sampled by using a gouge. Groundwater samples from the wells were taken by manually driven peristaltic pump. For the bore logs reference is made to Appendix 1a and the map with the sample locations, is presented in Appendix 1c.

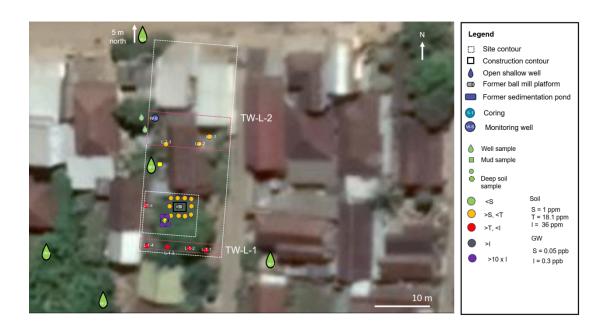
Appendix 2.c Site location map with boreholes and wells

During the field work, observations were made that might indicate the presence of soil and groundwater contamination. On some place on the topsoil presence of bricks, waste such as plastic bags and food remains were observed. For details, please refer to the bore logs in Appendix 2a.
