Alumizu Keycap Acceptable QC

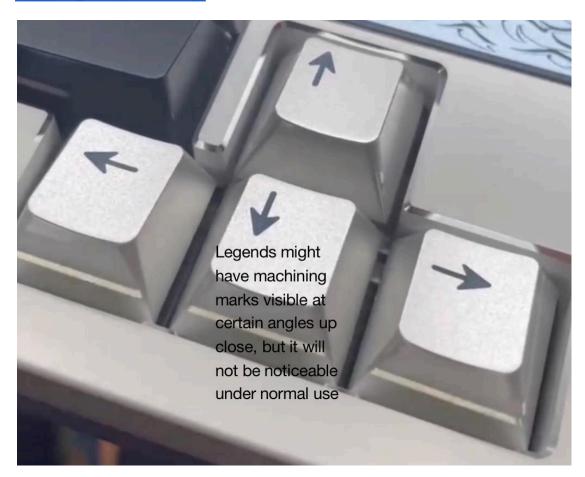
Machining Marks

Caps with legends might have small machining marks when you see it from some angle and under direct light. We kept changing many different angles for 2-3 minutes and found the mark shown below under direct light. It's unnoticeable in normal usage. Please refer to this video to check more: https://i.imgur.com/E0HhPQw.mp4

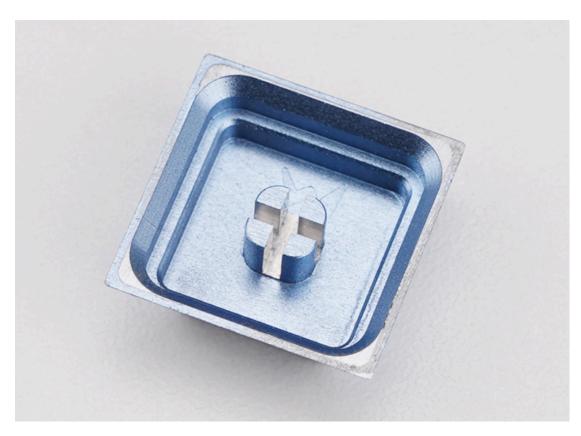
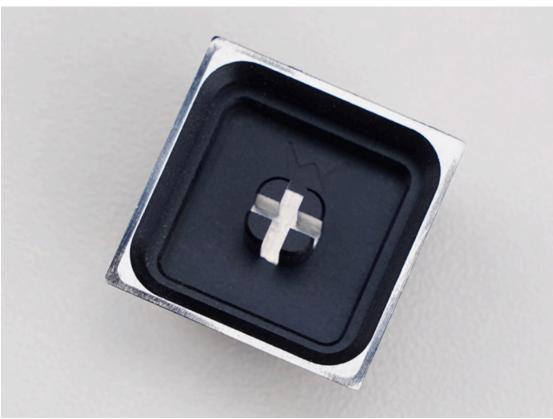
Underside

The underside of these caps will be raw aluminum on the finishing surface. Internal machining marks may exist。
