O mittur Lakes Monitoring

Overview

The objective of this study was to monitor the lakes based on standardized protocols that included the specifications ranging from measurement of lake's area, its elevation, crops grown in the command area, water quality to socio-economic status of the village. The group four covered 4 lakes namely Chikkakere, Hosakere, Shakti kunte and Doddakere. Apart from the stated objective the aim is to understand the significance of these water bodies in making the village self-sufficient with respect to dependency on water which is both a "human right and an economic good". Collecting data, presenting and analyzing it will allow us to take corrective actions in order to ensure that the issues of silting and bund leakage are resolved while also acting as a source of document for attracting funds.

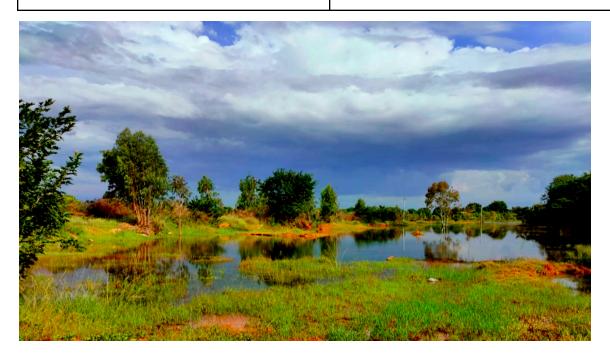
HOSAKERE LAKE

- From the catchment area a good amount of water enters the lake but due to bund leakage it can't be stored and thus utilized by the farmers.
- Immediate requirement of desilting.
- Wage disparity

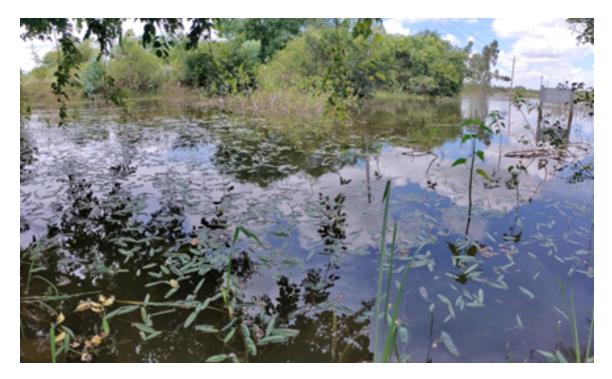
Lake Bund

Doddakere lake in the Avala Marakalagatta village is approximately 10-12 feet deep. The lake is seasonal in nature and is commonly known as "Palar" in kannada. **First thing to catch our attention when we arrived at the lake was the non-functional bund**. After talking with Prasanna, our local guide, we found that the bund had developed a leakage. We were able to record the bund location (13.069987, 78.315405) however, we could not mark the exact location of Rajakaluve (13.067073, 78.319090 approximate location) as there was excessive plant growth and the bund was not functional. The lake had two waste weirs (13.070052, 78.315346, 13.067146, 78.319232). Crops like tomato, paddy and other seasonal vegetables are grown in the command area (13.067040, 78.318736) using the water from the lake by employing drip irrigation practice.

- has been taken. (farmers are managing it by filling the space with sand to prevent bund leakage).
- Desilting has its own drawbacks. It is a costly proposal when compared to other alternatives and therefore needs study of alternatives as well as detailed hydrological investigations.

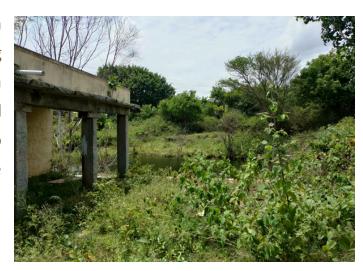
The lake is usually full during the months of October and November and sees a drop in water level usually during March-April. The lake also had an open well nearby (13.067047, 78.318931) and a pump house. The pump house is also used by travelers as a resting place. The

diameter of the well is 20 feet and the approximate depth of the well is recorded as 50 feet as told to us by Prasanna. The well however is not used for drinking purposes, it is mostly used for other purposes like irrigation and livestock management. The village earlier had a total of 3 borewells, which met the drinking requirement of people, a recent one was installed 3-4 years back, however, only 2 were functional as of the date of our visit.
