## **Storm Drain Repair – Along Country Walk Street and NE corner of Oak Haven Dr. & Country Walk St.**

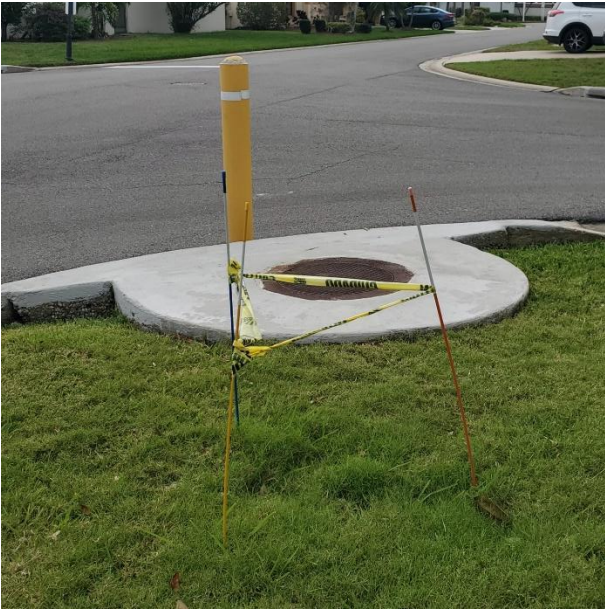
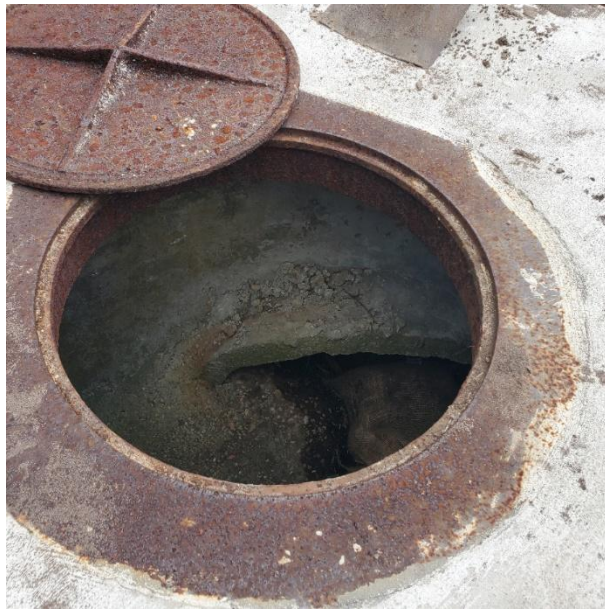
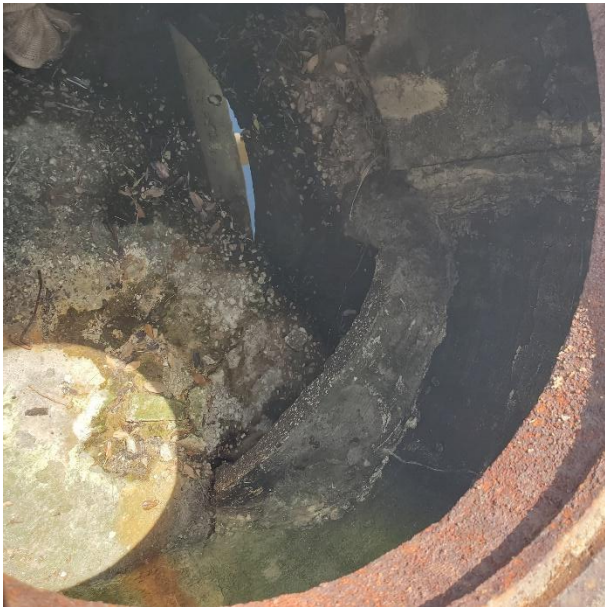
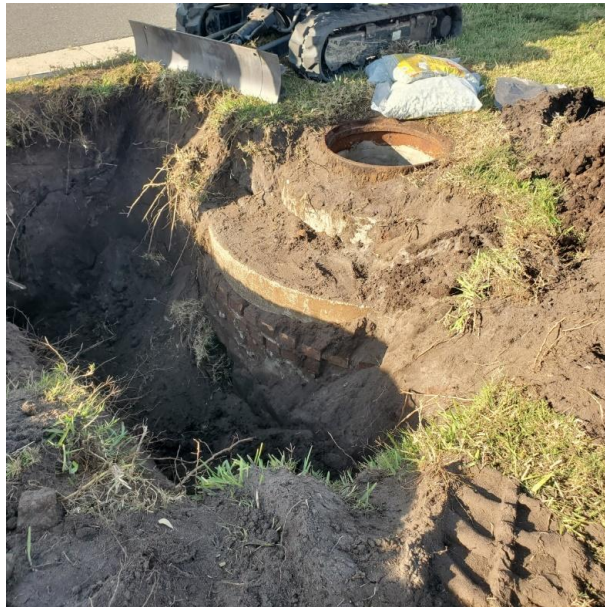
Eric explained that the repair that was done before was not done right at the corner which caused the pipe to have severe constriction in ability to drain water. At this time there is no problem with flooding at that intersection.

Paul Hise fell into the hole created by erosion underground and reported the incident. The Board sought bids for repair work and went with Eric from Lawnspring, Inc. to excavate and repair the area. He needed to address both the area near the pond, along Country Walk Street, and the drain on the NE corner of Oak Haven Drive (by 414). Cost was \$11,500.

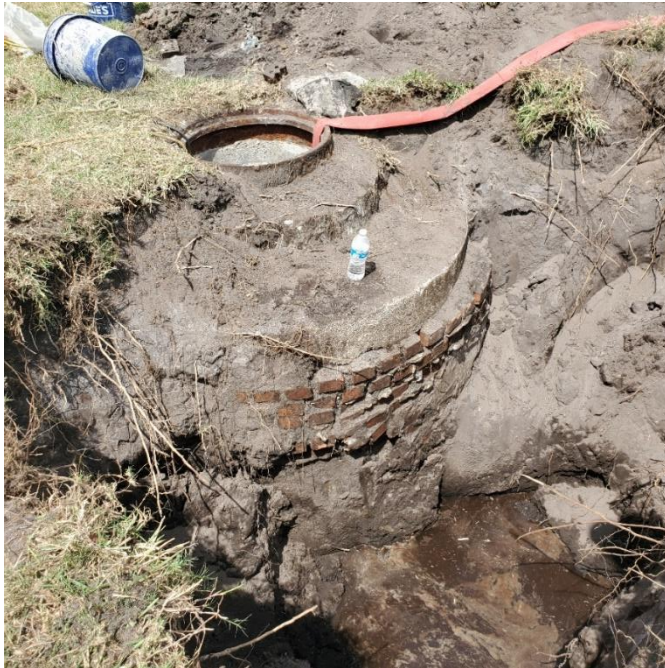
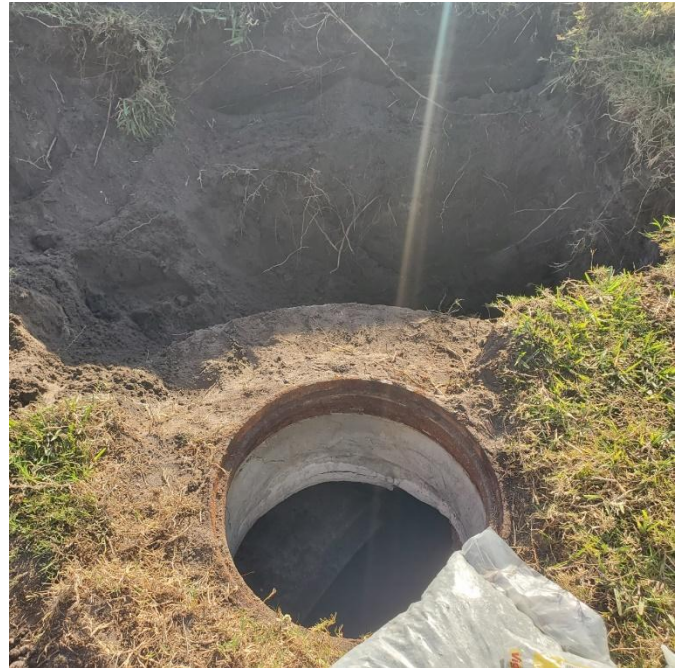
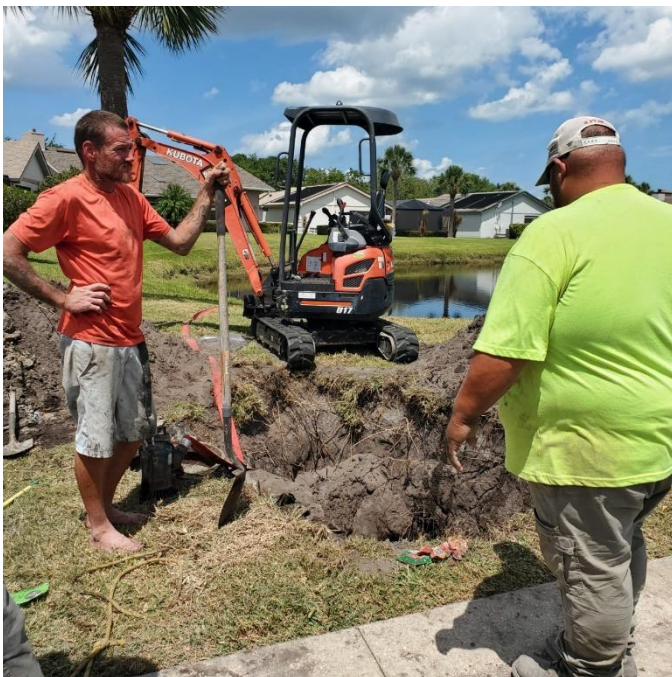
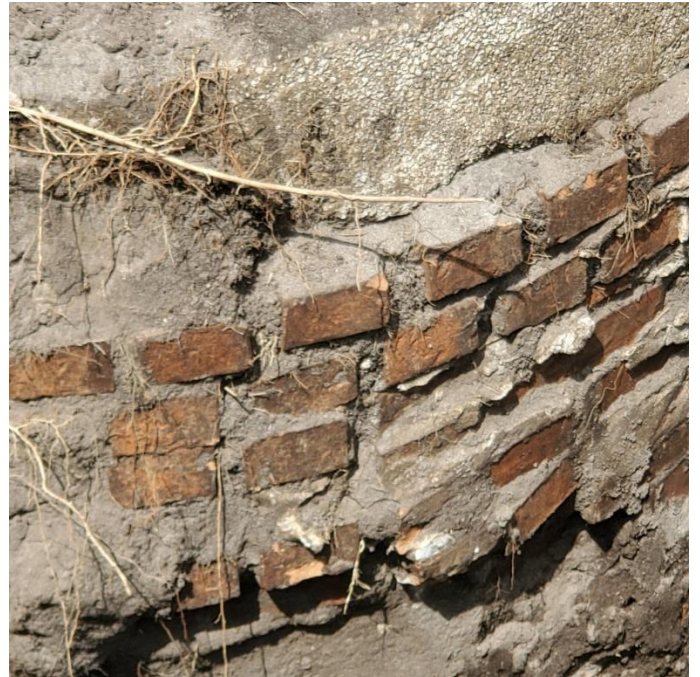
The piping in the area along Country Walk Street near the pond had a leak that was causing underground erosion. He sealed the leak and replaced the sod. He said that the type of construction on this area (bricks) are not the code today but it seems that the construction company at the time used this method and that there are probably more of these in our subdivision. He said that if this were left too much longer, we would see erosion closer to the street and possibly see damage to the road.
