Storm Drain Repair – Along Country Walk Street and NE corner of Oak Haven Dr. & Country Walk St.

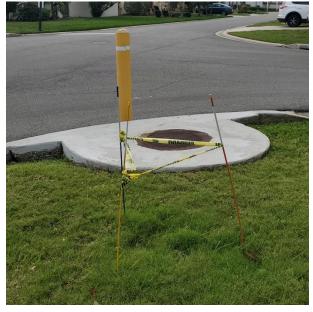
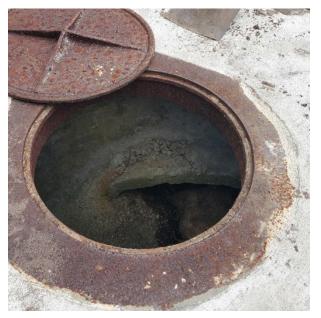
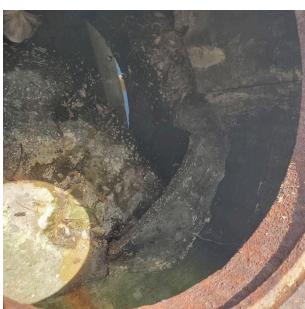
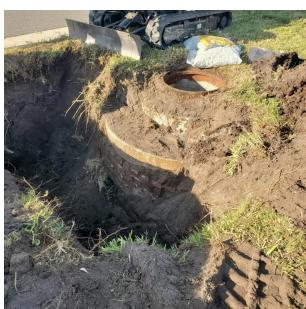
Eric explained that the repair that was done before was not done right at the corner which caused the pipe to have severe constriction in ability to drain water. At this time there is no problem with flooding at that intersection.

Paul Hise fell into the hole created by erosion underground and reported the incident. The Board sought bids for repair work and went with Eric from Lawnscaping, Inc. to excavate and repair the area. He needed to address both the area near the pond, along Country Walk Street, and the drain on the NE corner of Oak Haven Drive (by 414). Cost was \$11,500.

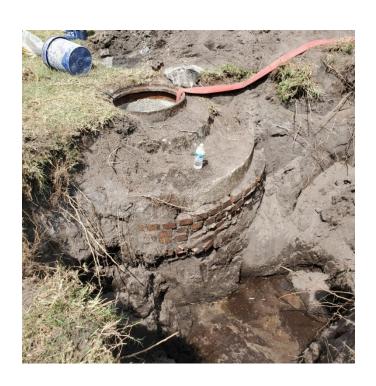
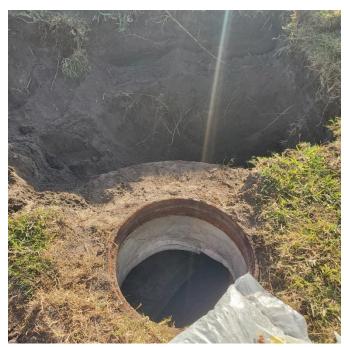
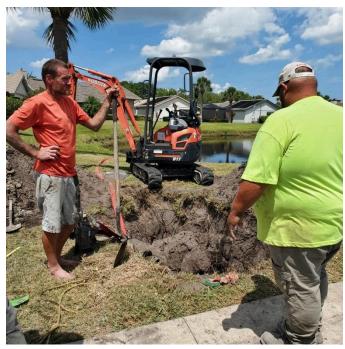
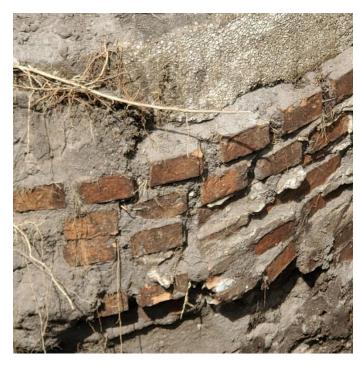
The piping in the area along Country Walk Street near the pond had a leak that was causing underground erosion. He sealed the leak and replaced the sod. He said that the type of construction on this area (bricks) are not the code today but it seems that the construction company at the time used this method and that there are probably more of these in our subdivision. He said that if this were left too much longer, we would see erosion closer to the street and possibly see damage to the road.
