# **VEHICLE APPRAISAL**

Vehicle Make & Year: 1963 Cadillac Fleetwood 60 4 Door Sedan  
VIN: 63M143394 Body Style: 4 Door Sedan  
Color: Briar Rose Poly Interior (color/material): Gray leather and fabric  
Vehicle Inspected at: Owner's garage @ XXXXXXXXXXXXX  
Owner: XXXXXXXXXXXXX Phone: XXXXXXXXXXXXX Email: XXXXXXXXXXXXX  
Address: XXXXXXXXXXXXXXXXXXXXX

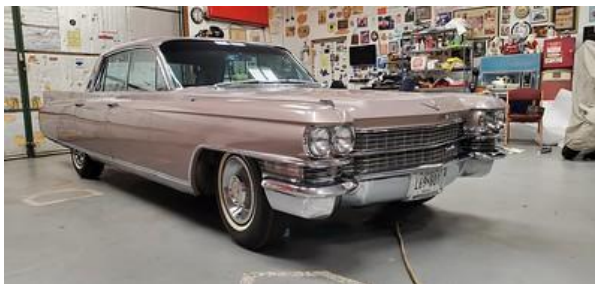
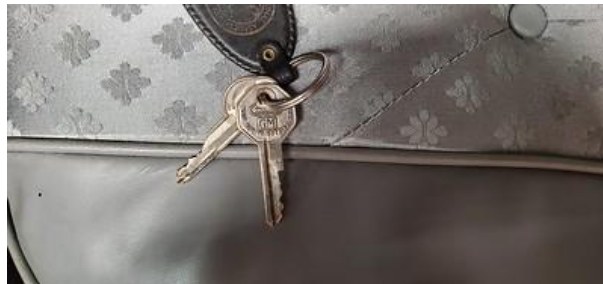
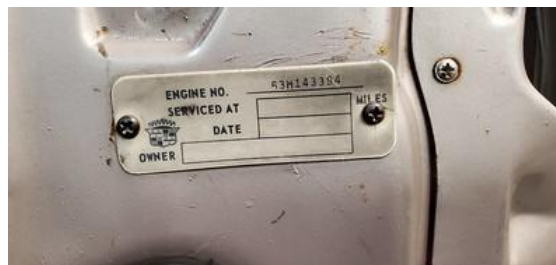
(Mileage: 39,337 original miles) Mr XXXXXX is the third owner of the vehicle. The first owner was an older lady that purchased the vehicle new. The vehicle was repainted about 25 years ago by the second owner. This is an extremely low mileage 1963 Cadillac that has an overall rating as a #2 car. The vehicle shows that it has had very little use over the years.

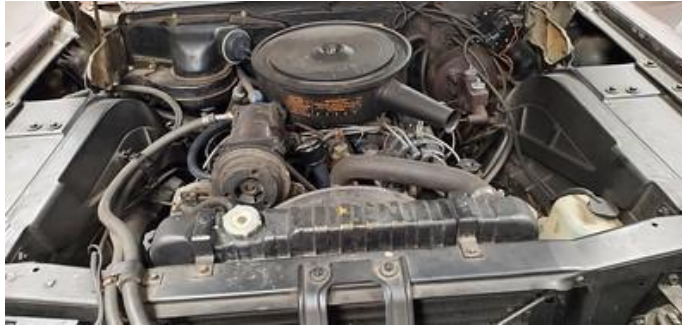
**Engine/Engine Compartment:** (Overall Condition Grade #2) 390 cid/325hp 4bbl. The engine bay is mostly original and everything functions as it should. The blower motor was recently replaced. The vehicle has a new stainless steel exhaust system. The air cleaner assembly still has the original decals/labeling on it and they are in very good condition.

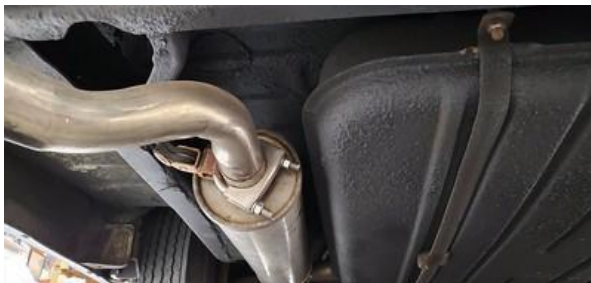
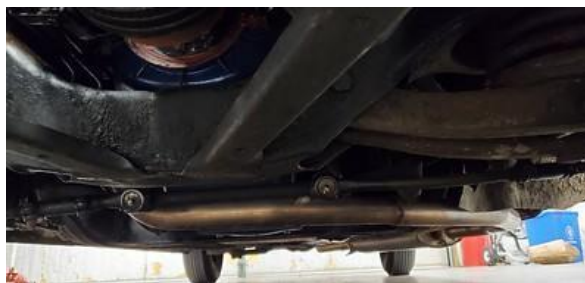
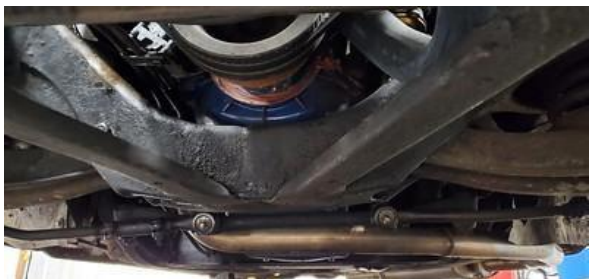
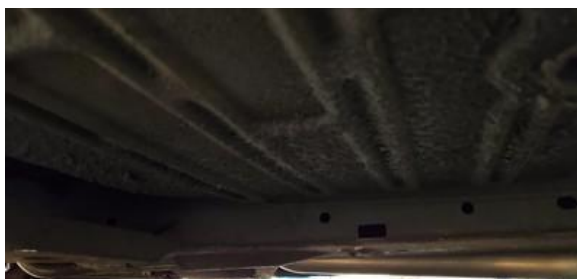
**Chassis:** (Overall Condition Grade #2) The undercarriage and frame appear to have some type of undercoating on it. A visual inspection revealed very little or no rust at all.

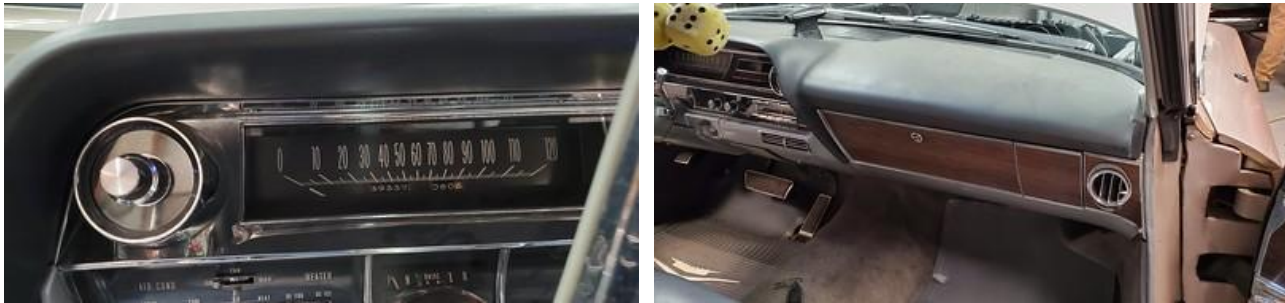
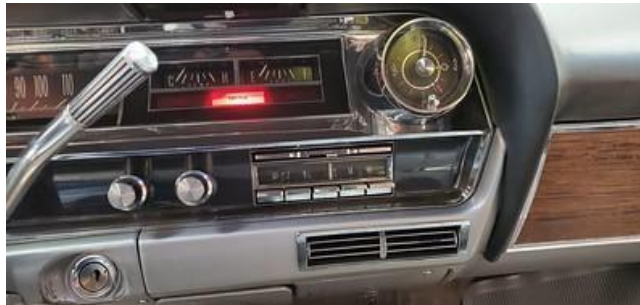
#### Instrument Panel Pictures

**Interior:** (Overall Condition Grade #2) The interior is in fine condition and mostly original. The vehicle is equipped with the Guide-Matic automatic headlight dimming system with the Autronic Eye and it is still functional. The front ashtray and lighter appear like new. The vehicle is equipped with left and right rear seat ashtrays and lighters and they also appear like new. The original carpet is in very good condition. The original power trunk release and power pull down is still in functional condition. The door panels, dash panel, headliner, and seat leather are original. The fabric on the seats has been replaced by the current owner. New reproduction floor mats have been added, they are period correct. The original trunk liner and

mat are in very good condition. The air condition works. The original AM radio works. It has the original vanity mirror on the front sun visor. The rear interior lamps are functional (all of the interior lights are still working). The rear seat center fold down armrest is in fine condition. The vehicle is equipped with power door locks, power windows, power antenna, power vent windows, and power seats which are all in functional condition. The manual remote driver's side mirror is functional. The tilt steering column is functional.

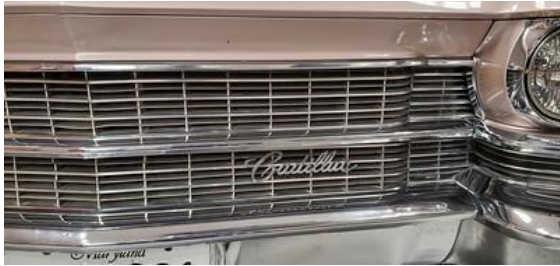
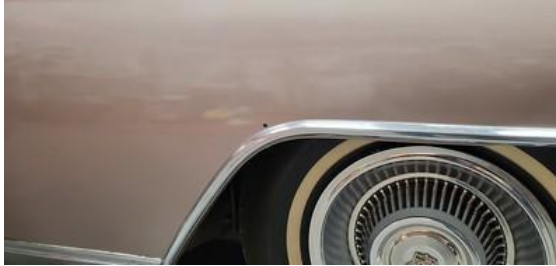
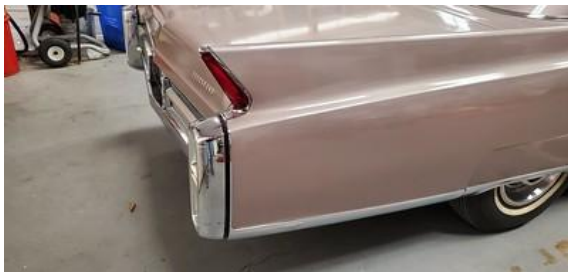
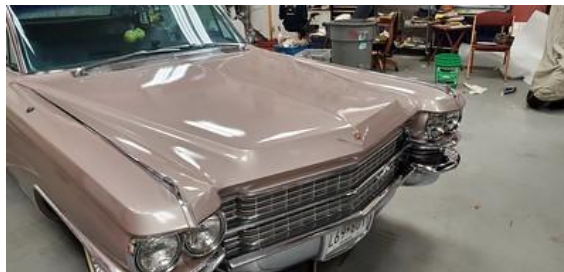
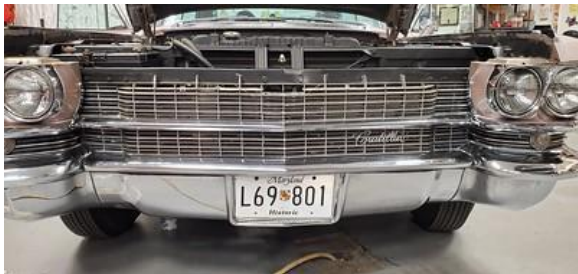
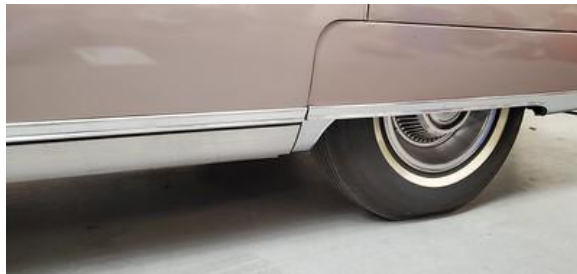
**Exterior:** (Overall Condition Grade #2) There is some minor pitting on the exterior chrome. The right front fender was replaced at some time in the past. The vehicle was repainted about 25 years ago. It was/is an average repaint. The paint does shine very nicely. At the time of the appraisal, there were no visible signs of rust on any of the body panels. The wheel covers are in Very Good to Fine condition. There was/is some slight mis-alignment in the rear fender skirts. The glass was/is in fine condition.
