## 1. 喷的保温棉

## 2. Uffi主要在七十年代用的保温材料。1980, 在加拿大全部禁止使用。Why is Uffi insulation no longer used?

## 3. 从1995 到2007, 有一种叫 kitec 的水管。可能随时会破裂漏水。在加拿大, 约有300,000 的房子用了这种水管。

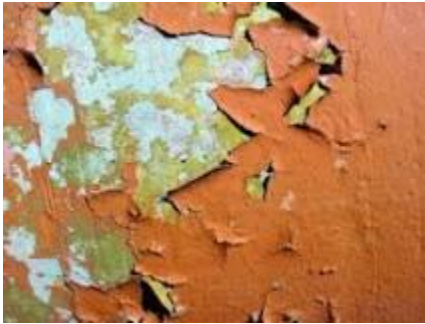
4. 含铅的油漆 Is lead still used in paint?

**Lead-based paints were banned for residential use in 1978.** Homes built in the U.S. before 1978 are likely to have some lead-based paint. When the paint peels and cracks, it makes lead paint chips and dust.
