## s2.7 - 2nd floor bath floor - Subfloor Deficiency

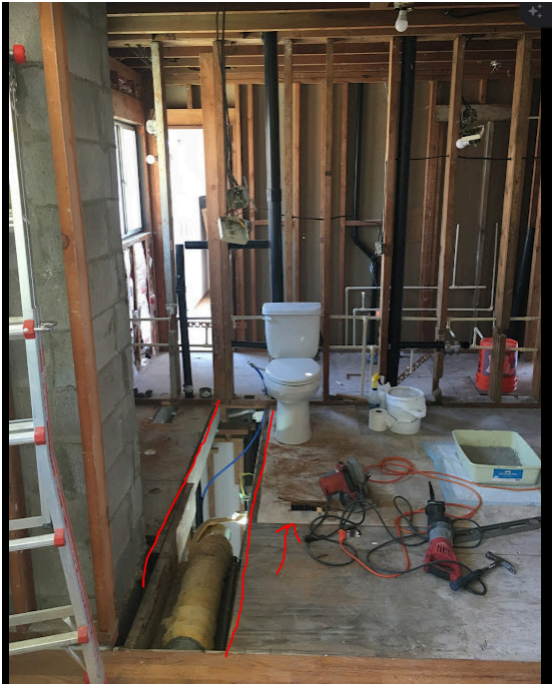
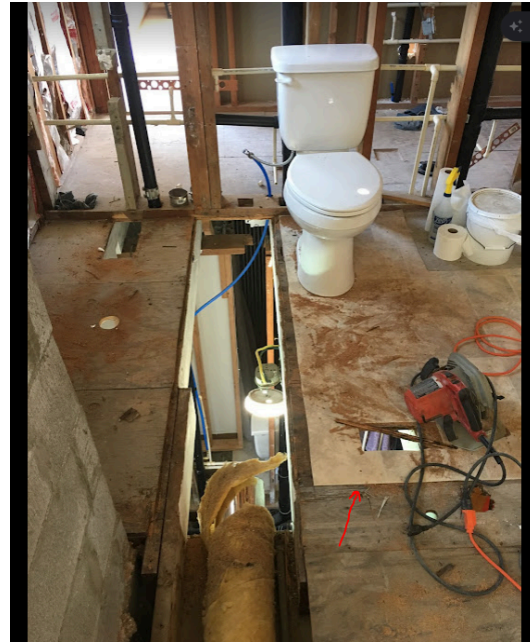
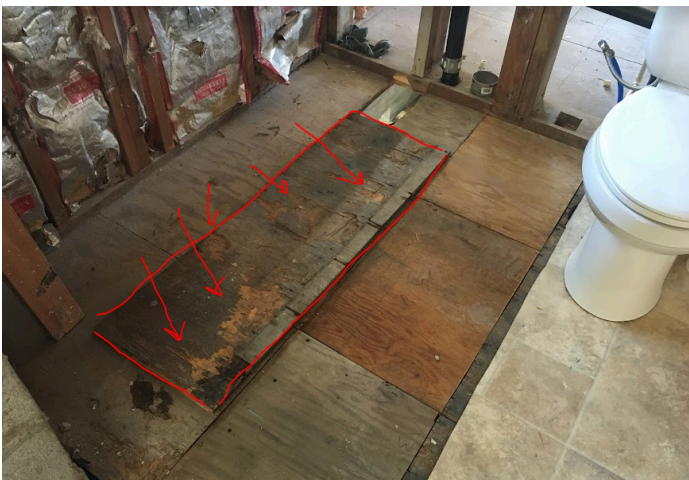
When we focused on areas around the tube, we found significant soft spots in the floor. .

We pulled up the vinyl and found new, 1/4 luan that he referenced as “plywood”. It had been overlaid over the original sub floor. The subfloor all around the tub needed to be removed due to damage. This subfloor damage would have been visible to the contractor before he installed the 1/4” overlay.

July 6, 2021 - this shows the part that had to be cut out...

Here's the board that was cut out next to the repair. The contractor would have been looking directly at the compromised board in that condition when he overlaid it.

It was a 3/4 ply subfloor and in some areas 50% of the material was gone. This should not have been overlaid. It should have been cut out and repaired.

We ended up having to tear up the new work to look for damage and then we had to replace a portion of the subfloor which was damaged which was about 16" by 60".

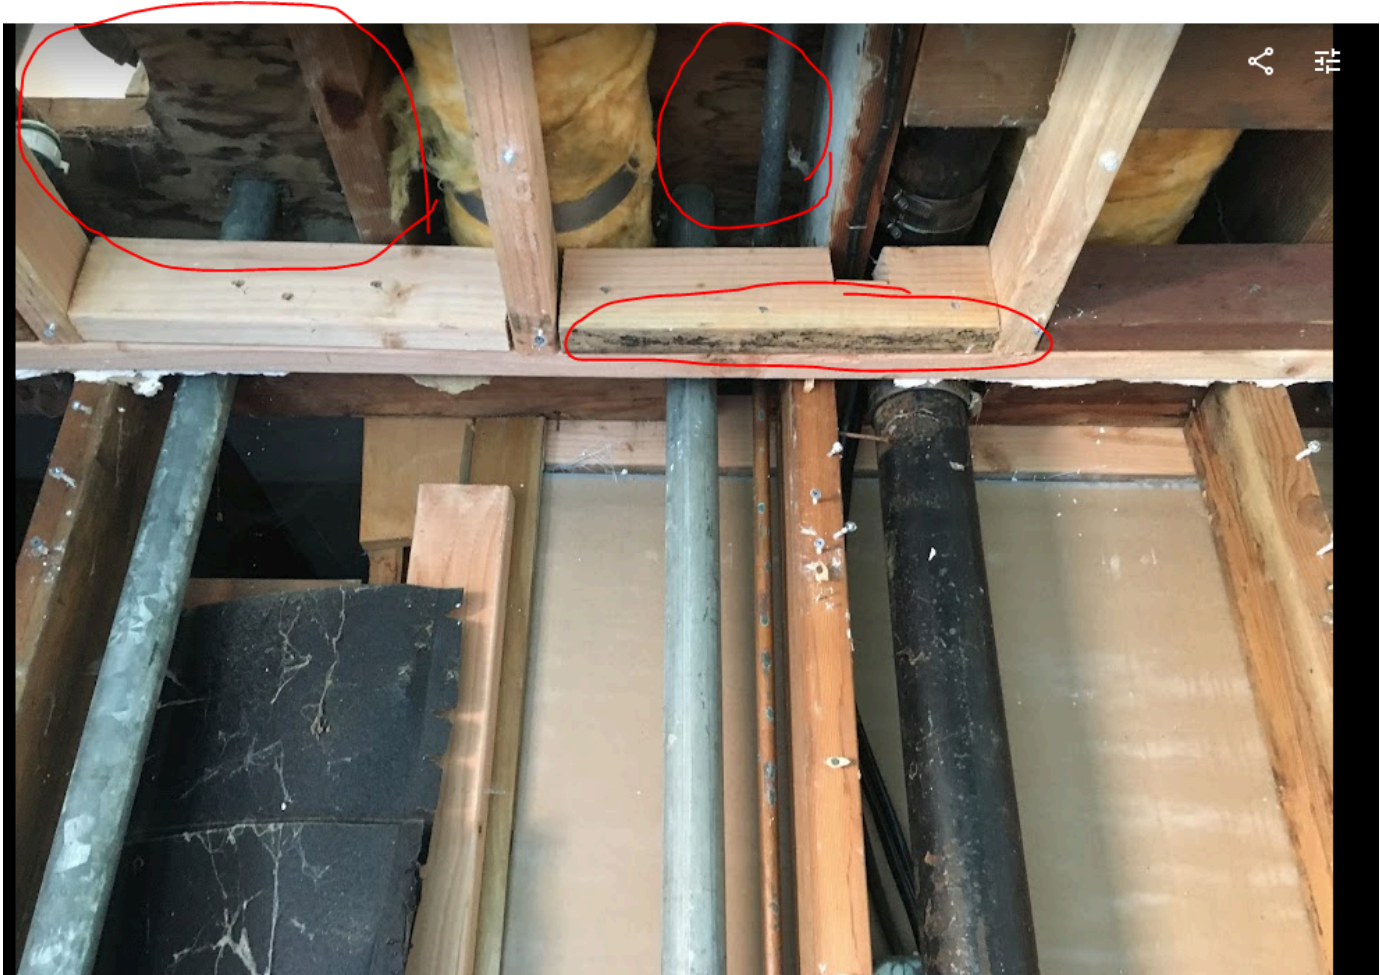
This photo was taken from below. The hole in the left bay is tub drain. The duct between the two red circles is the same bay that was removed in the photos above. That piece of 2x4 with mold on it should have been new in the October or November time frame and it accumulated that much mold between then and march. Presumably from other leaks in teh bathroom plumbing that were not remedied when the contracting work started.
