**POST-GRADUATION  
IN  
SIX SIGMA BLACK BELT**

Lean Six Sigma in Mold Making Industry

**Data Validated Investigation for Enriching Workplace  
(D-VIEW)**

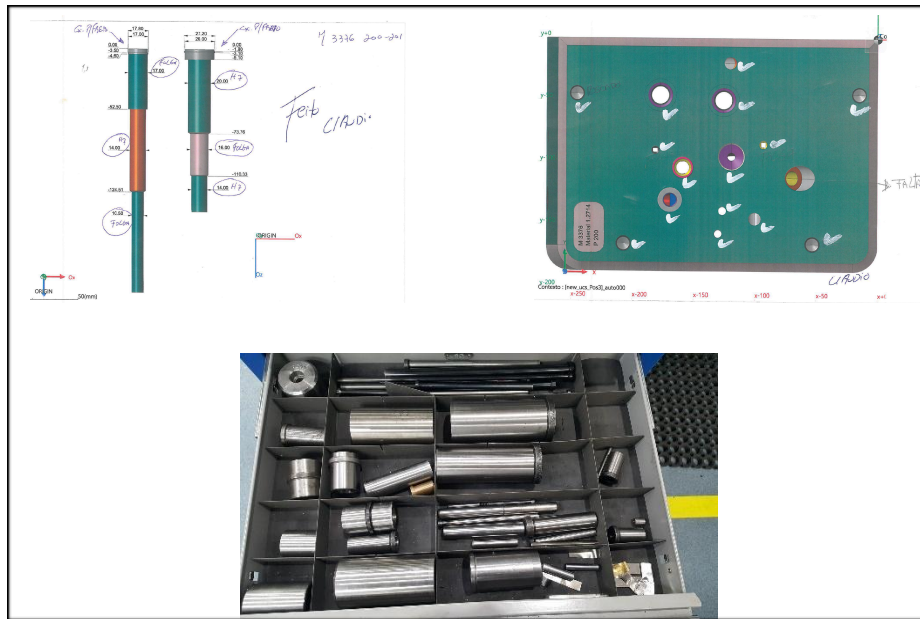
Figure 8: Auto Control Checklist and Calipers

- Workers were provided training of design viewer software. Along with the part, they were given a checklist of dimensions to be verified and calipers were used for checking.

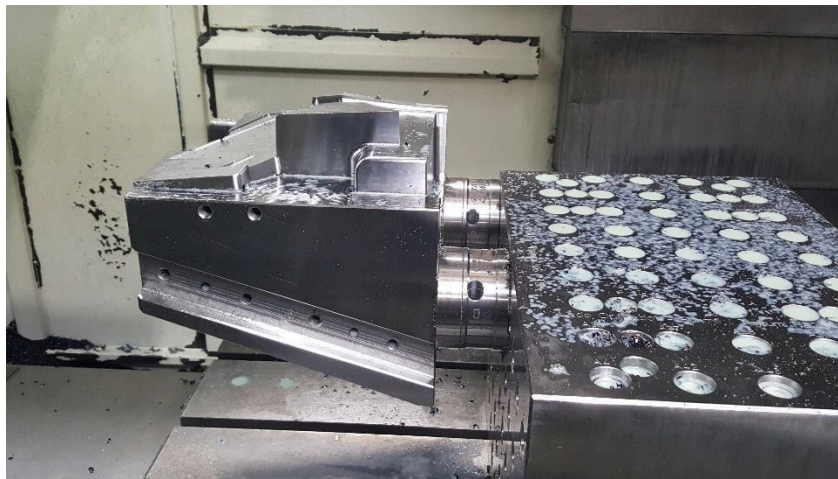
Figure 17: SMED

- SMED – The implementation was made in Jan-Feb 2019. The SMED system was acquired to reduce setup time and to eliminate mistakes in fixing the parts which would reduce NCs.
