## 16 Bayview Road

We were not given permission to scan the entire yard. We scanned the main line although we knew where it was from the valve system discovery. 14 Bayview Road Gas was tracked and it crosses into 16 Bayview Road and out to the road. It is 3' 9" below grade. Should not be an issue for a new service if/when needed.

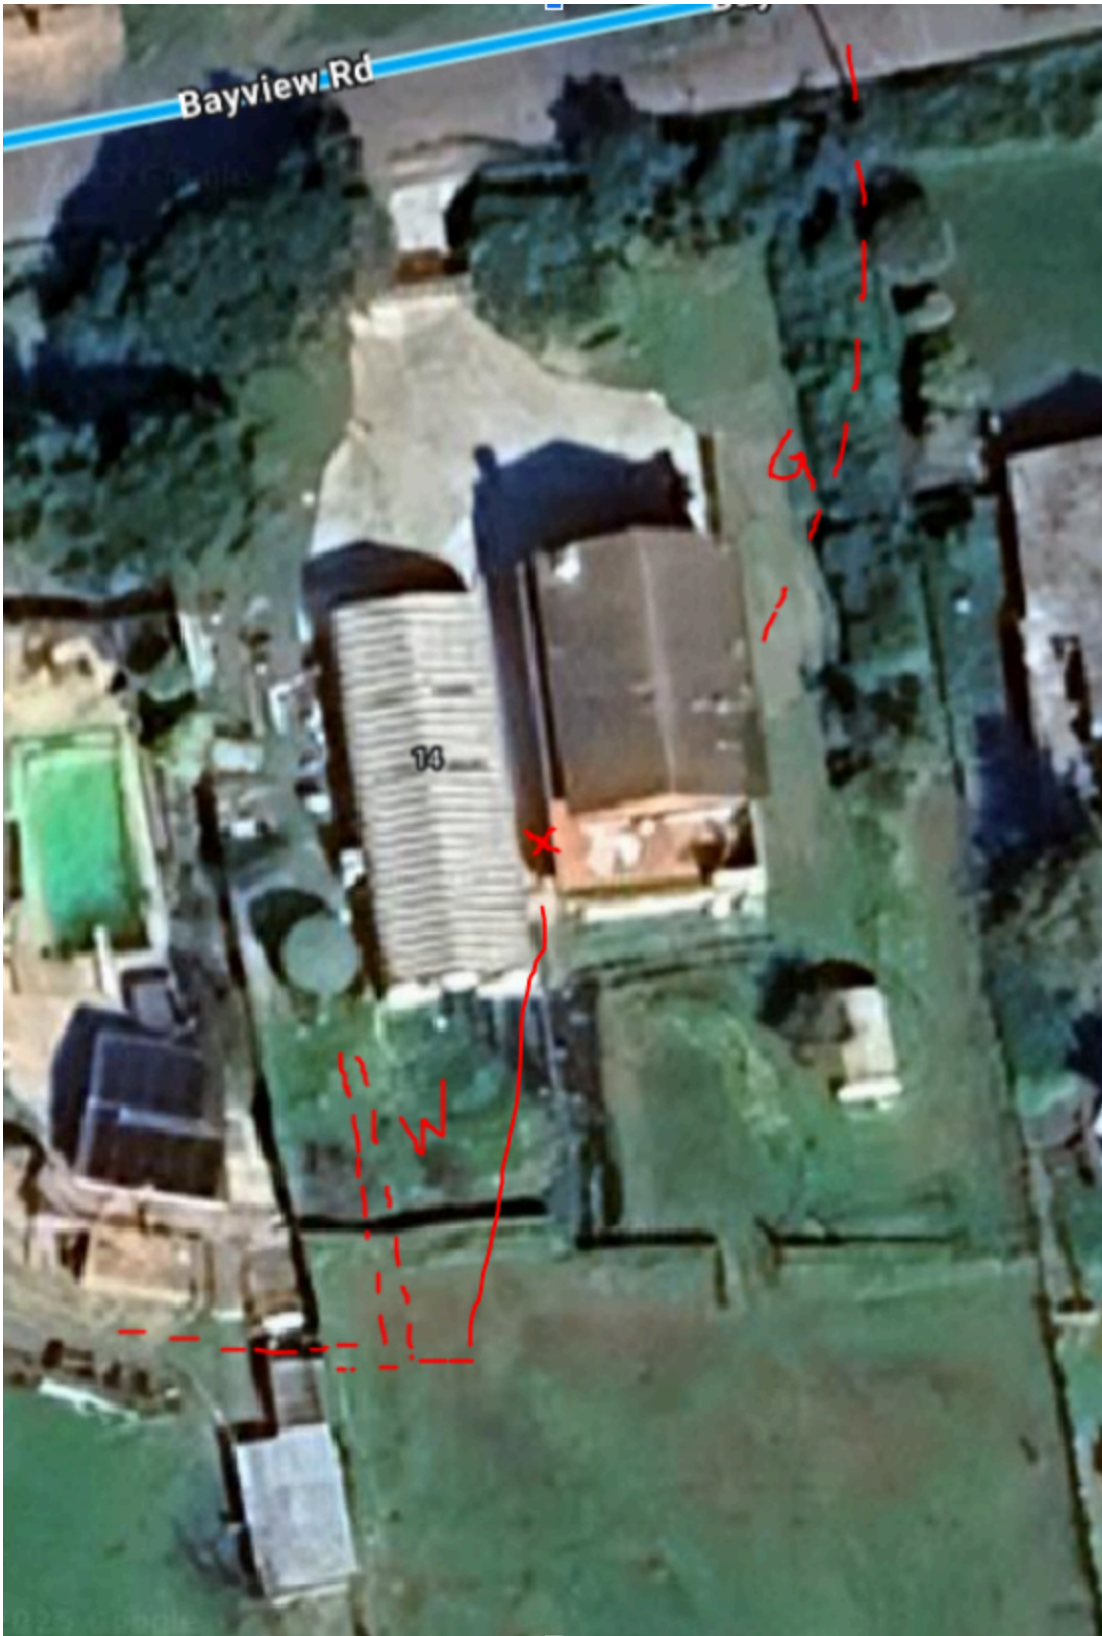
Rear yard below tank and above pasture

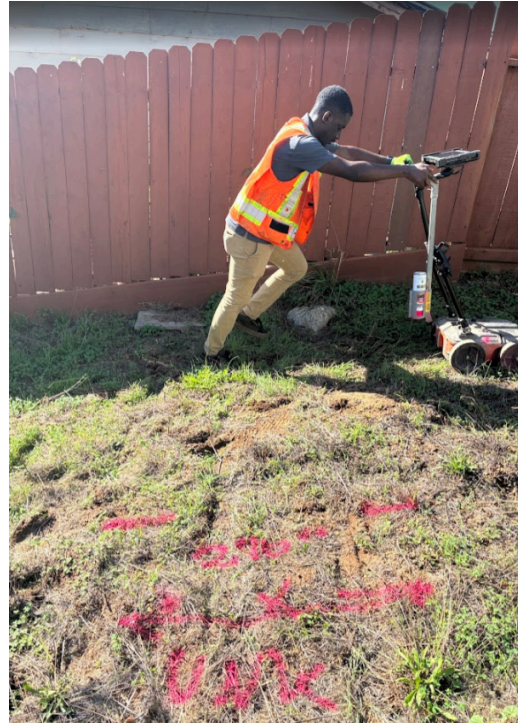
2' 10" deep -- it was a wide area because ground was wet and radar was less accurate

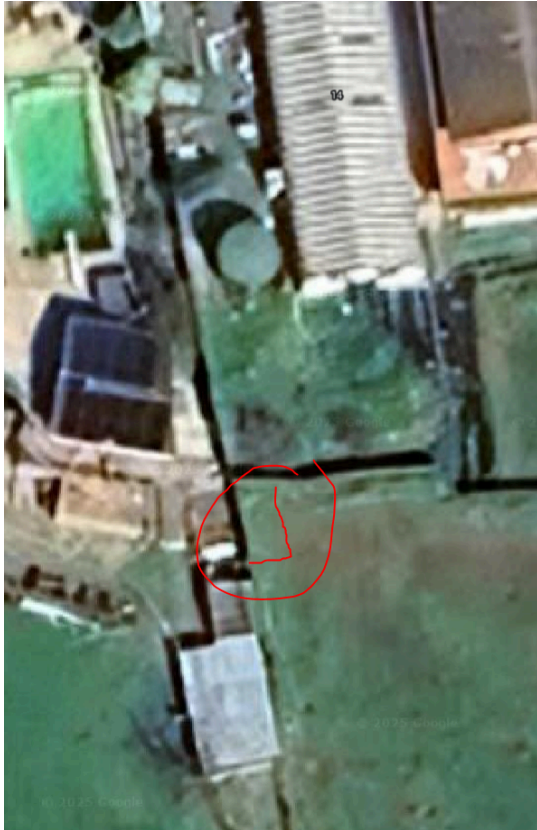
That is 2' 2" or 2' 6"

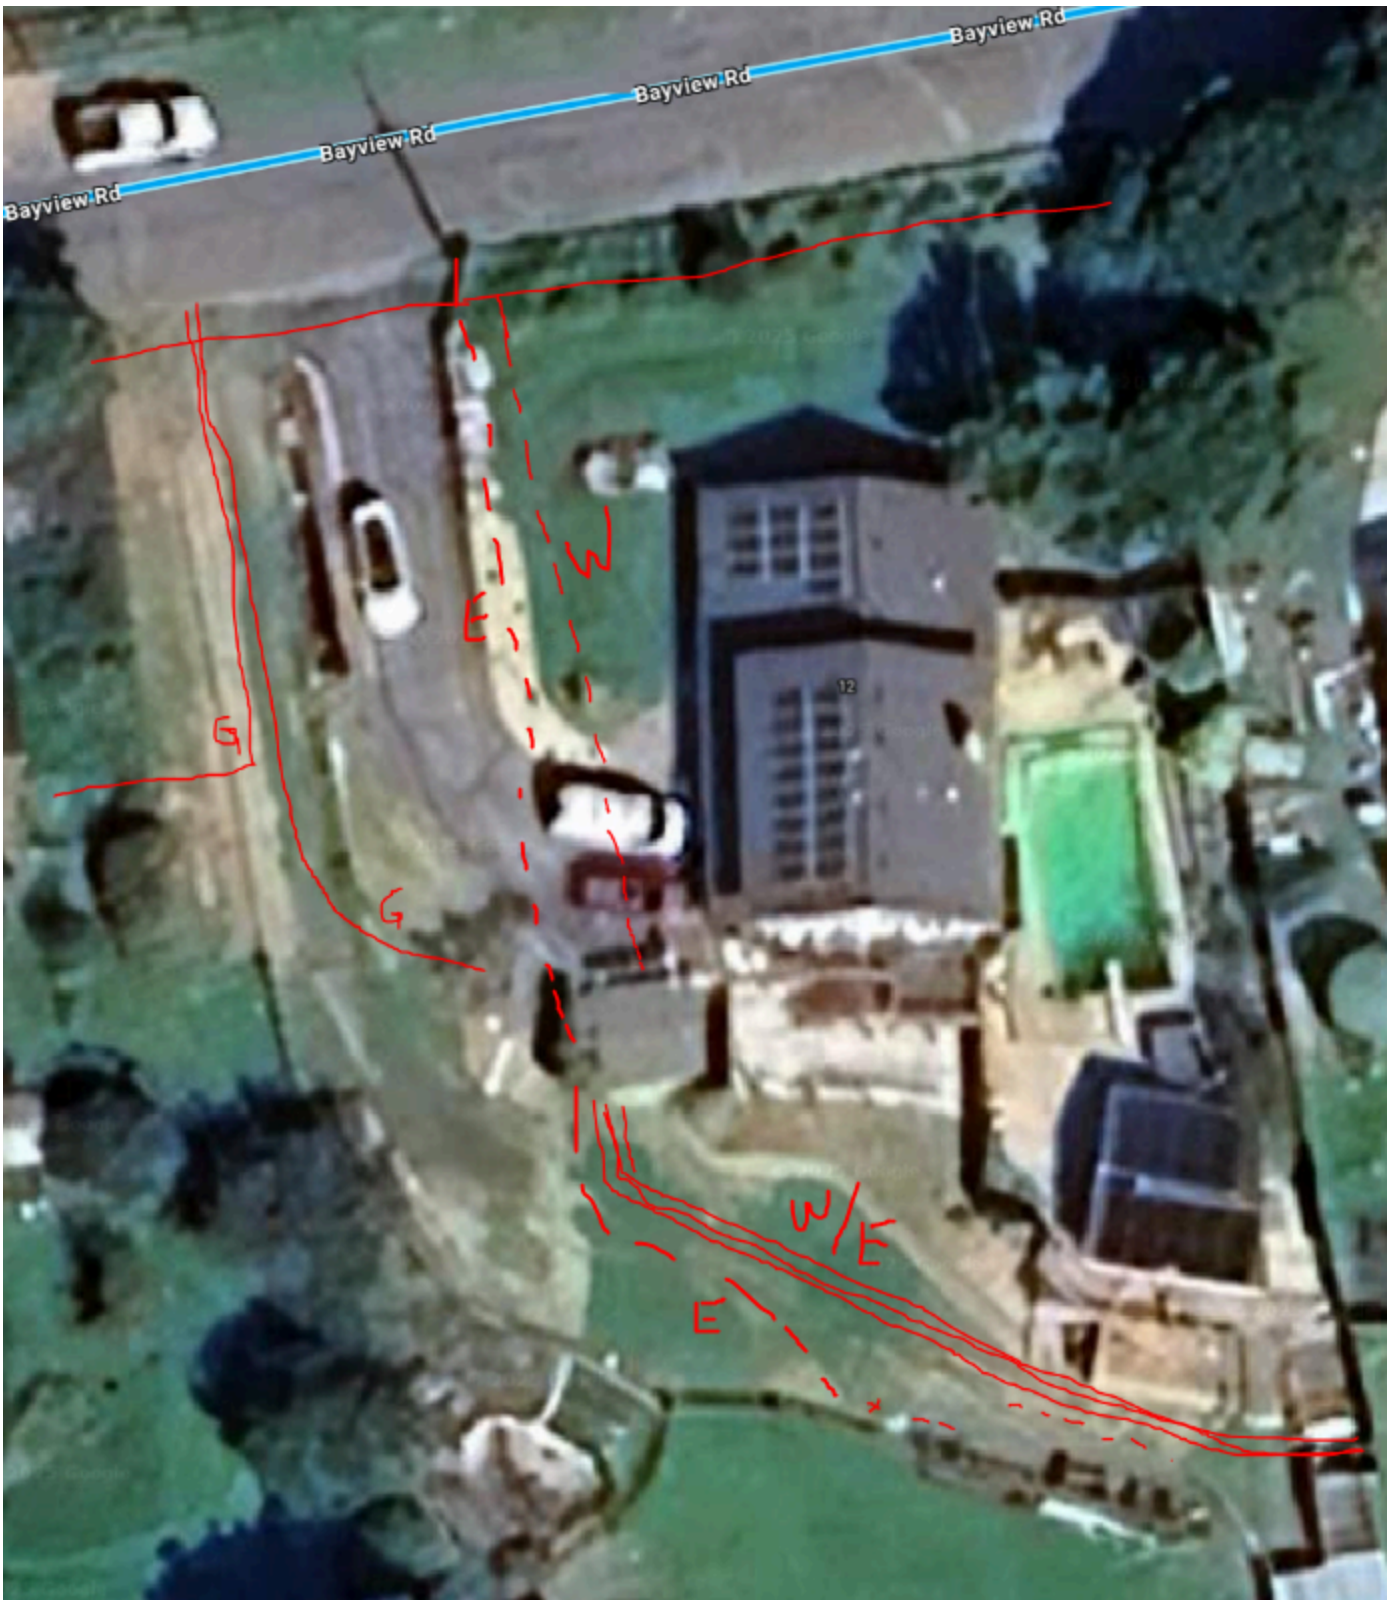
NOTE: the Electric lines are estimated, the water and gas were mapped

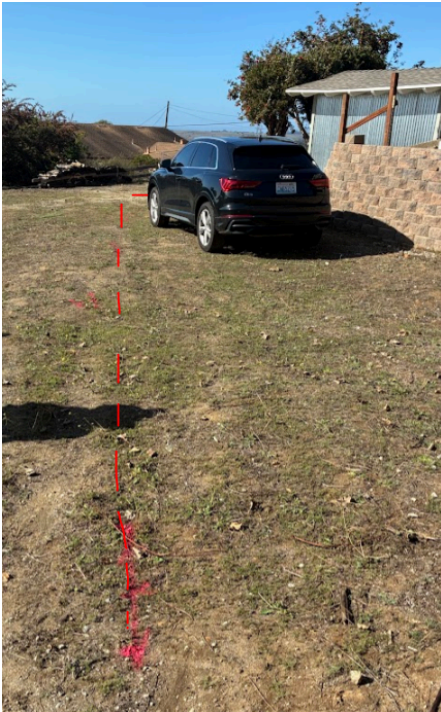
It crosses over the septic pit. It must be fairly shallow there.

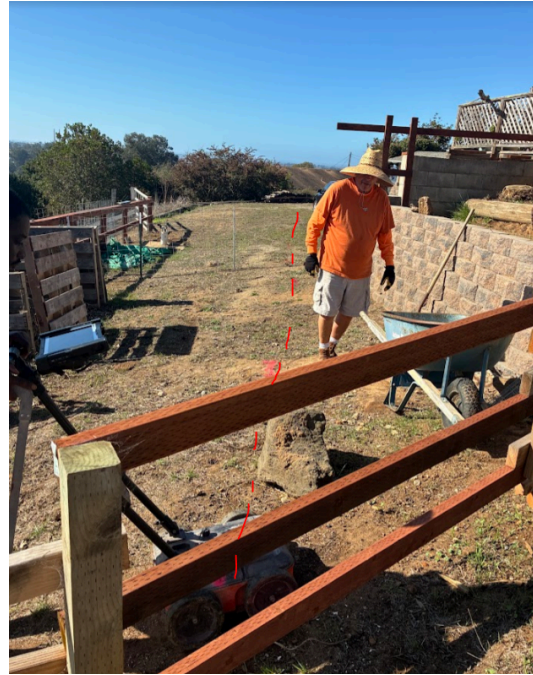
We could not find the well supply line  
On the backside of the head, there is a short area about 6" deep of something we are thinking it may be electrical.

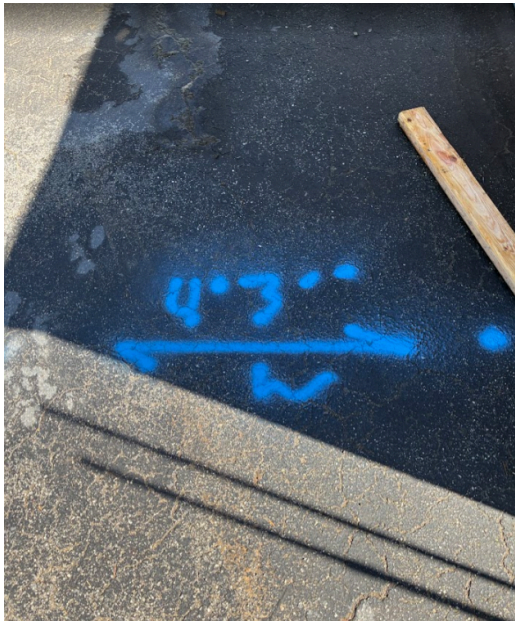
| <p data-bbox="110 848 769 919">This is in driveway about 4' from edge that drops to elbow 4'3" deep.</p> | |

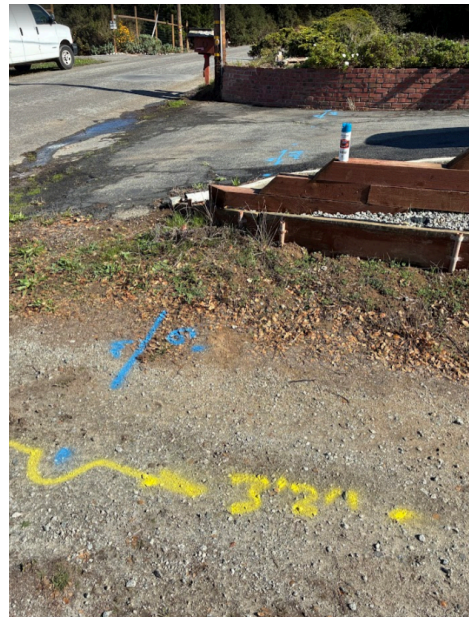
The blue mark is 6' deep

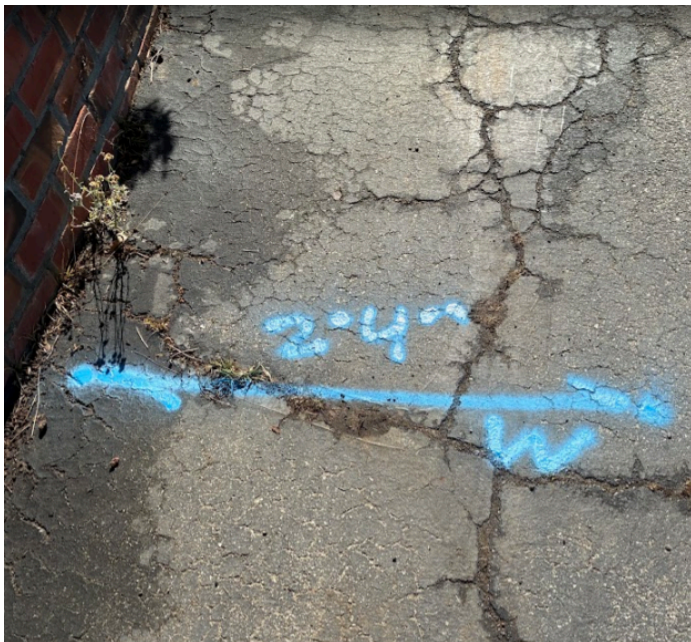
2'4" under left side of our driveway (when looking up driveway)

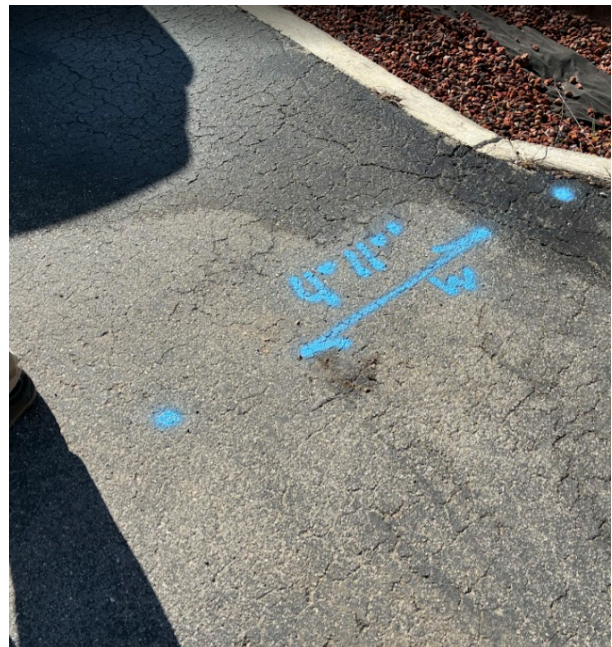
5' under right side of our driveway (when looking up driveway)

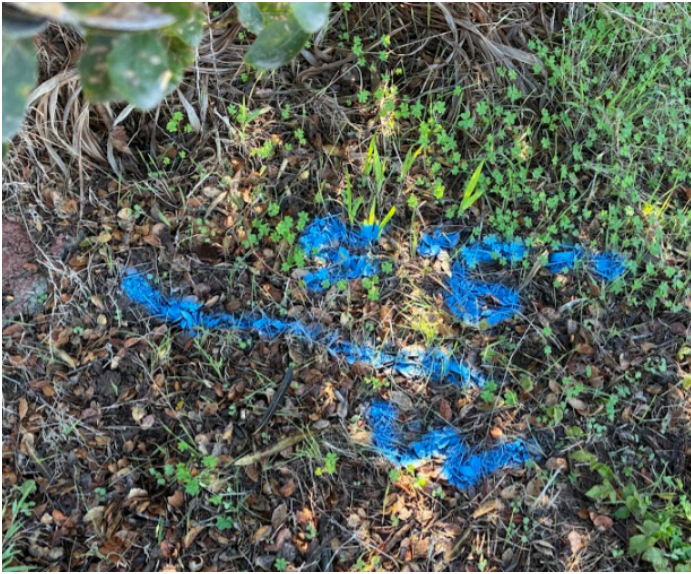
This is approaching Deirdre's side driveway from her yard, where it was only 6" deep at the edge of driveway

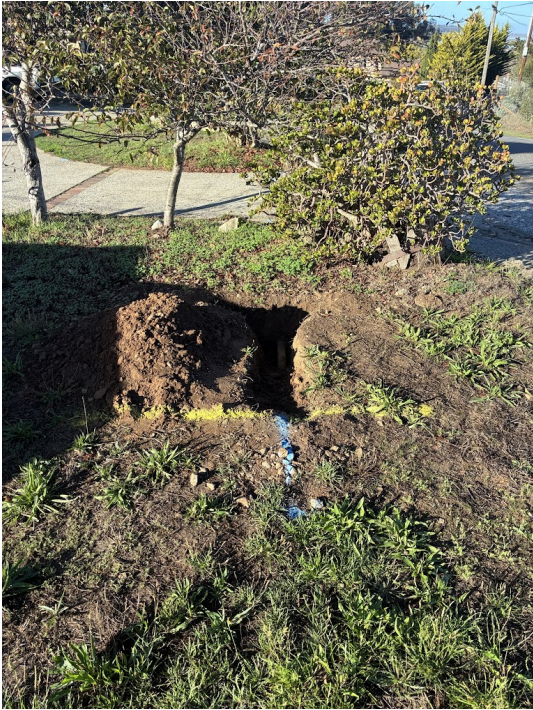
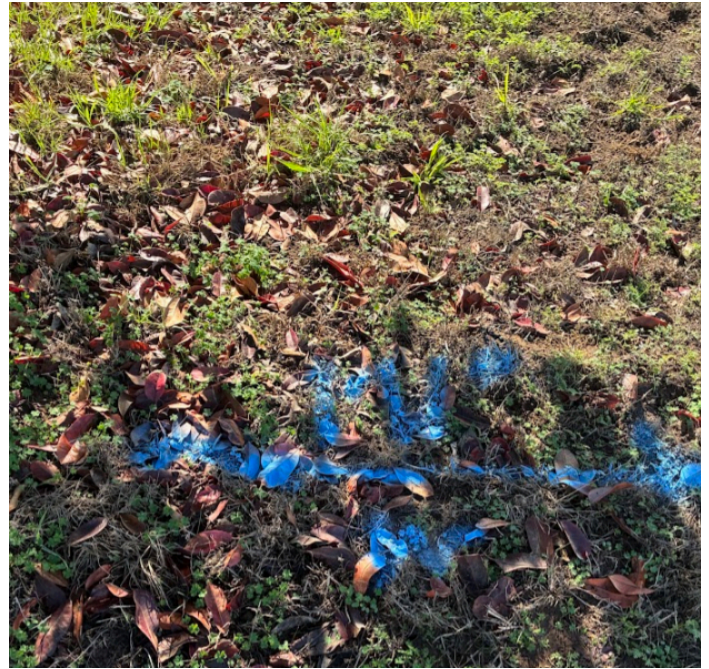
When looking at home this is on left side of left driveway

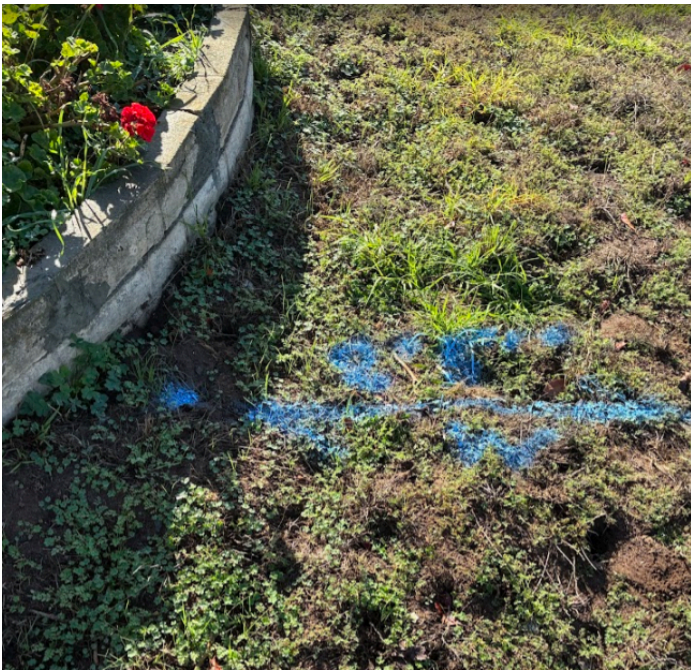
2'5 on right side of garden bed when looking at  
Jeromy's house

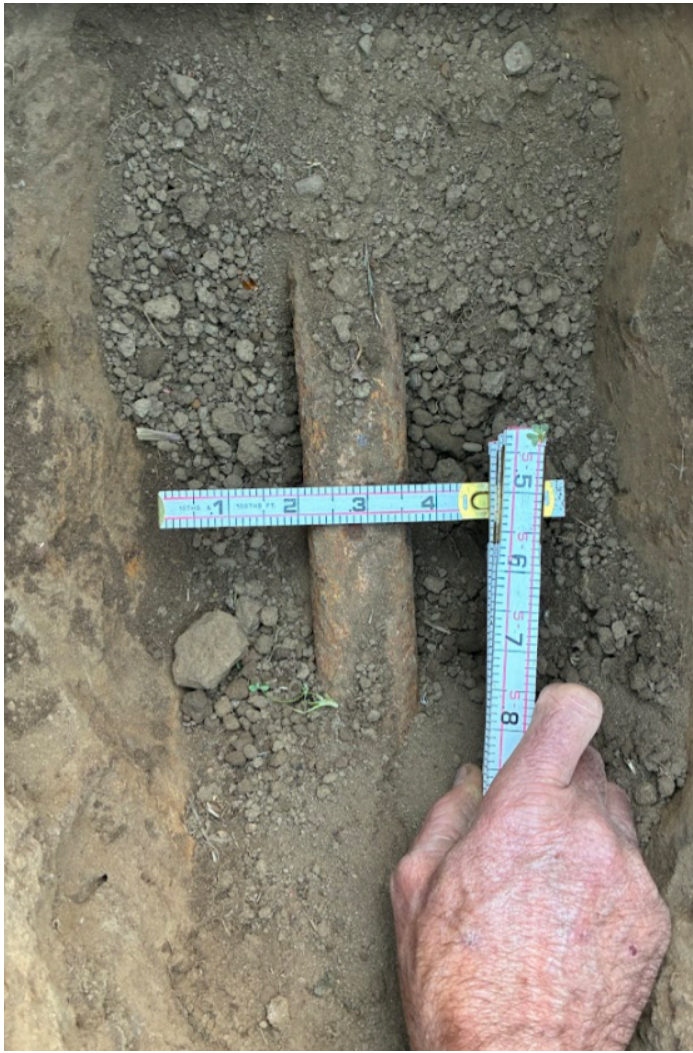
Waters Main is 1 5/8 OD below 6 bayview connection...

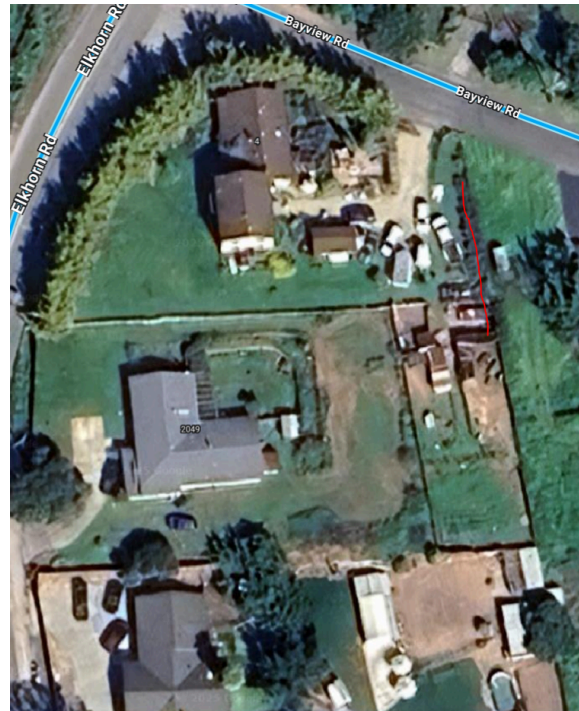
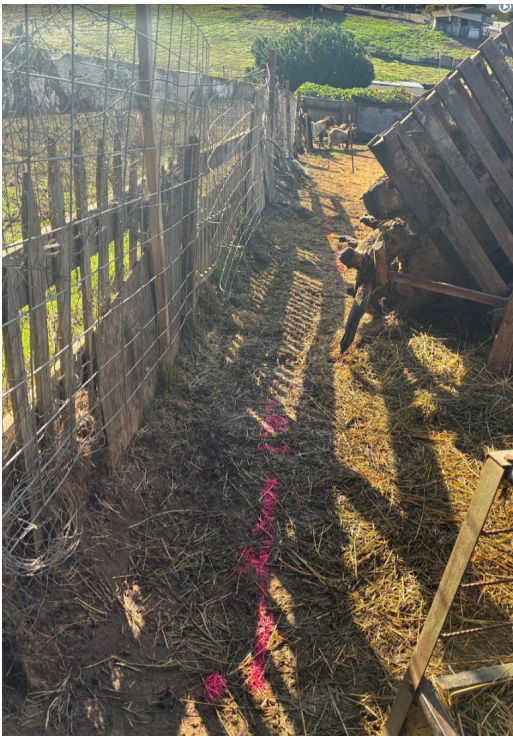
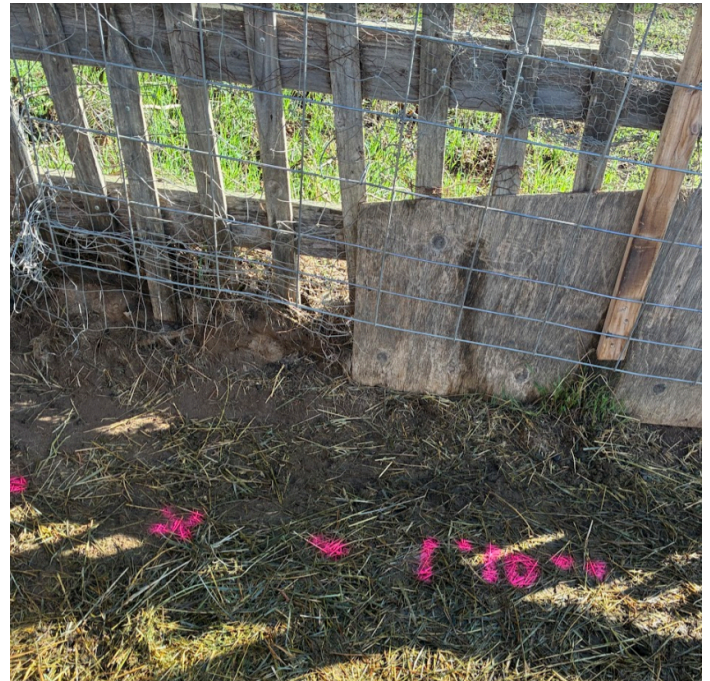
Inaccessible for maintenance or repair

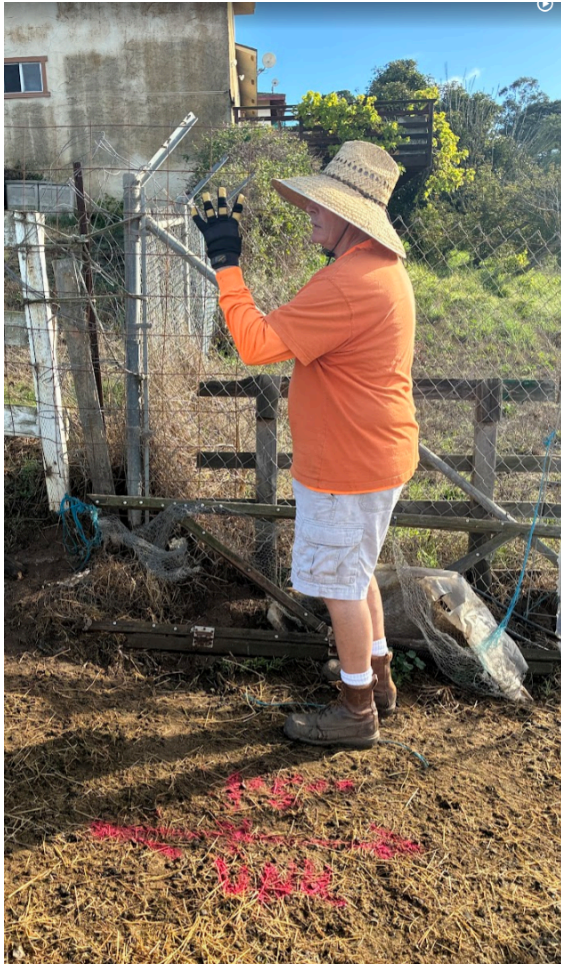
1.5" deep 4' from fence

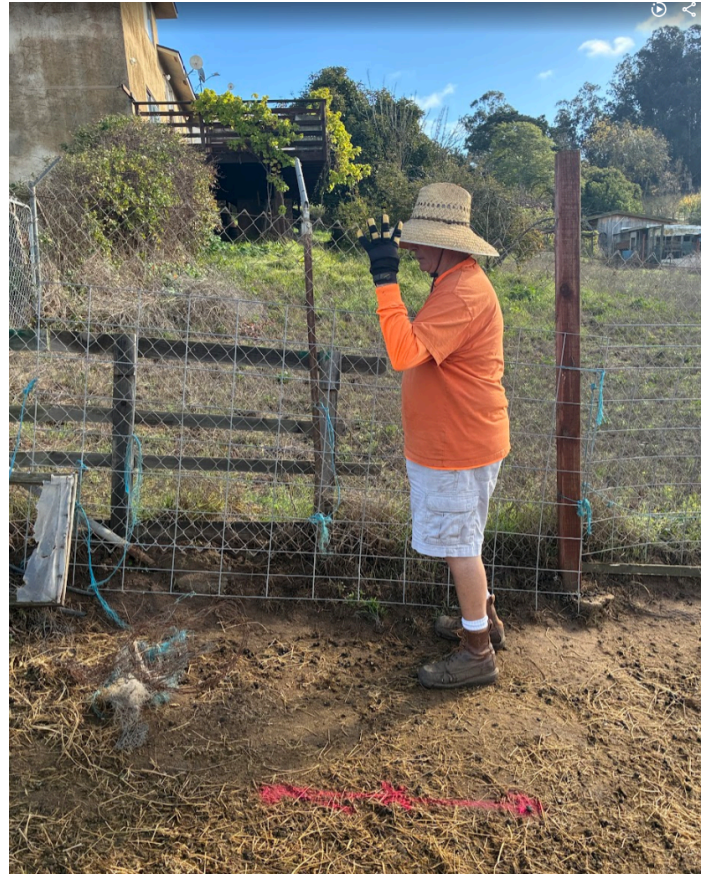
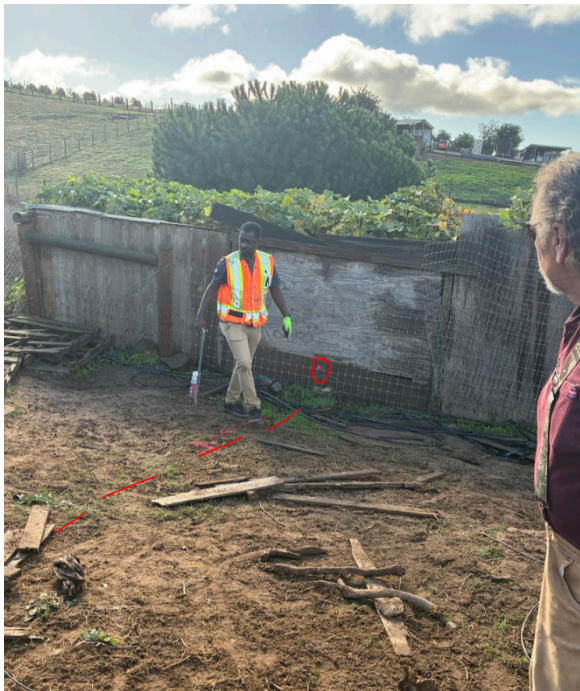
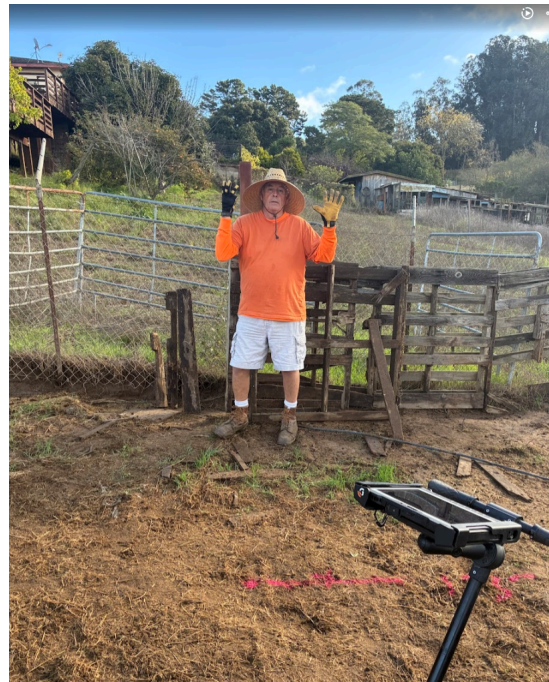
PVC line where riser broke -- and it's been capped,  
but it is not controlled by shut off on 4 Bayview.  
Controlled by one of the 2 on Elkhorn Road

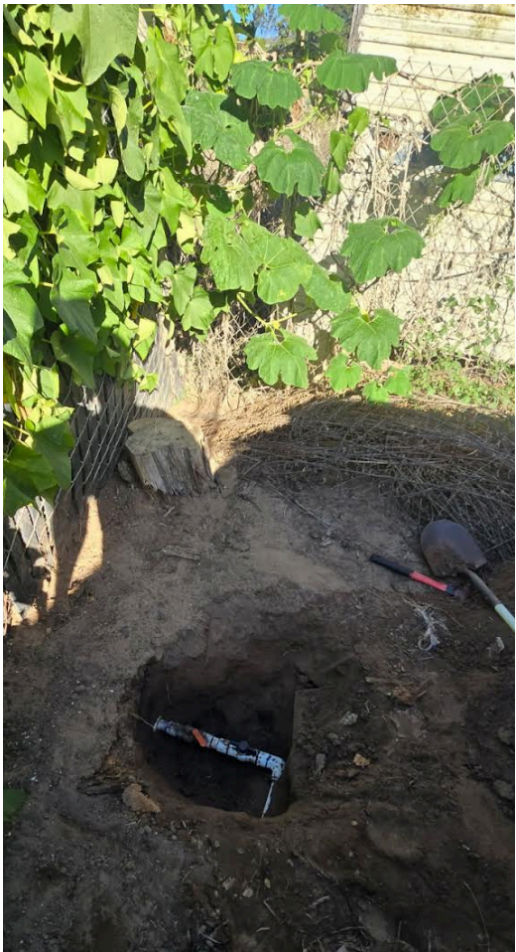
The water main comes in 10'-12' from rear of property but the shut off exposed is only about 6' from end of property. It's as if the shut off in view does not align with the incoming supply.
